WATER SUPPLY ANNUAL REPORT 2019-20

Water supply
2019-20 Annual Report

For year ending 30 June 2020

Lake Mountain Alpine Resort and Mount Baw Baw Alpine Resort

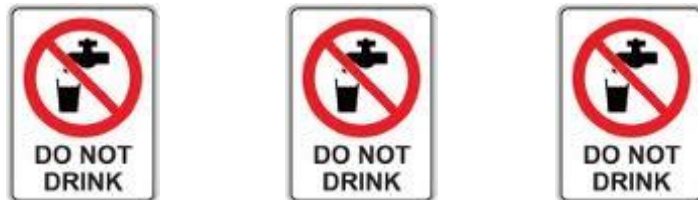
- A blanket signage program for all water outlets on the resort has been completed and maintenance schedule that is monitored through the resort Water Supply Risk Management Plan. All water outlets have been signed warning visitors to Lake Mountain that water is untreated and of the health risks that may arise from its use.

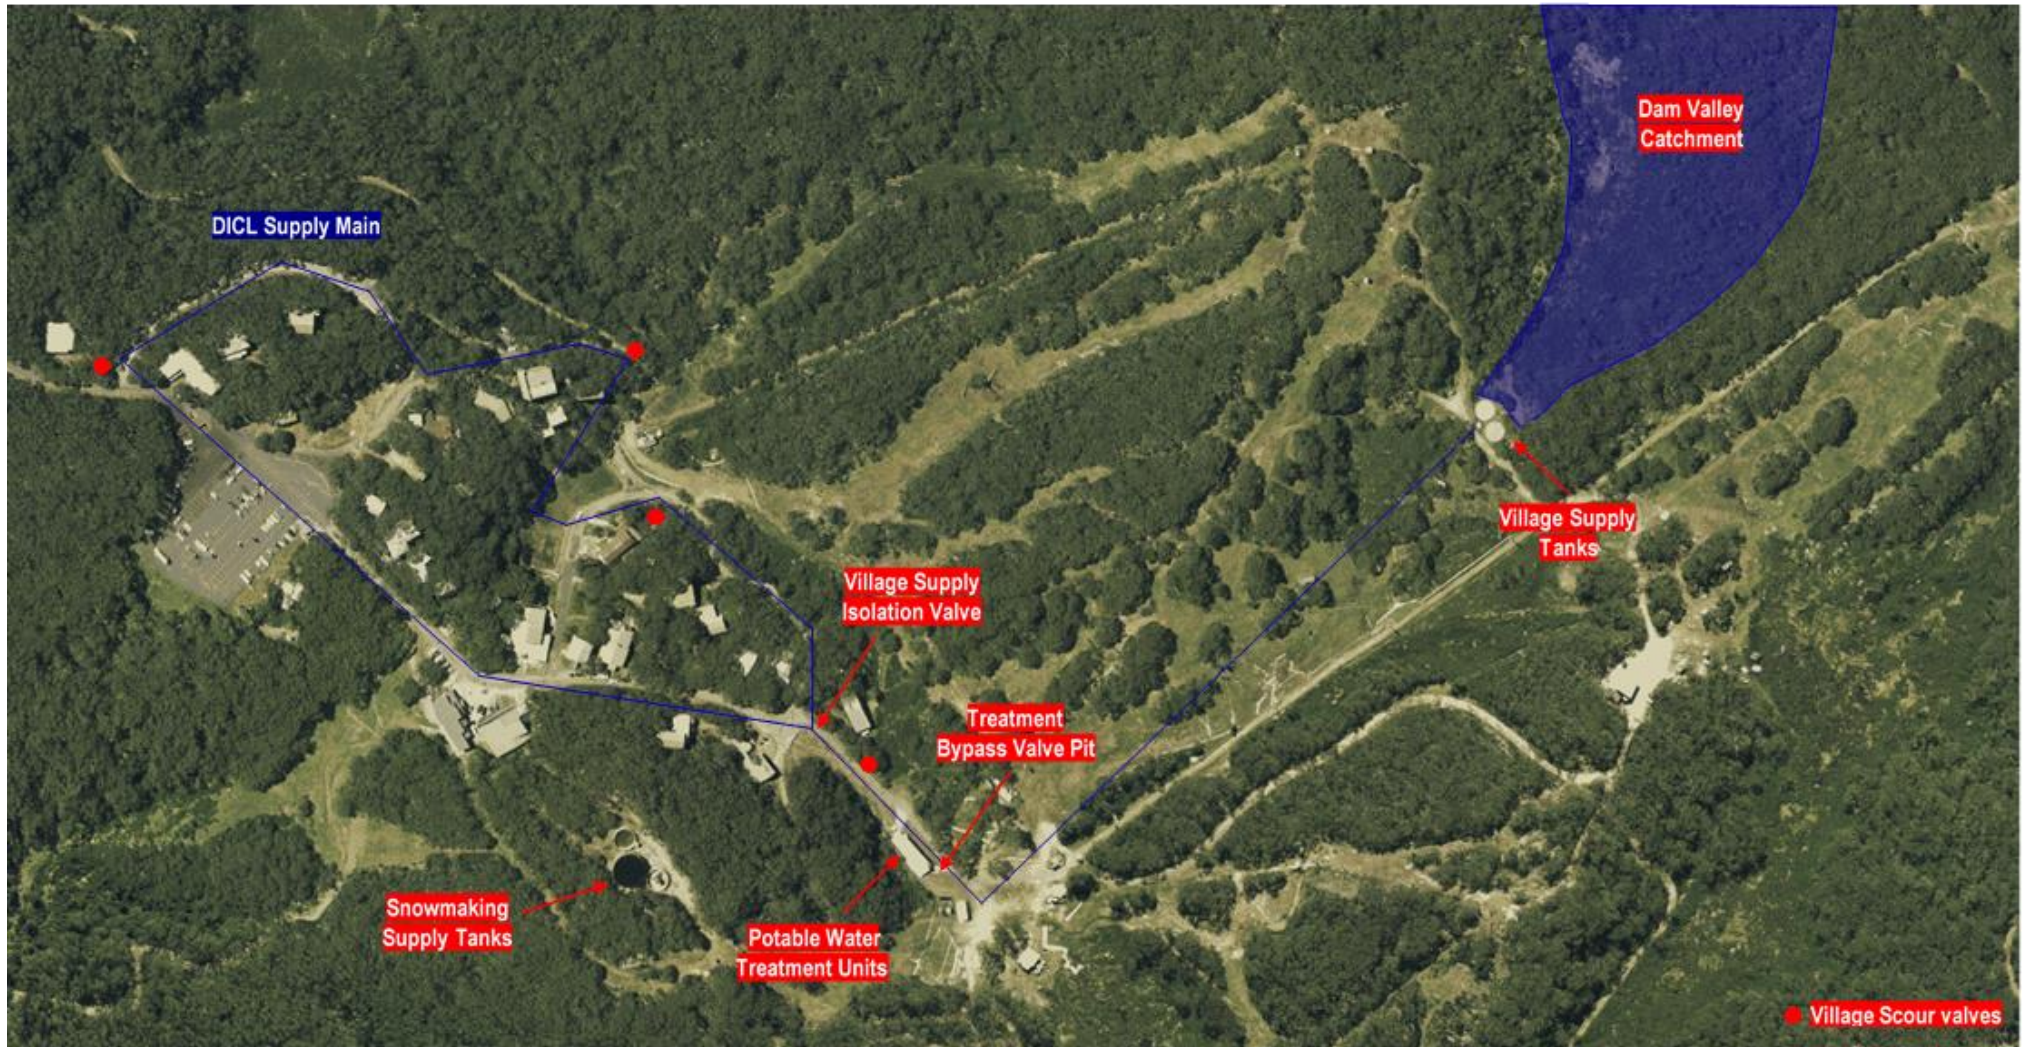
Figure 1: Aerial plan of the Baw Baw Village catchment locality and drinking water treatment and supply network

There are 4 scour valves within the reticulation system, and these are typically run at monthly intervals to ensure that there is no accumulation of sediments within the network. More or less sluicing is conducted dependent on water quality or availability. As the reticulation system is of a ring main configuration creating minimal dead ends, there is minimal stagnation in the lines (see figure 1 & 2).

Regular sluicing is undertaken at 4 scour valves within the reticulation system (figures 1 and 2). Catchment inspections are also a scheduled maintenance task under the RMP undertaken monthly to ensure that the catchment is clear of dead animals, faeces, and any other foreign matter, which may compromise or contaminate village water quality. Additional catchment inspections are also undertaken in the event of reported irregularities (i.e. dead animal smells, etc.).

Alpha Radiation has been tested using raw water samples sourced from Dam Valley catchment (figure 1) to determine screening levels.

Beta Radiation has been tested using water samples sourced from Dam Valley catchment (figure 1) to determine screening levels.

Copper tests were sampled from raw water supply tank samples (figure 1).

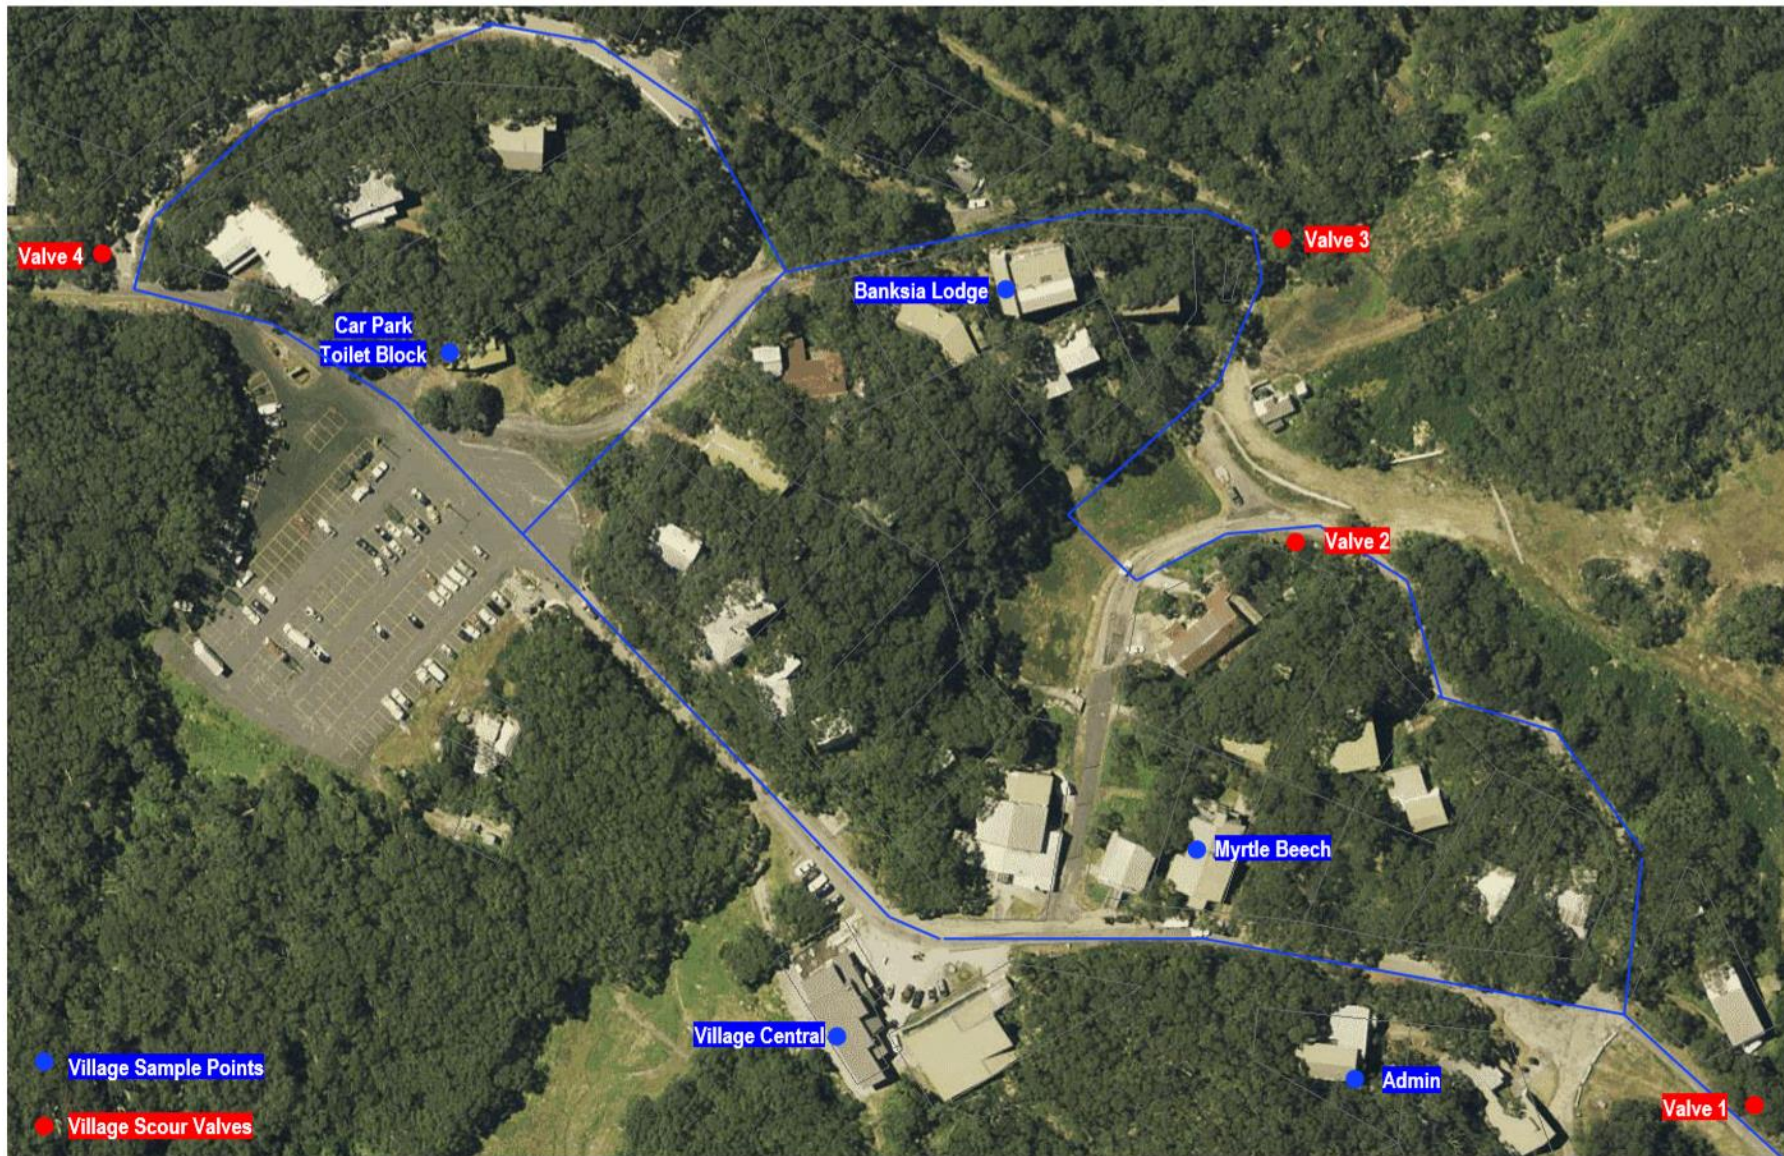
Figure 2: Baw Baw Village drinking water reticulation network, scour valves and sample locations

The following drinking water quality samples were taken from the village reticulation points shown in figure 2.

Chloroacetic acid sampled post treatment within the reticulation network at the points shown in figure 2 to determine levels of chlorine treatment by-products.

Dichloroacetic acid sampled post treatment within the reticulation network at the points shown in figure 2 to determine levels of chlorine treatment by-products.

Trichloroacetic acid sampled post treatment within the reticulation network at points shown in figure 2 to determine levels of chlorine treatment by-products.

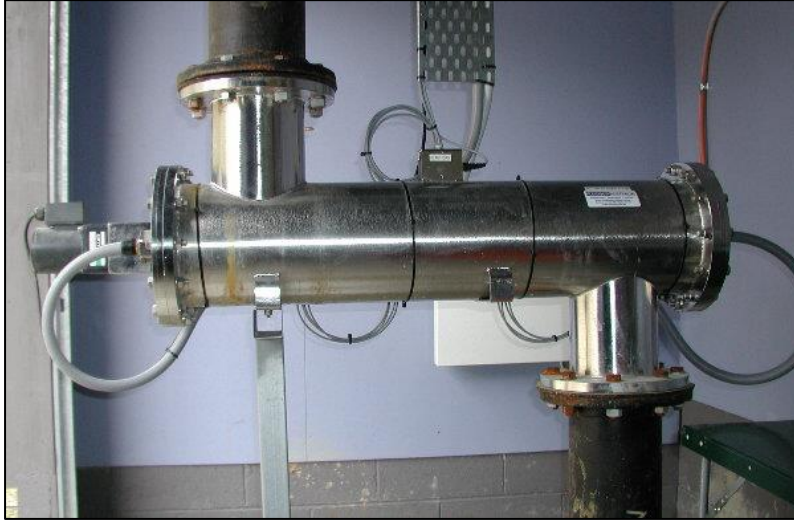
The Resort utilises a Hanovia PMD200F Ultra Violet (UV) Treatment Plant to sterilise water to a consumable quality. A sketch image and photograph of the UV treatment plant is shown below.

Figure 3: Hanovia PMD200F UV Treatment System in place

In addition to the abovementioned UV Treatment Plant (see figures 3 and 4), a residual trim unit provides automated chlorine dosing dependant on flow rates, post UV treatment. The residual trim unit acts as a secondary disinfection barrier in the resort's multiple barrier approach to water treatment. This unit provides the ability to control the level of dosing remotely and maintain a disinfection residual within the reticulation system.

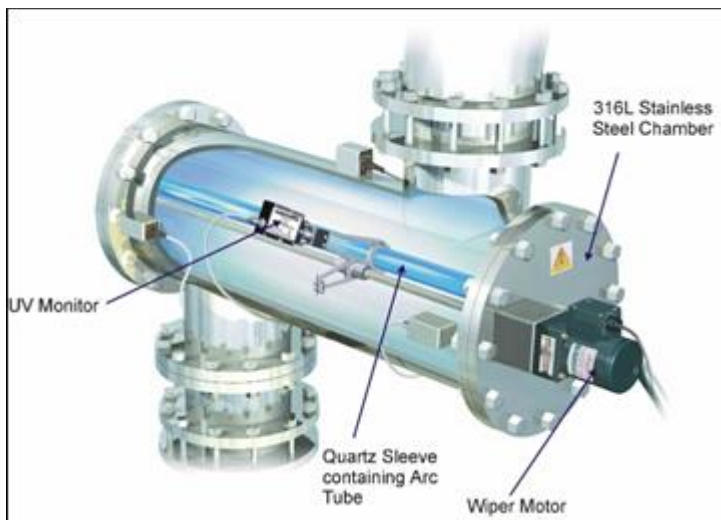
Figure 4: Hanovia PMD200F UV treatment unit
