ANNUAL REPORT 2016-2017

DRINKING WATER SUPPLY

**MT BULLER AND
MT STIRLING ALPINE RESORTS**

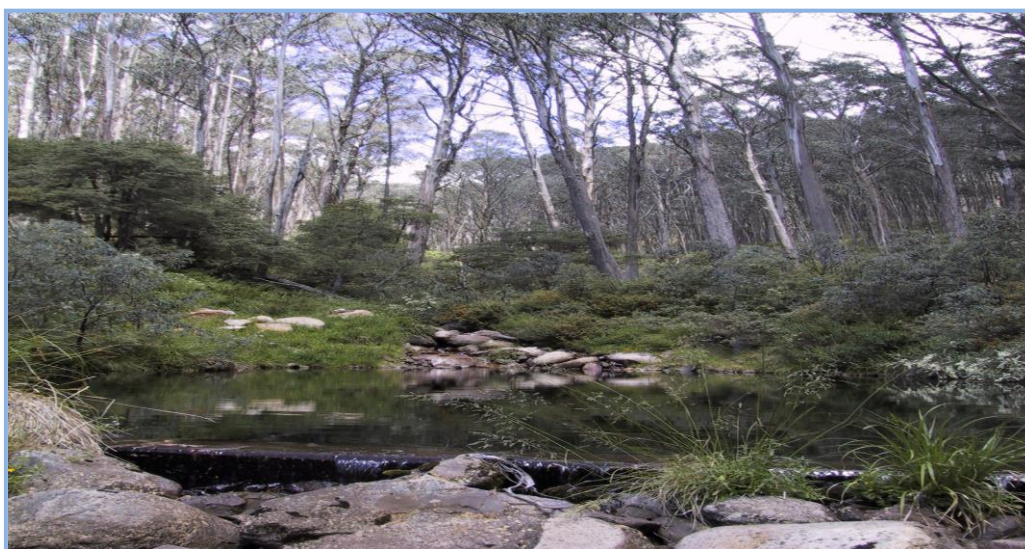
Boggy Creek Catchment

The above picture gives a good indication of the nature of the catchment from which the Mt Buller Alpine Village drinking water is sourced. The topography is steep and vegetated. The catchment lies in montane, sub alpine and alpine areas. There are few weeds or other exotic flora. Fauna consists of a range of species including deer, wombat, wallabies and varied bird species. The catchment is relatively inaccessible and is an area where vehicle access is controlled. There are several walking paths through the catchment, and camping is not permitted.

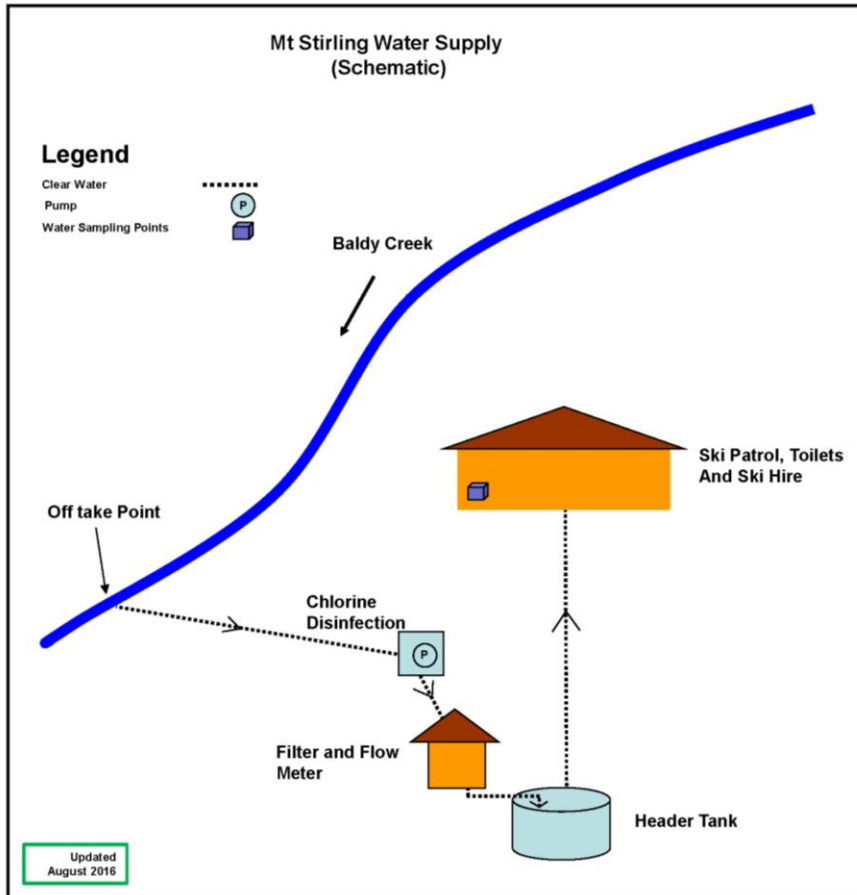
Water is pumped from Baldy Creek, and then disinfected with sodium hypochlorite through a cartridge filter prior to being stored in a Header Tank. The water is then gravity fed through the small reticulation system.

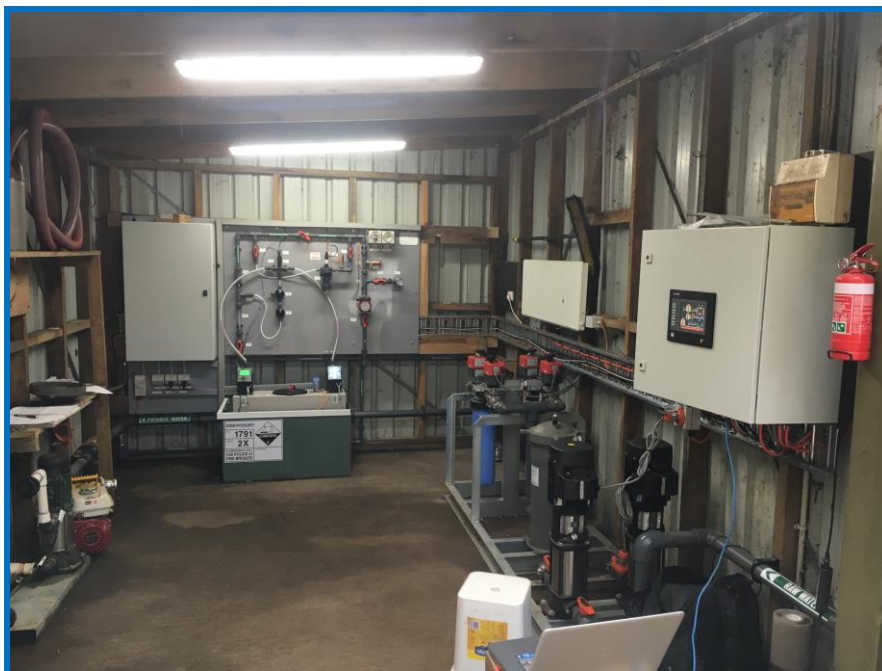
Upgrade Mirimbah Water Treatment Plant

The water treatment plant was upgraded at Mirimbah in the summer of 2017. The water treatment process remains the same, however all the treatment equipment has been replaced. The big

improvements with the system include; a new raw water (settling) tank, new automated chlorine dosing system, remote monitoring and control to all parts of the process.

As part of the system upgrade the balance tank that sat between the Mirimbah head tank and the Mirimbah store has been removed. The balance tank was a contributing factor to an *E.coli* detection in the Mirimbah system and as a result not meeting the *E.coli* water quality standard. More detailed information on this issue is discussed under the Emergency Incident and Event management section of the report.

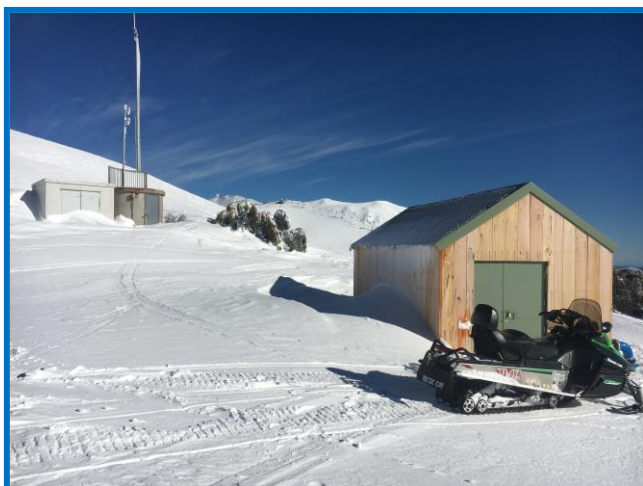
**New High Level Water
Treatment Plant Building**

The High Level Water Treatment Plant was upgraded during the 2017 summer period. The treatment process has not changed, but the equipment, pipework, and fittings have all been upgraded.

Some of the improvements are; A new purpose built building to house the HL WTP, a new UV disinfection system, correct spacing between equipment to allow for adequate mixing/measuring of free chlorine and laminar flows, new Variable Frequency Drive controlled pump for Koflers and Flakeside duties.

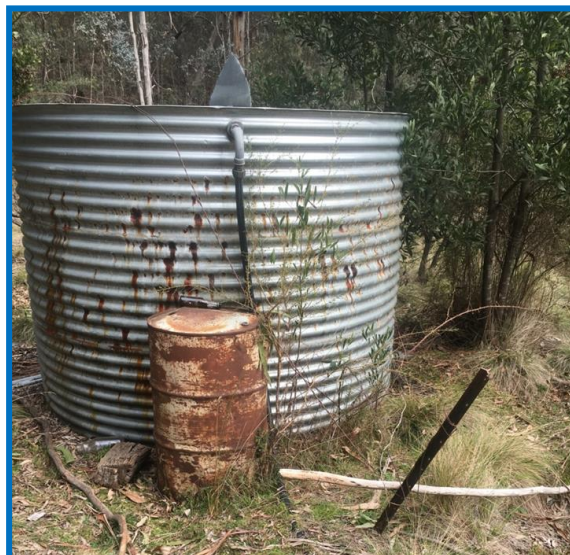
Redundant Mirimbah Store Buffer Tank

- low usage resulting in chlorine decay. I.e. low chlorine residuals
- Mirimbah Store buffer tank
 - Its inspection hole is permanently uncovered, exposing treated water to environmental conditions
 - Chlorine consumed through oxidation of metals in tank
 - A possible contamination of biological activity in the tank
 - Further decay of chlorine with minimal draw at the store over the past few weeks.

During the summer the WTP was upgraded (see pages 12-13) and the Mirimbah Store buffer tank was eliminated/bypassed.
