WATER SUPPLY ANNUAL REPORT 2020-21

Water supply
2020-21 Annual Report

For year ending 30 June 2021

Lake Mountain Alpine Resort and Mount Baw Baw Alpine Resort

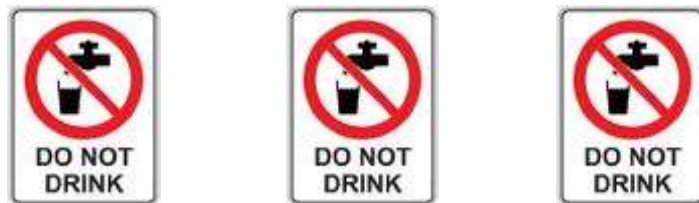
- A blanket signage program for all water outlets on the resort has been completed and maintenance schedule that is monitored through the resort Water Supply Risk Management Plan. All water outlets have been signed warning visitors to Lake Mountain that water is untreated and of the health risks that may arise from its use.

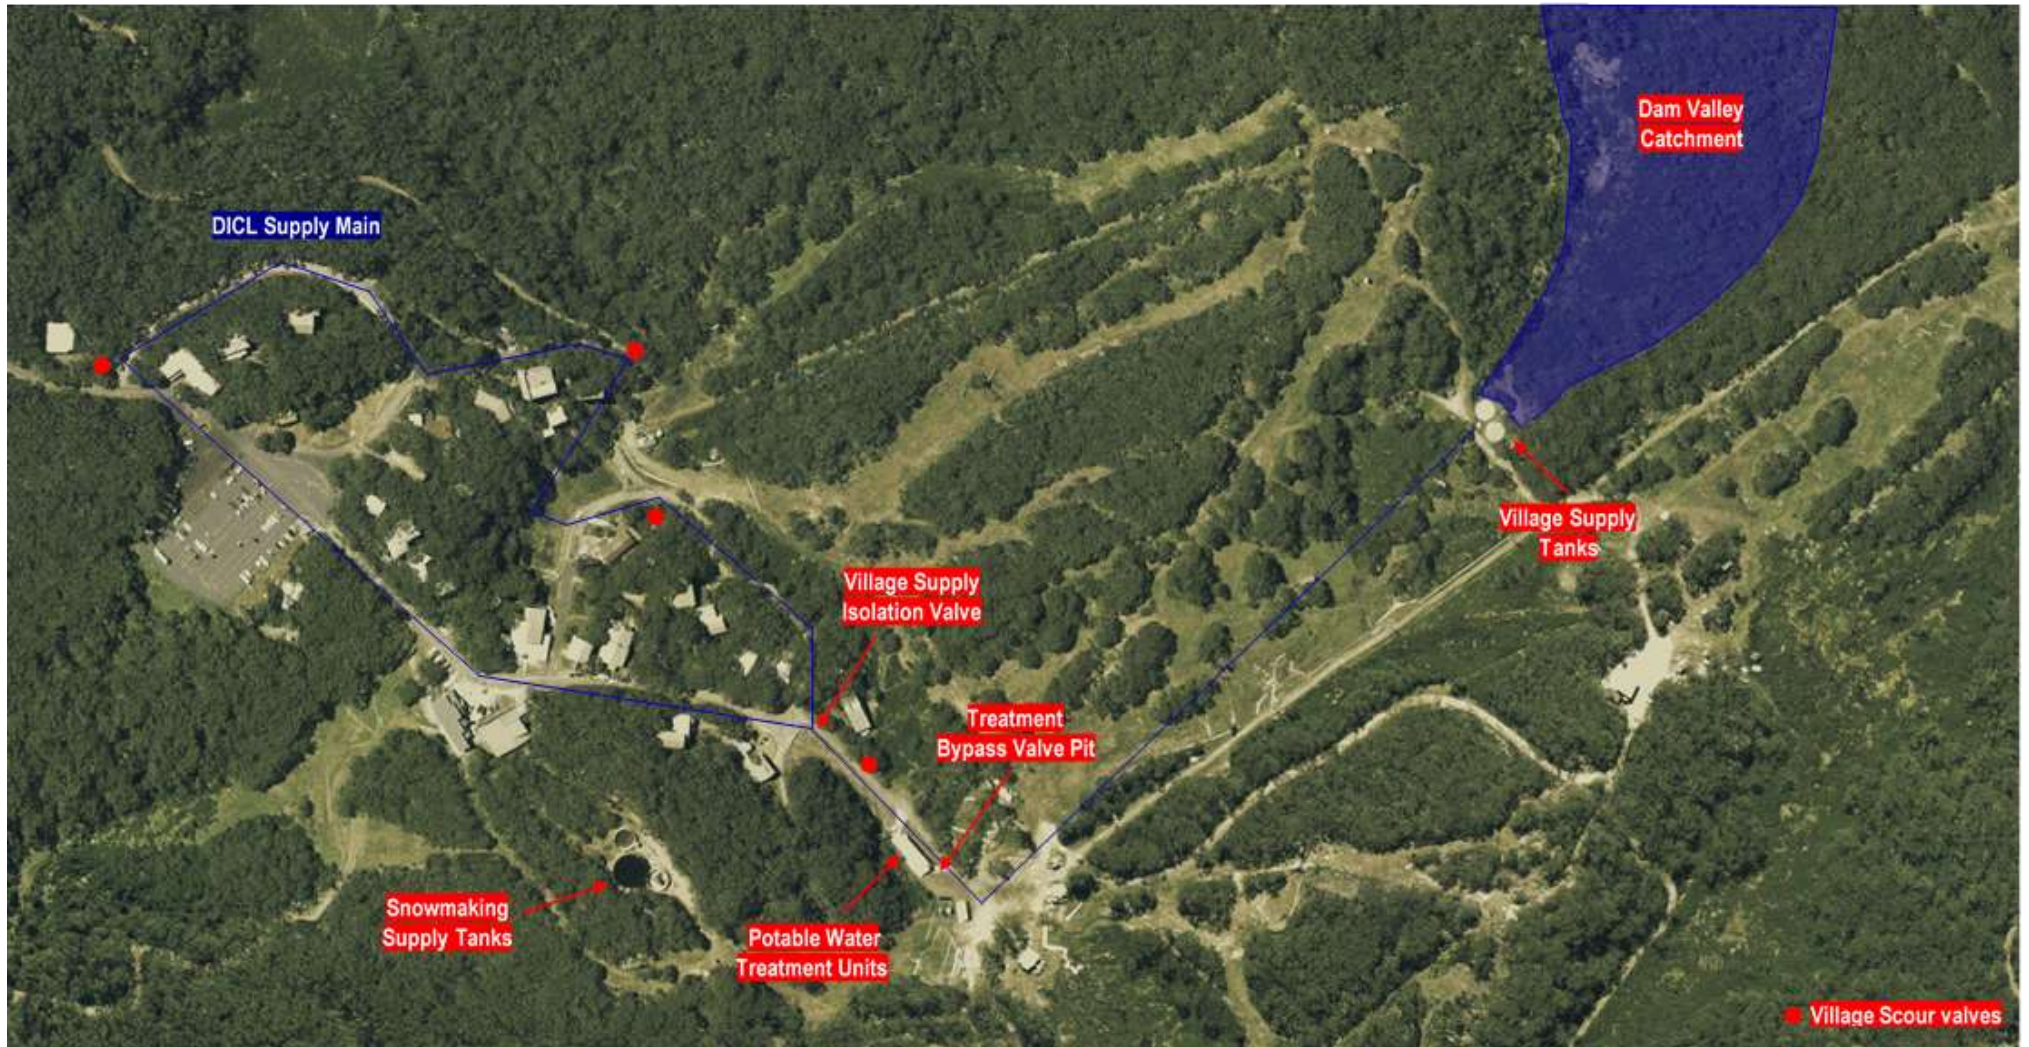
Figure 1: Aerial plan of the Baw Baw Village catchment locality and drinking water treatment and supply network

The service area encompasses the entirety of the Baw Baw Village which can be seen in figure 2. Water is treated at the potable water treatment units (figure 1) on demand before being distributed throughout the village under a pressurised system. The majority of the village reticulation is made from 100mm galvanised or DACL pipework. There are 4 scour valves within the reticulation system, and these are typically run at monthly intervals to ensure that there is no accumulation of sediments within the network. More or less sluicing is conducted dependent on water quality or availability.

Location	Treatment Process	Added Substances	Byproducts monitored
Drinking Water Treatment Units (figure 1)	Pre-oxidation	Chlorine Dioxide	Chlorite
	Ultra Violet (UV) Hanovia PMD200F	N/A	N/A
	Chlorination C-Tech Residual Trim Unit	Sodium Hypochlorite	THMs

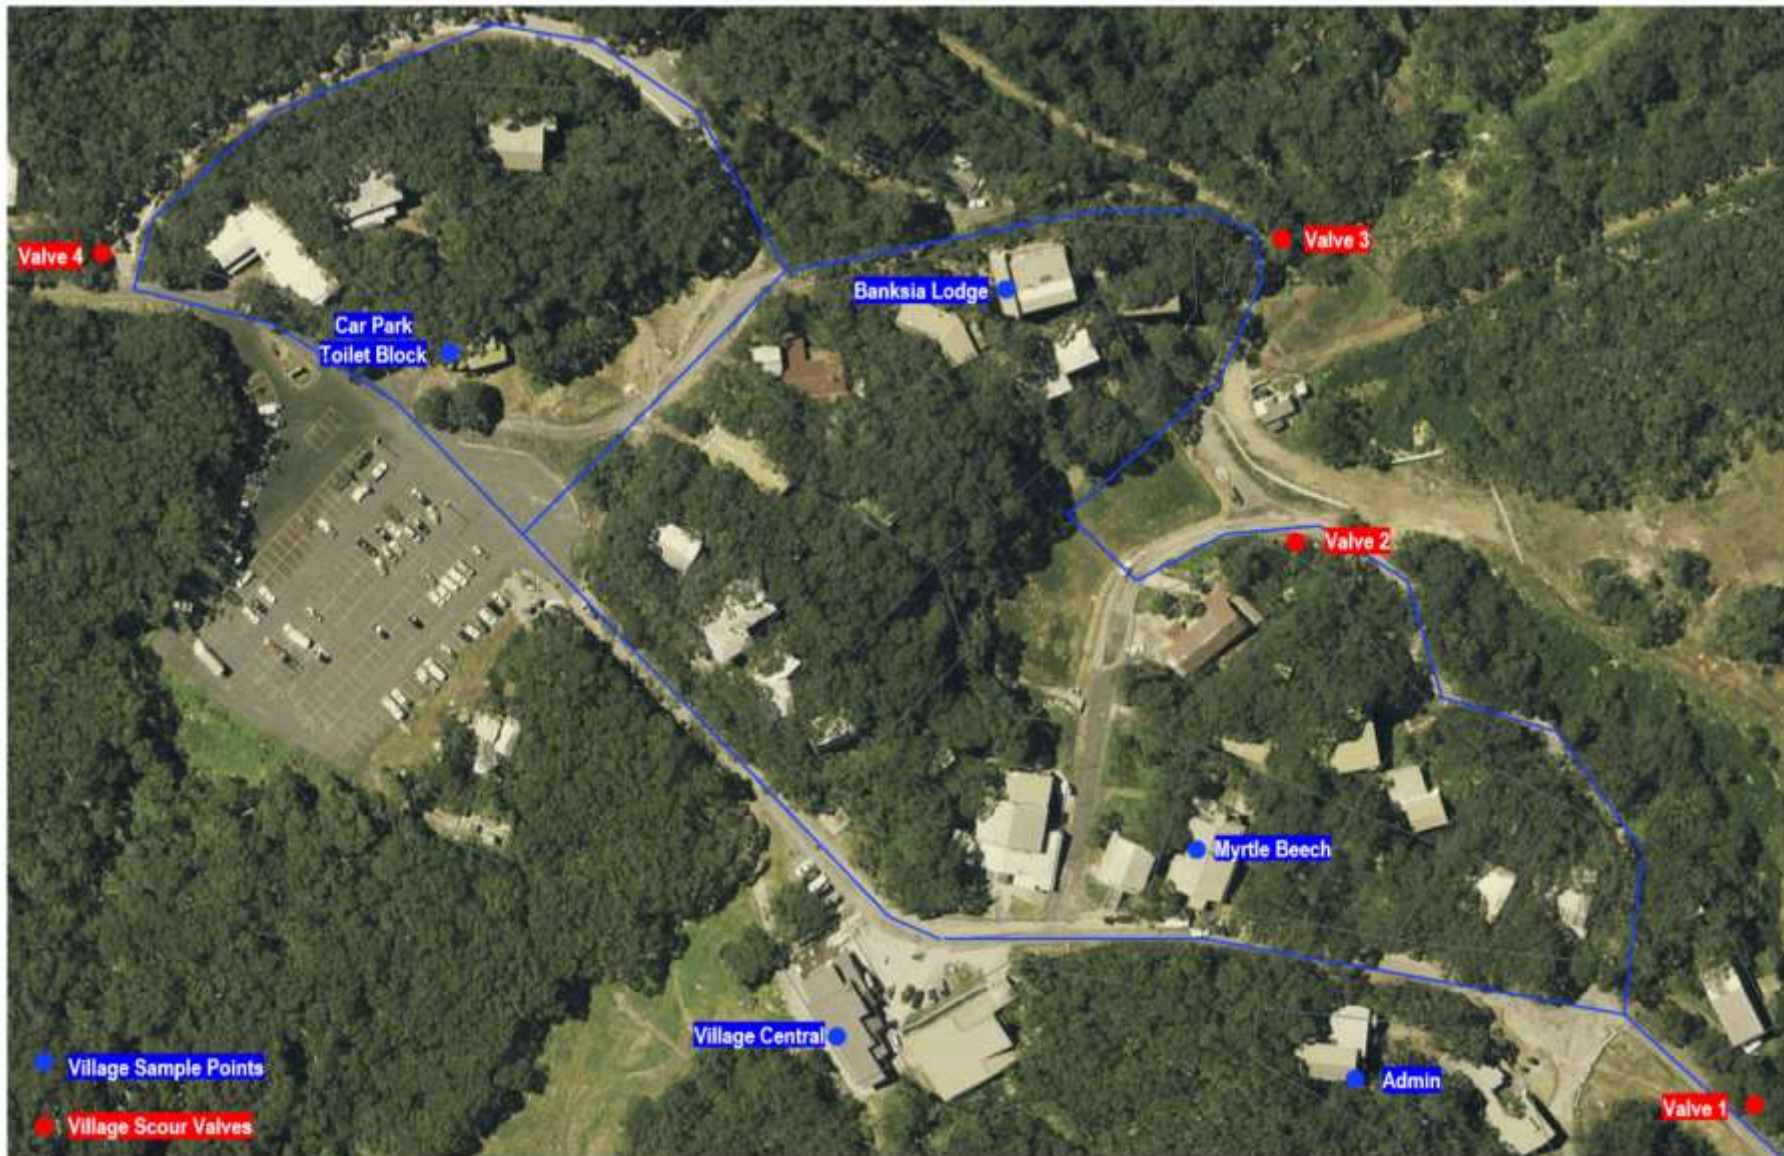
Figure 2: Baw Baw Village drinking water reticulation network, scour valves and sample locations

Chloroacetic acid sampled post treatment within the reticulation network at the points shown in figure 2 to determine levels of chlorine treatment by-products.

Dichloroacetic acid sampled post treatment within the reticulation network at the points shown in figure 2 to determine levels of chlorine treatment by-products.

Trichloroacetic acid sampled post treatment within the reticulation network at points shown in figure 2 to determine levels of chlorine treatment by-products.

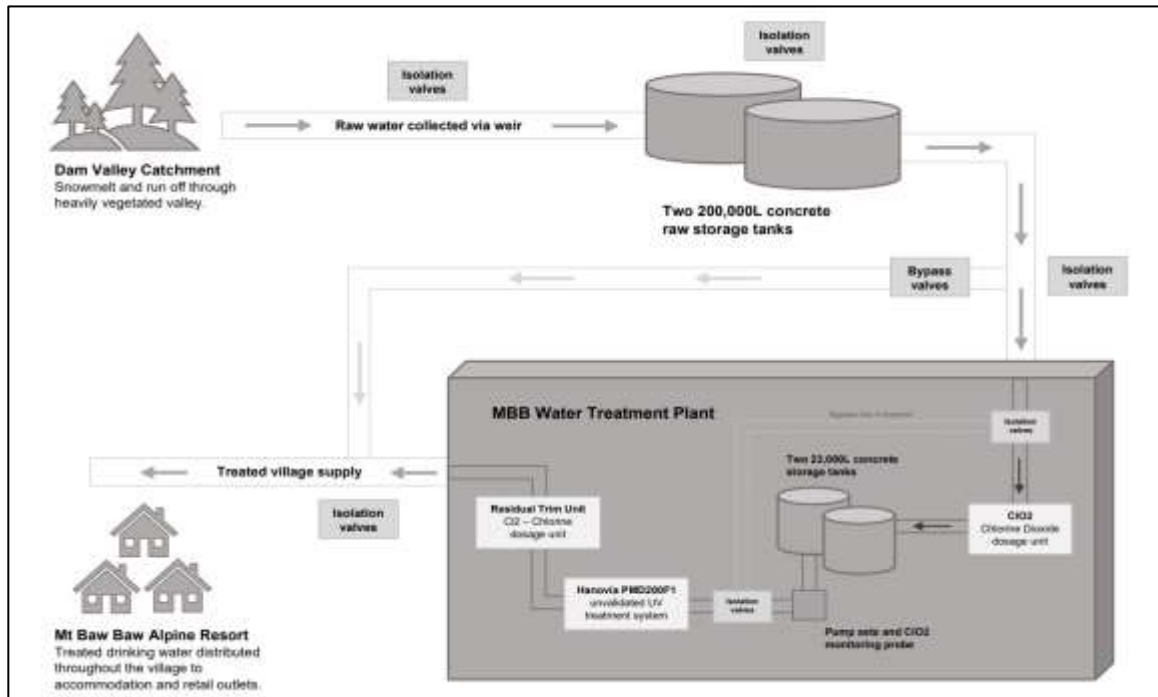
Figure 3: Mt Baw Baw schematic diagram of village treatment systems.

The Resort utilises a multibarrier approach to drinking water treatment which includes peroxidation with chlorine dioxide and disinfection by UV and sodium hypochlorite.

Chlorine Dioxide (installed May 2021) is used as pre oxidising agent to enhance effectiveness of disinfection treatment systems and improve aesthetic properties. Chlorine Dioxide is generated onsite and dosed into two 23,000L holding tanks to reduce the volume of organic matter, before being treated as required via UV and Sodium Hypochlorite. As a byproduct of Chlorine Dioxide, Chlorite is monitored frequently to ensure compliance with health and aesthetic guidelines.

The UV treatment plant consists of one Hanovia PMD200F Ultra Violet (UV) treatment system which acts as the resort’s primary treatment barrier. The UV unit is an unvalidated system with dose calculated using flow rate, UVT (assumed static rate) and UV intensity. There are nil by-products to be monitored as a result of UV treatment.

A residual trim unit provides automated sodium hypochlorite dosing post UV treatment. Dose rates are set to a manual dose rate or flow pace dependent on current system demand. The residual trim unit acts as a secondary disinfection barrier in the resort’s multiple barrier approach to water treatment. This unit provides the ability to control the level of dosing remotely and maintain a disinfection residual within the reticulation system. As a byproduct of sodium hypochlorite, trihalomethanes (THMs) are monitored frequently to ensure compliance with health and aesthetic guidelines.
