# WATER SUPPLY ANNUAL REPORT 2019-20

### Water supply 2019-20 Annual Report

For year ending 30 June 2020

#### Lake Mountain Alpine Resort and Mount Baw Baw Alpine Resort

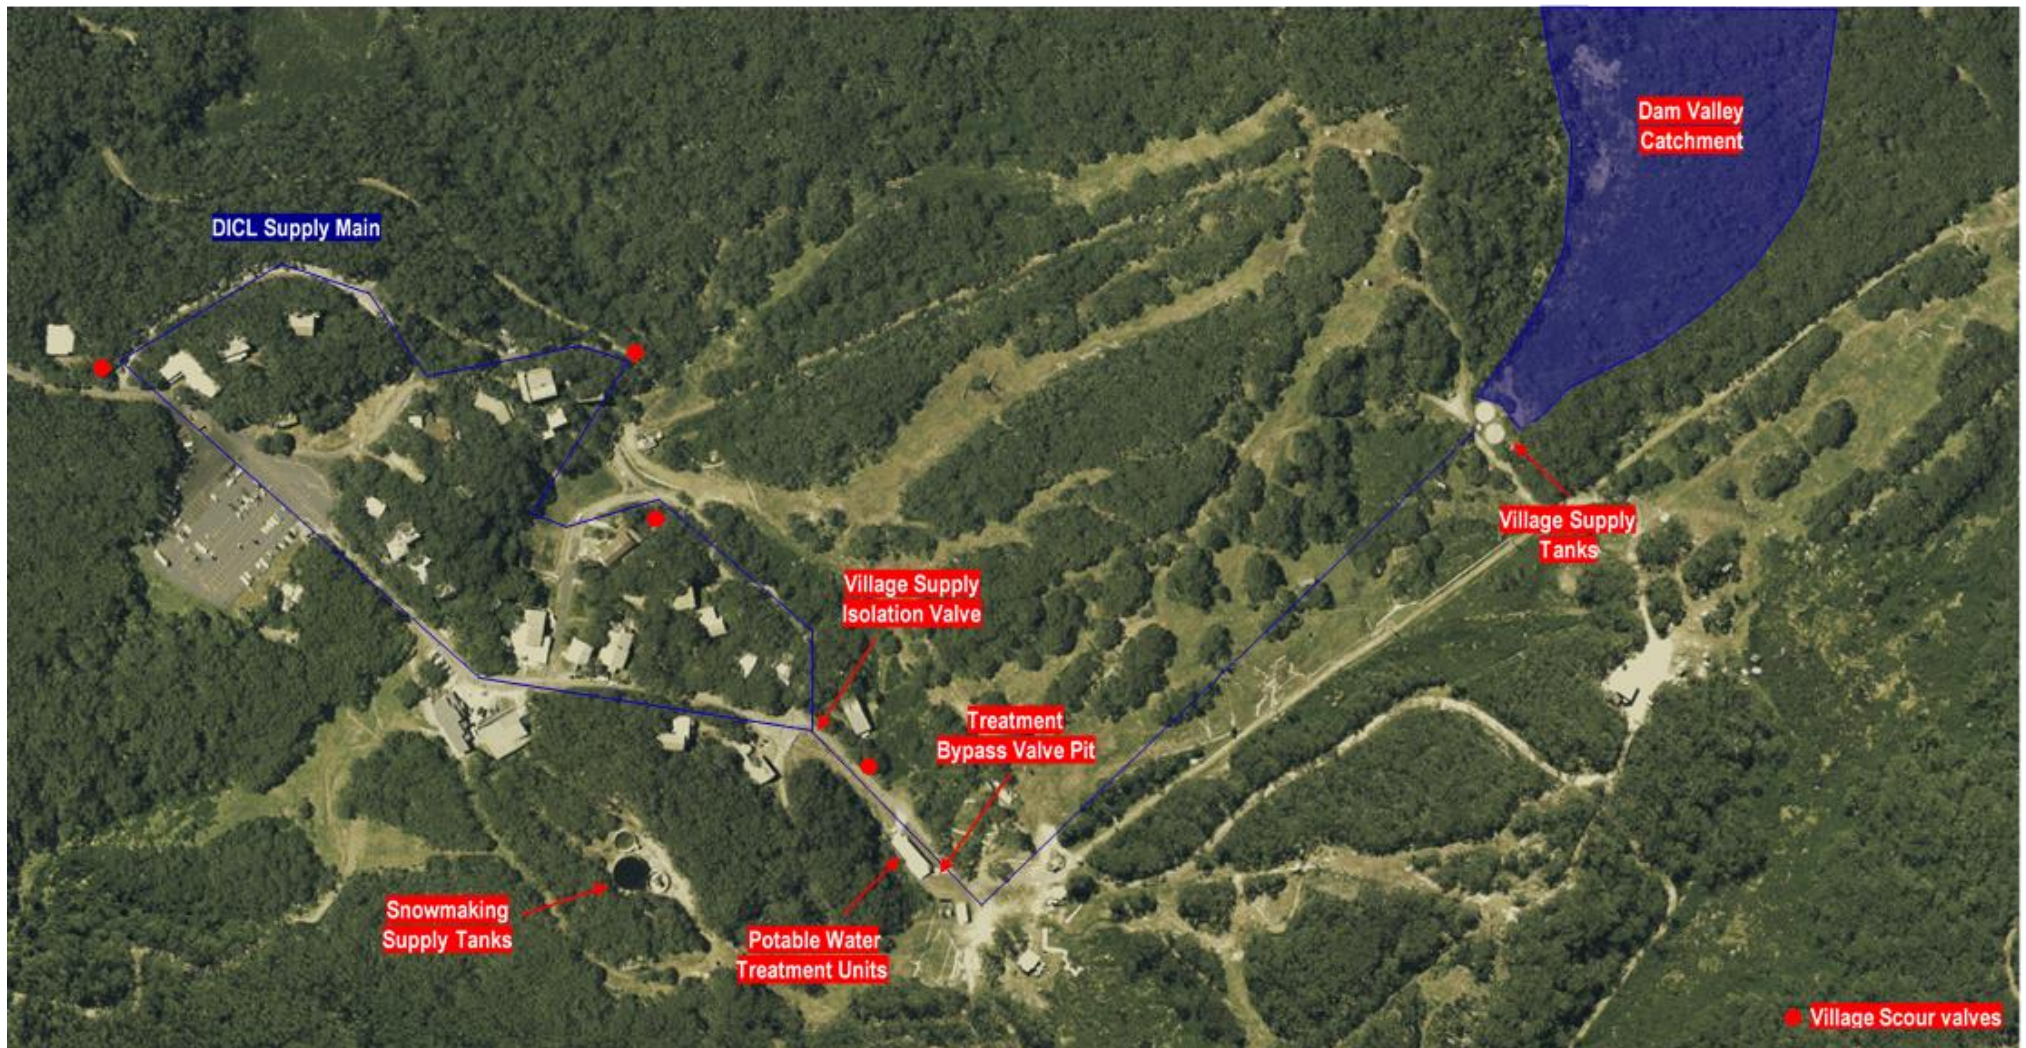
Figure 1: Aerial plan of the Baw Baw Village catchment locality and drinking water treatment and supply network

There are 4 scour valves within the reticulation system, and these are typically run at monthly intervals to ensure that there is no accumulation of sediments within the network. More or less sluicing is conducted dependent on water quality or availability. As the reticulation system is of a ring main configuration creating minimal dead ends, there is minimal stagnation in the lines (see figure 1 & 2).

Regular sluicing is undertaken at 4 scour valves within the reticulation system (figures 1 and 2). Catchment inspections are also a scheduled maintenance task under the RMP undertaken monthly to ensure that the catchment is clear of dead animals, faeces, and any other foreign matter, which may compromise or contaminate village water quality. Additional catchment inspections are also undertaken in the event of reported irregularities (i.e. dead animal smells, etc.).

| Location | Treatment Process | Added Substances |
|---|---|---|
| Drinking Water Treatment Units (figure 1) | Ultra Violet (UV) Hanovia PMD200F | N/A |
