# WATER SUPPLY ANNUAL REPORT 2021-22

## **FOREWORD**

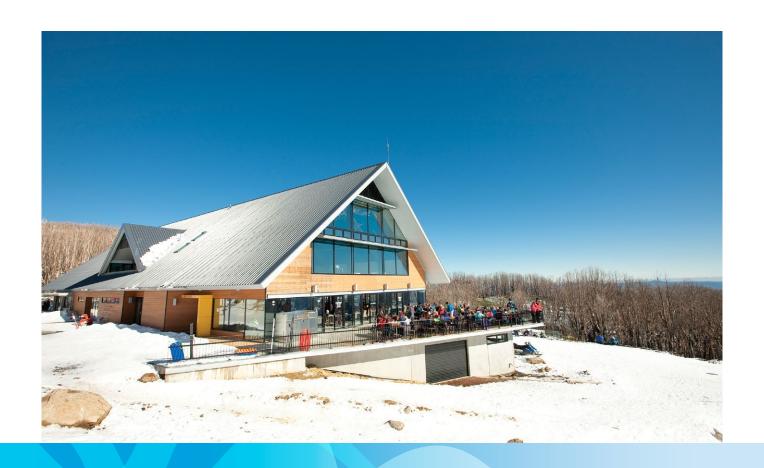
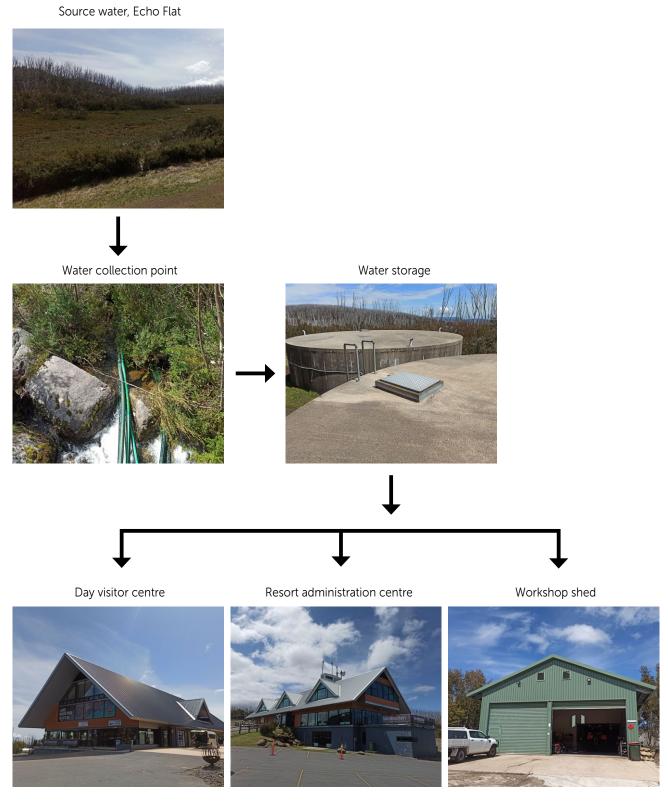
Figure A1: Lake Mountain Alpine Resort, Gerraty's water supply, storage and reticulation system

The main water supply system for Gerraty's consists of a small concrete weir directing water from the Taggerty River via a series of 50mm poly pipes, under a gravity/ syphons process, to 3 enclosed concrete tanks. The combined storage capacity of these tanks is 800kl. The storage tanks supply water to resort's facilities via a 100mm ductile iron pipe.

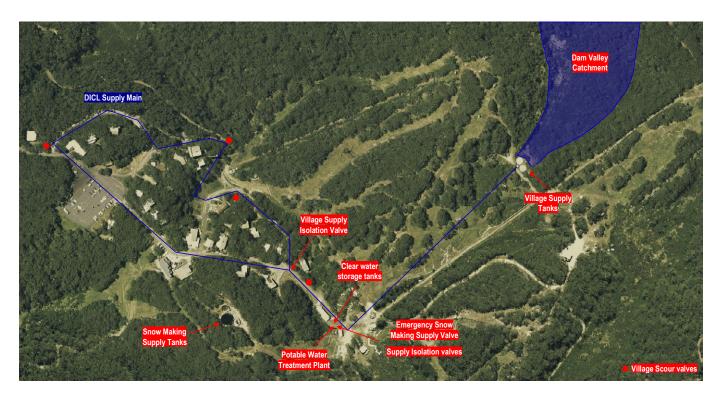
Figure B1.4.1: Aerial plan of the Baw Baw Village catchment locality and drinking water treatment and supply network

The service area encompasses the entirety of the Baw Baw Village which can be seen in *figure B1.4.2*. Water is treated at the WTP (*figure B1.4.1*) into clear water storage tanks and distributed throughout the village under a pressurised system. The majority of the village reticulation is made from 100mm galvanised or DICL pipework. There are 4 scour valves within the reticulation system, and these are typically run on an ad-hoc basis to clear out accumulation of sediments within the network. More or less sluicing is conducted dependent on water quality or availability.

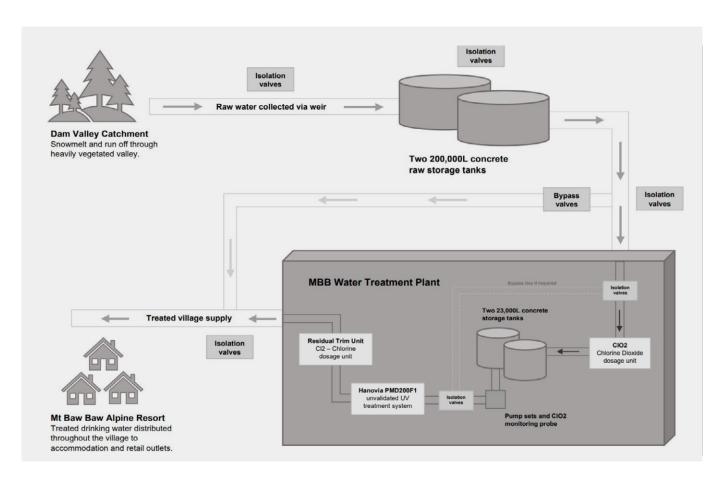
Figure B2.1.1: Mt Baw Baw schematic diagram of village treatment systems (pre May 2022).

Prior to this the Resort utilised a multibarrier approach to drinking water treatment which included pre oxidation with chlorine dioxide and disinfection by UV and sodium hypochlorite.

Chlorine Dioxide (installed May 2021) is used as pre oxidising agent to enhance effectiveness of disinfection treatment systems and improve aesthetic properties. Chlorine Dioxide is generated onsite and dosed into two 23,000L holding tanks to reduce the volume of organic matter, before being treated as required via UV and Sodium Hypochlorite. As a byproduct of Chlorine Dioxide, Chlorite is monitored frequently to ensure compliance with health and aesthetic guidelines.

The UV treatment plant consists of one Hanovia PMD200F Ultra Violet (UV) treatment system which acts as the resort's primary treatment barrier. The UV unit is an unvalidated system with dose calculated using flow rate, UVT (assumed static rate) and UV intensity. There are nil by-products to be monitored as a result of UV treatment.

A residual trim unit provides automated sodium hypochlorite dosing post UV treatment. Dose rates are set to a manual dose rate or flow pace dependent on current system demand. The residual trim unit acts as a secondary disinfection barrier in the resort's multiple barrier approach to water treatment. This unit provides the ability to control the level of dosing remotely and maintain a disinfection residual within the reticulation system. As a byproduct of sodium hypochlorite, trihalomethanes (THMs) are monitored frequently to ensure compliance with health and aesthetic guidelines.

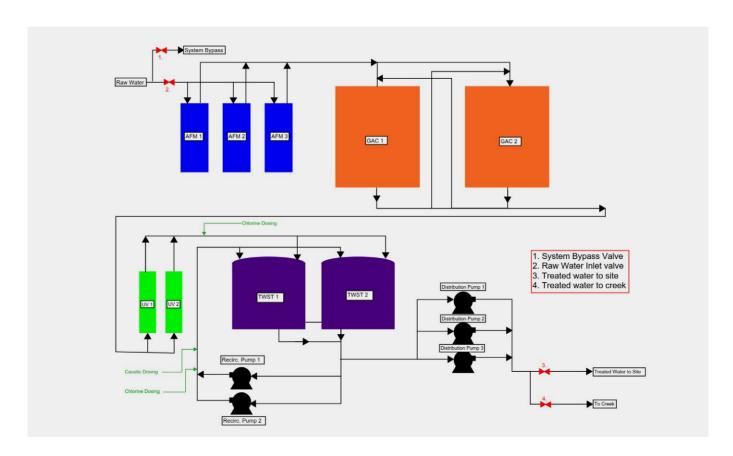
Figure B2.1.2: Mt Baw Baw water treatment plant schematic (post May 2022).

- AFM media filtration to remove the majority of coarse solids.
- GAC filtration (lead/lag configuration) to achieve organic removal.
- UV disinfection to disinfect water and final bacteria control.
- Sodium Hypochlorite dosing to maintain level of chlorine in treated water for further bacteria control.
- Caustic (Sodium Hydroxide) to maintain level of pH in treated drinking water.
- Recirculation system allows free chlorine concentration to be topped up continuously as required.
- Distribution pump to deliver water to the site.

AFM uses amorphous alumino-silicate (glass) to remove 90% of 1-micron and larger particles and acts as a prefilter to reduce fouling and backwash frequency of the GAC filters. Three units provide for redundancy in the event of unexpected faults or planned servicing. Backwashing occurs on an automated time or differential pressure basis to reduce clogging and head loss, improving filtration performance.

GAC is used to absorb dissolved organic matter, pesticides, algal toxins and compounds which historically have resulted in taste and aesthetic problems in the village supply. GAC filtration when used prior to disinfection reduces the formation of disinfection by-products in later disinfection processes. Two GAC filtration units in a lead/lag configuration provide for redundancy in the event of unexpected faults or planned servicing (media replacement). Backwashing occurs on an automated time or differential pressure basis to reduce clogging and head loss, improving filtration performance.

The treatment plant consists of two TrojanUVMax SV50 Ultra Violet (UV) units in a duty/standby configuration. These are validated for 3.0-log Cryptosporidium & Giardia inactivation credit, based on MS2 & T1 testing as per USEPA UVDGM 2006.

Sodium Hypochlorite (hypo) is the secondary form of disinfection within the WTP. The residual trim hypo dosing unit provides automated dosing post UV treatment to meet specified set points. Dose rates are controlled through the Human-Machine Interface (HMI) both onsite and remotely and can be adjusted as required. Two pumps are used to supply the course dose of hypo to the system pre clear water storage and a third is used to provide a top up dose on the recirculation line. Analysers provide continuous readings of the Free Available Chlorine (FAC) within clear water storage tanks to allow set points to be withheld at all times.

Caustic soda (caustic), or sodium hydroxide (NaOH) is used to increase the pH of the drinking water post hypo dosing which decreases pH levels. Acidic water has a higher likelihood of corrosion to pipework and equipment making pH adjustment and important process in water treatment.
