2020

DRINKING WATER ANNUAL REPORT

HOTHAM
Mount Hotham Resort Management Board

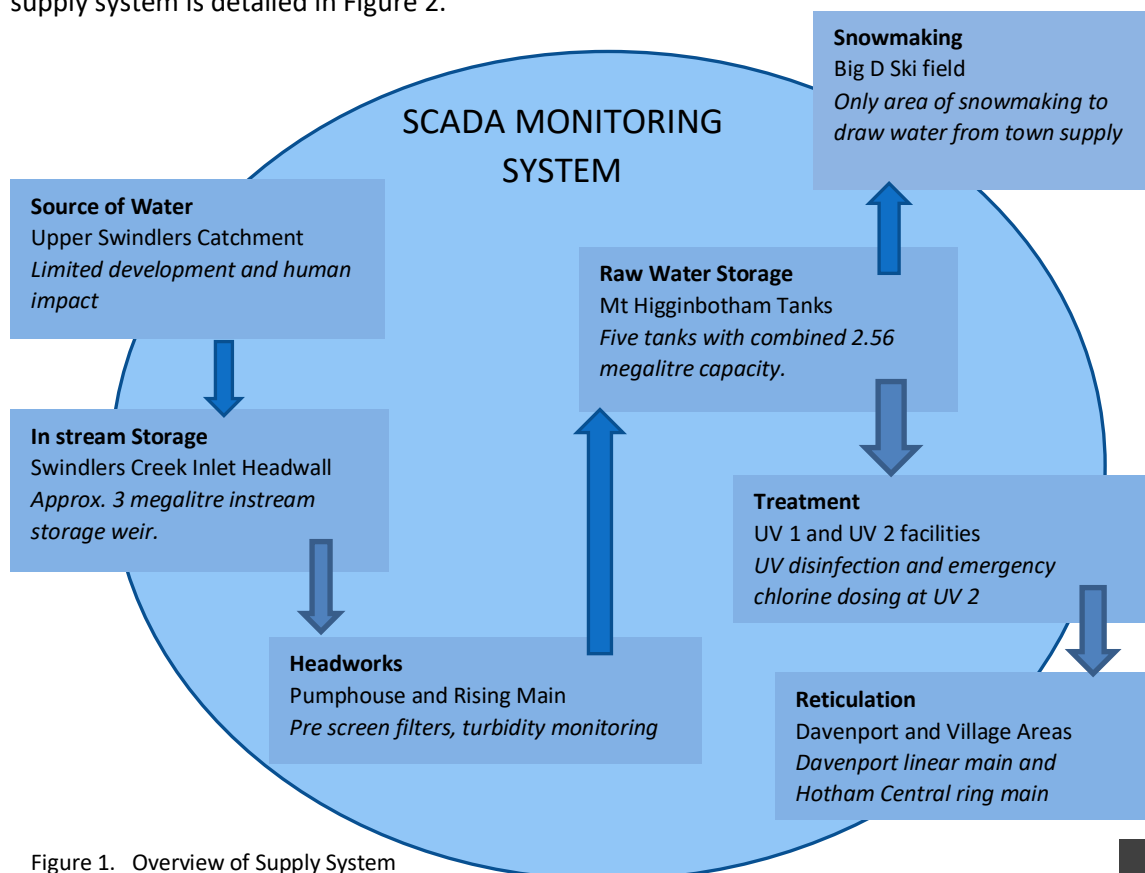
Figure 1. Overview of Supply System

Water is sourced from Upper Swindlers Creek, a catchment of approximately 177 hectares. Water is collected at the Swindlers Inlet headwall and raw water is gravity fed to the pump station before being pumped through a pressure rising main to storage tanks located at the summit of Mount Higginbotham. From the storage tanks, the raw water flows to the ultra violet (UV) units 1 and 2 where it is disinfected immediately prior to its distribution to customers through the village water reticulation system. The water supply system is outlined in Table 1 and a working overview is shown in Figure 1. The key components of the water supply system is detailed in Figure 2.

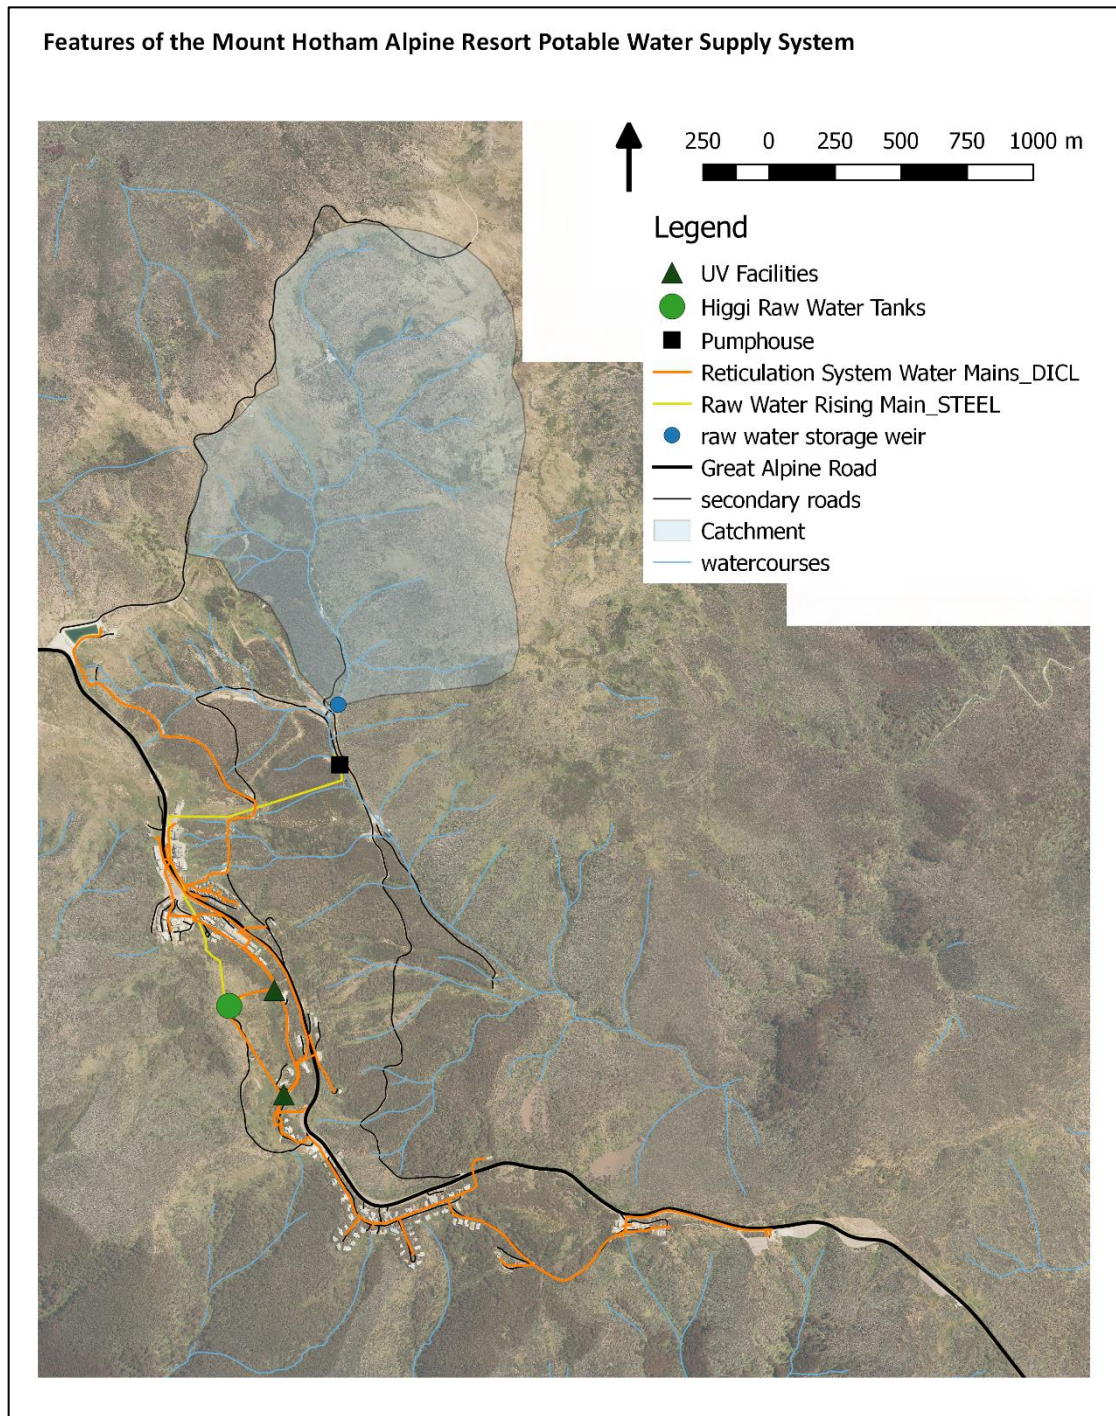
Figure 2. Key components of the drinking water supply system within the Mount Hotham Alpine Resort
