### **Water supply 2020-21 Annual Report**

For year ending 30 June 2021

#### **Lake Mountain Alpine Resort and Mount Baw Baw Alpine Resort**

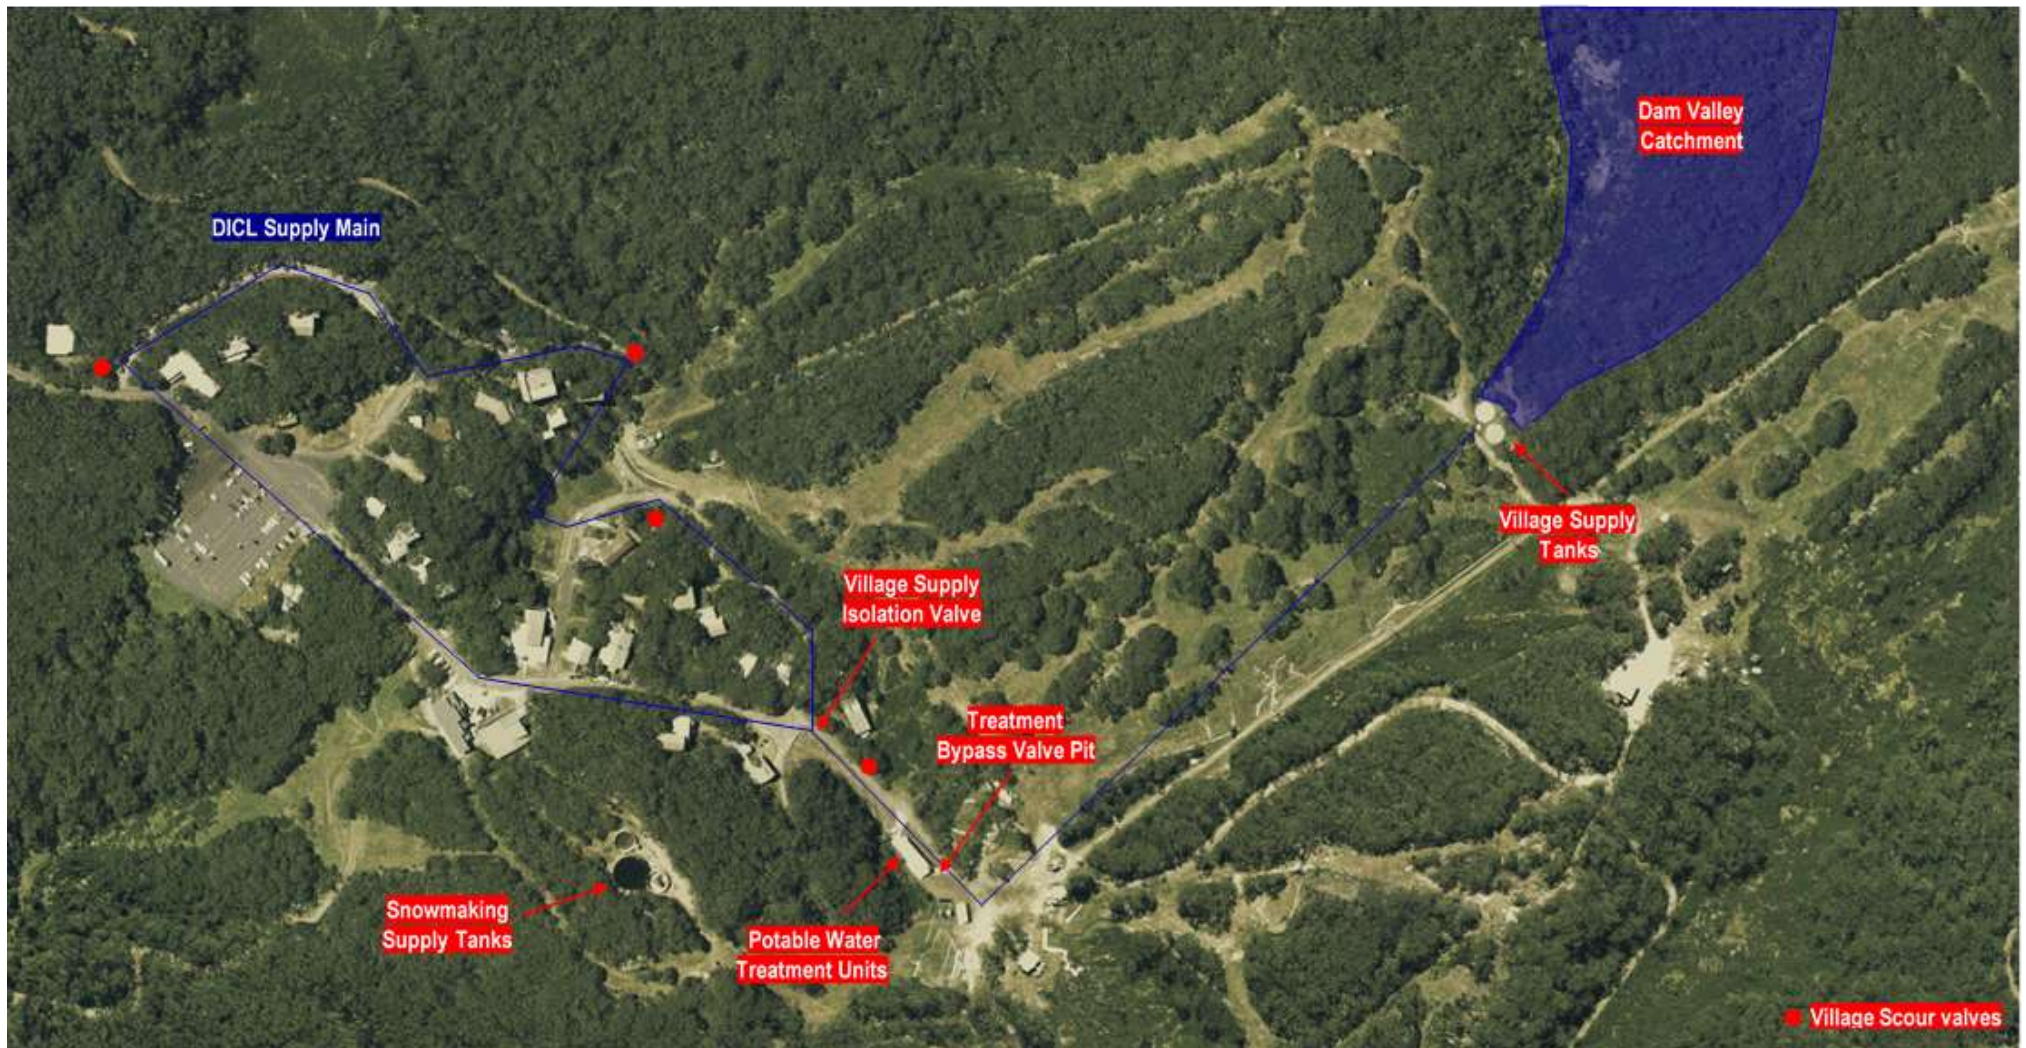
Figure 1: Aerial plan of the Baw Baw Village catchment locality and drinking water treatment and supply network

The service area encompasses the entirety of the Baw Baw Village which can be seen in figure 2. Water is treated at the potable water treatment units (figure 1) on demand before being distributed throughout the village under a pressurised system. The majority of the village reticulation is made from 100mm galvanised or DICL pipework. There are 4 scour valves within the reticulation system, and these are typically run at monthly intervals to ensure that there is no accumulation of sediments within the network. More or less sluicing is conducted dependent on water quality or availability.

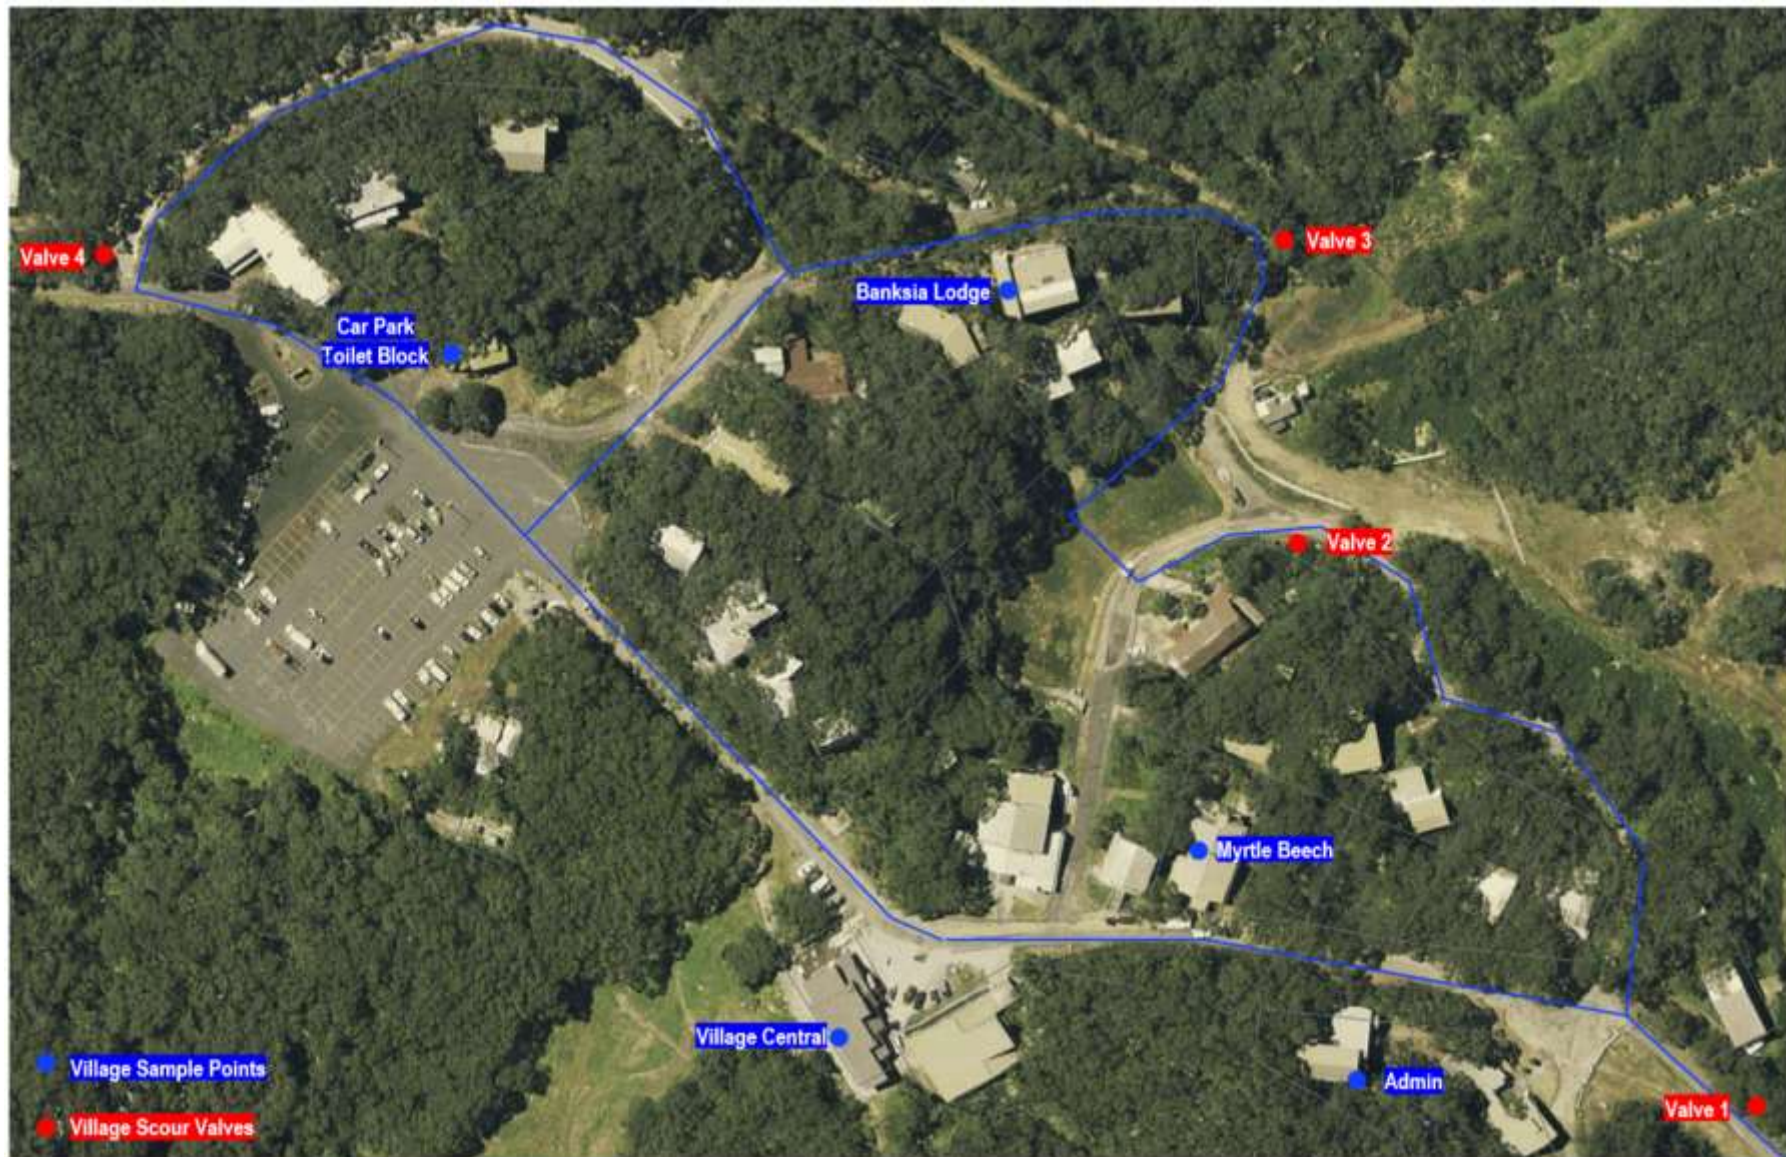
Figure 2: Baw Baw Village drinking water reticulation network, scour valves and sample locations
