Mount Buller Water Storage Project
Hydrological and Ecological Monitoring and
Adaptive Management Program
Impact Year 3 Monitoring

FINAL REPORT

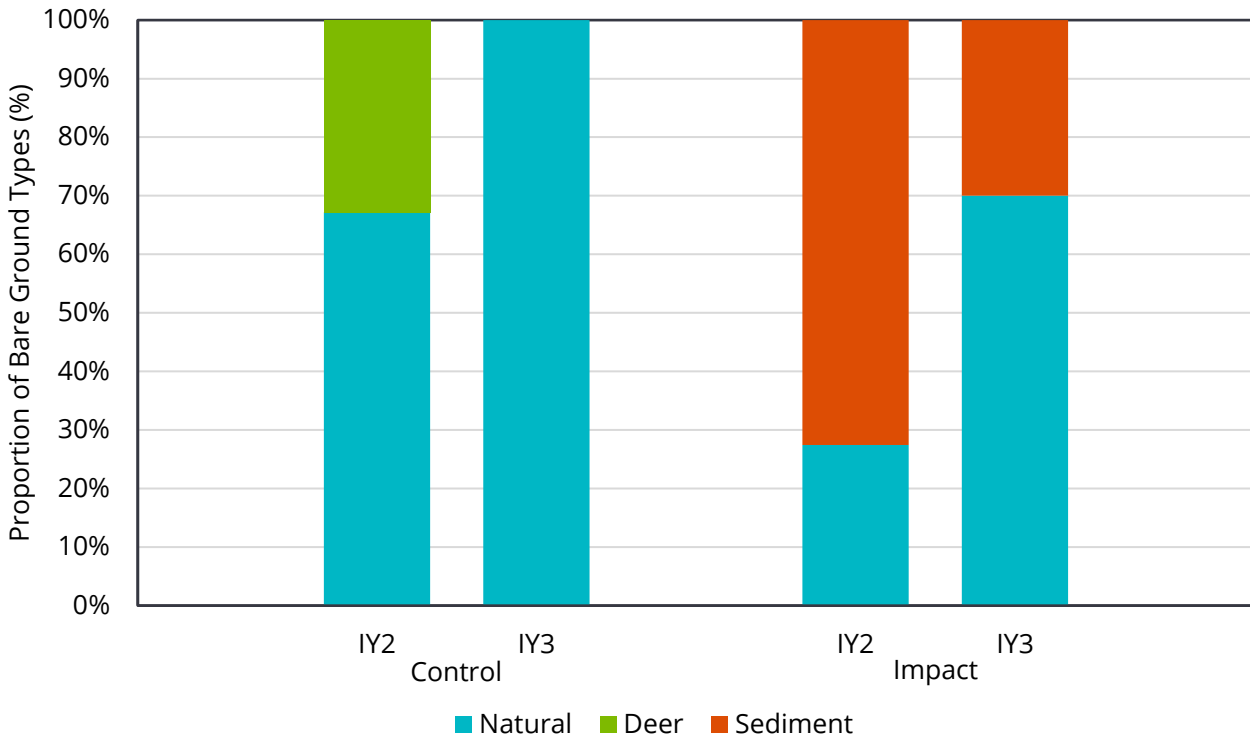
Chart 4 Types of bare ground recorded at control and impact sites as a proportion of all bare ground recorded at those sites

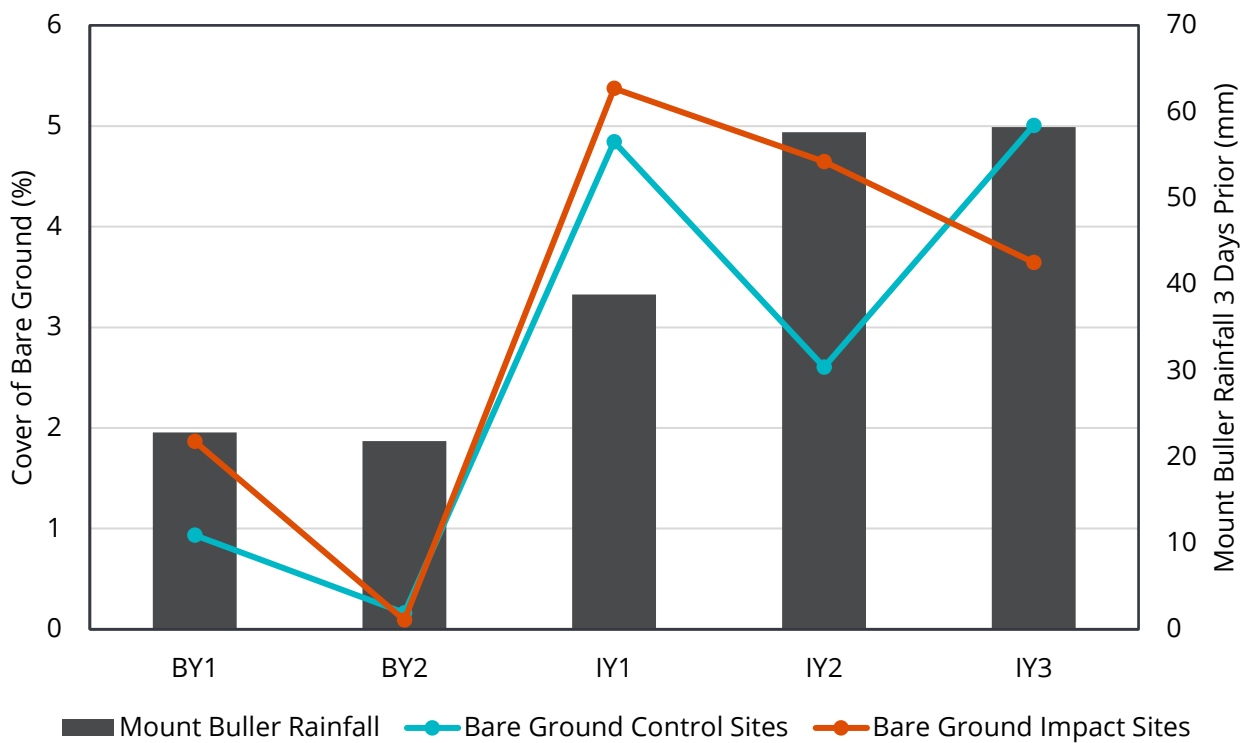
Chart 11 Percentage cover of total bare ground at Alpine Bogs over time relative total rainfall at Mount Buller three days prior to bare ground being recorded along transects

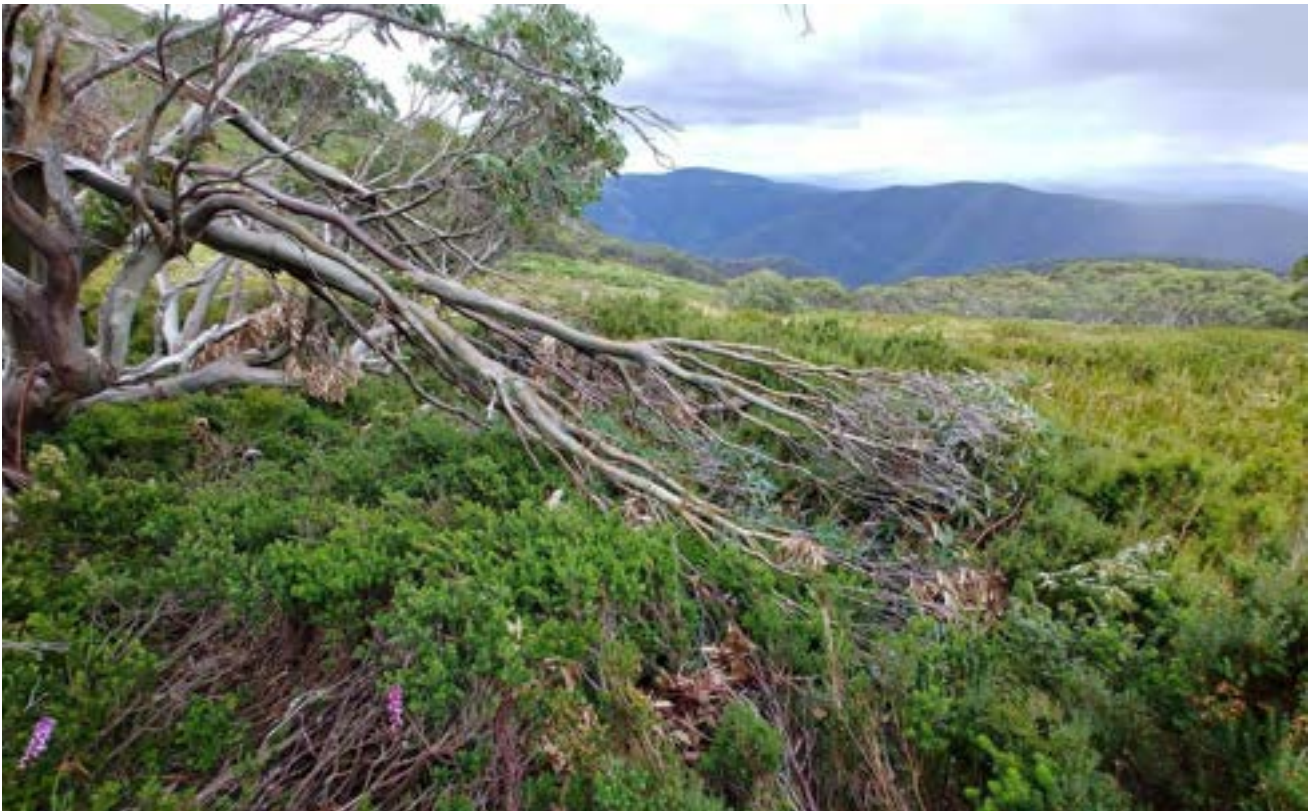
Photo 12 Example of rime ice damage to Snow Gum in IY3, resulting in fallen branch smothering Alpine Bog vegetation at Bog 4.2 (IY3; 9 February 2022).

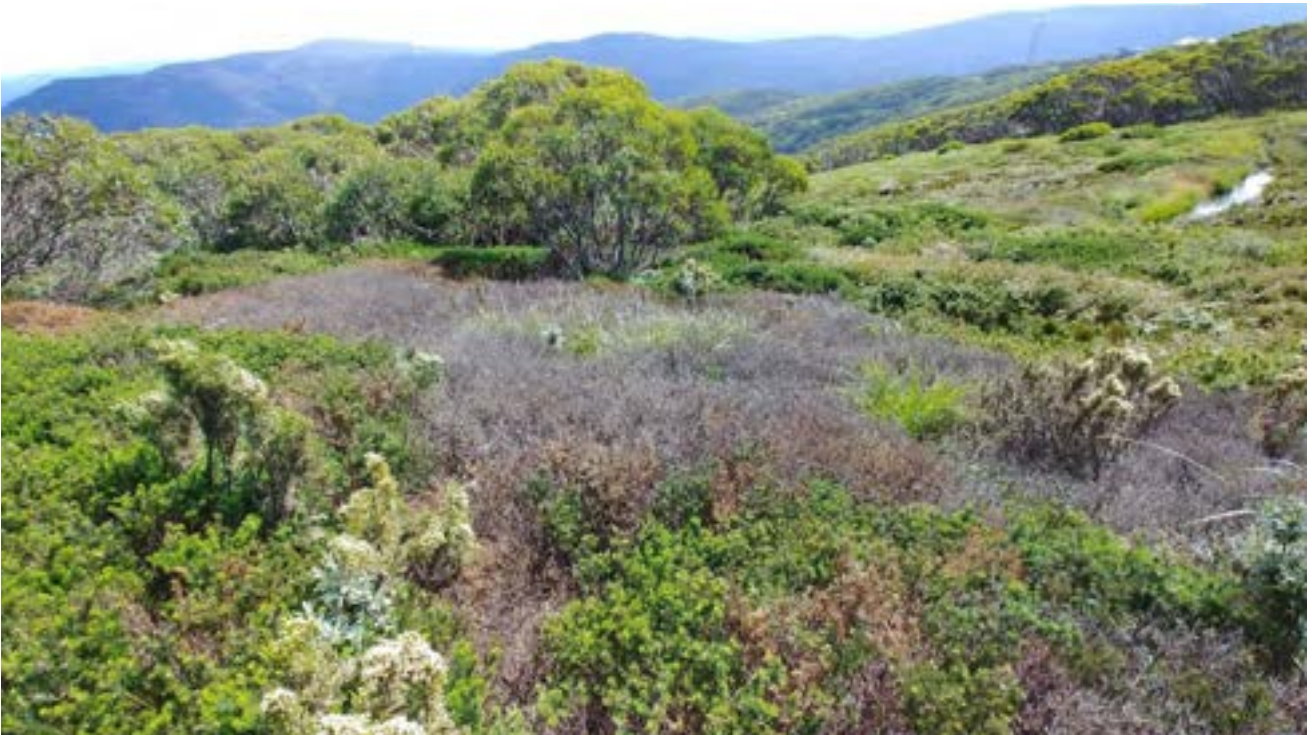
Photo 13 Dieback of non-bog-dependent flora at western boundary of Bog 11.2 (Location D1; IY3; 1 February 2022).
