# Mount Buller Water Storage Project: Hydrological and Ecological Monitoring and Adaptive Management Program - Impact Year 4

30 October 2023

Mount Buller Water Storage Project  
Hydrological and Ecological Monitoring and  
Adaptive Management Program  
Impact Year 4 Monitoring

FINAL REPORT

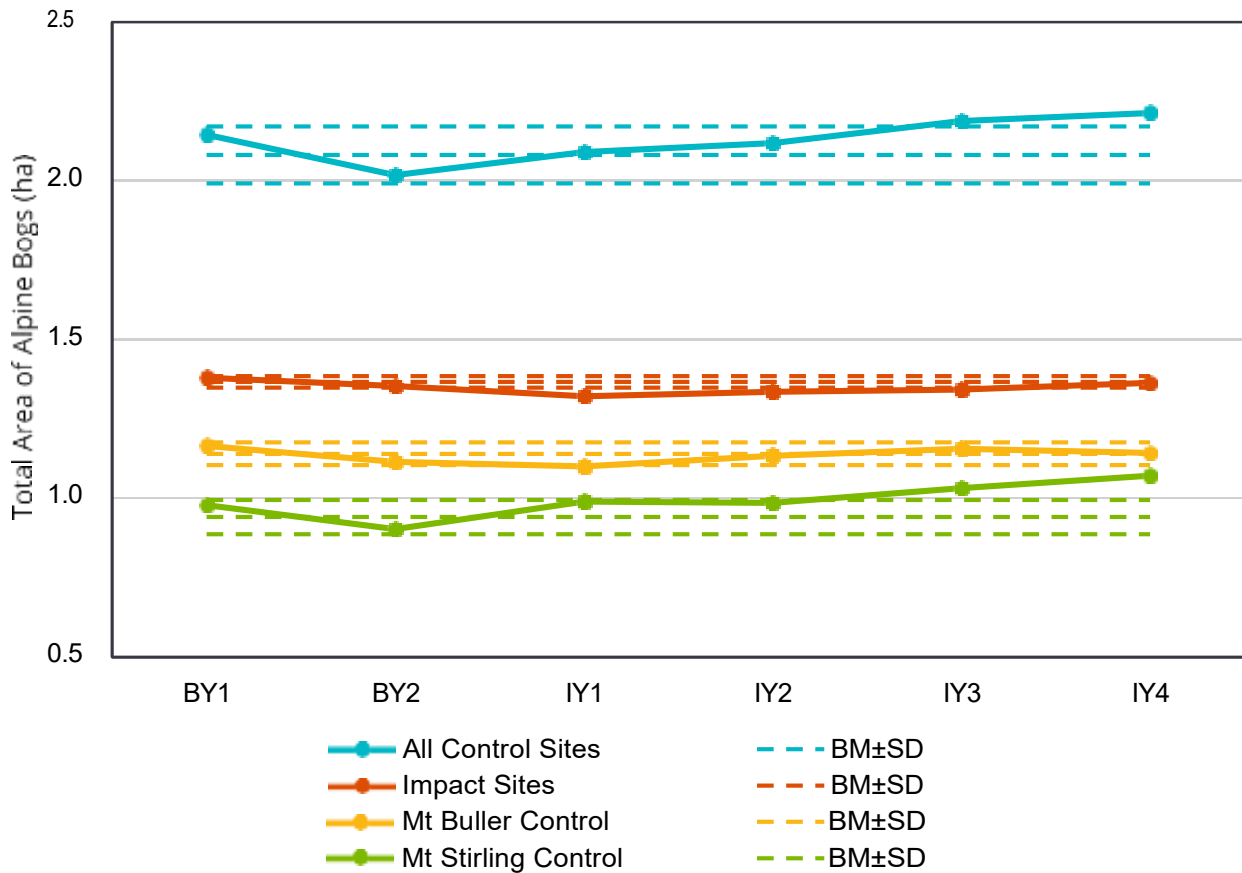
Alpine Bog areas were mapped using DGPS. The results of this mapping are summarised in Chart 1 and depicted in Figure 4 (raw results for each Alpine Bog are available in Appendix 5). The total combined area of all Alpine Bogs at impact sites was 1.3636 hectares in IY4, which is less than the baseline mean of 1.3666 hectares (a decrease of 0.0030 hectares or 0.2%). The total combined area of all Alpine Bogs at control sites was 2.2136 hectares in IY4, which is greater than the baseline mean of 2.0812 hectares (an increase of 0.1324 hectares or 6.4%, almost entirely at Mount Stirling control sites). The relative change in the area of impact sites in IY4 was therefore a decrease of 6.6%, although this change was not statistically significant (BACI contrast = 0.0145; SE = 0.0082; F-statistic = 3.1577; numerator DF = 1; denominator DF = 59; P = 0.0807).

**Chart 1 Total area (hectares) of Alpine Bogs over time relative to the baseline mean ± one standard deviation (BM±SD)**

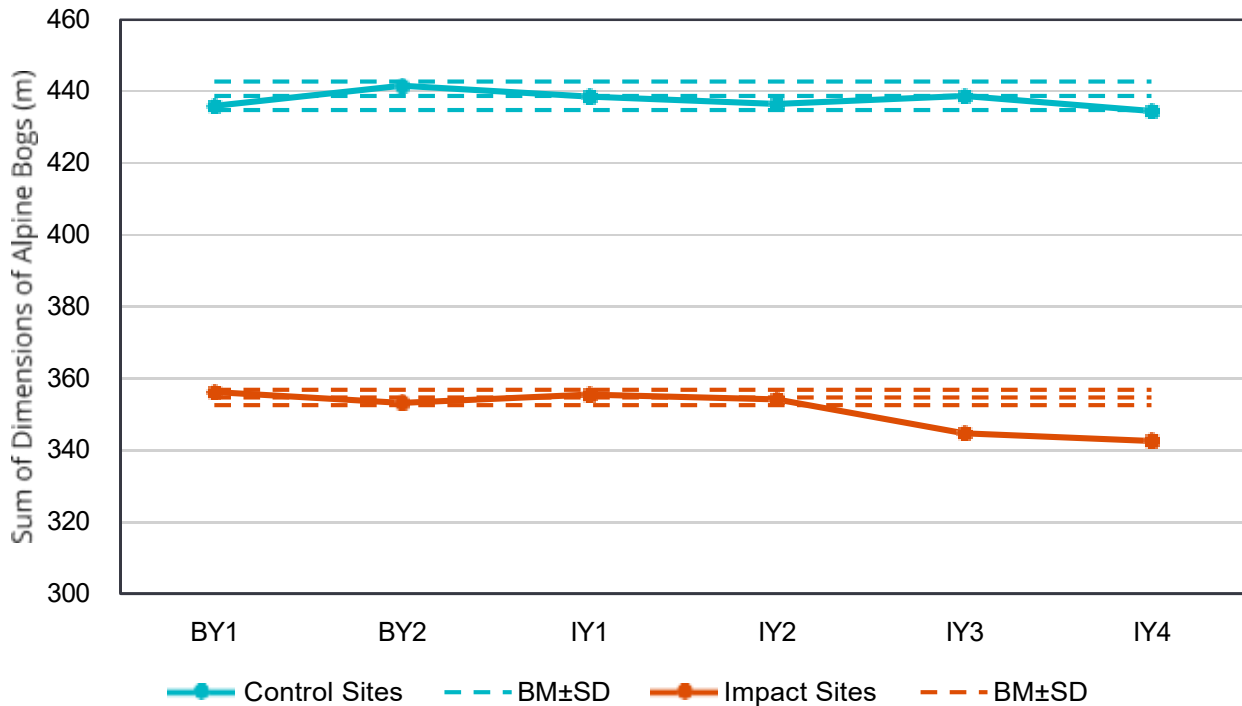
The dimensions of each Alpine Bog were estimated using line transects and the Diagnostic Key to Alpine Bogs (Appendix 3). The results of these estimates are presented in Chart 2 (raw results for each Alpine Bog are available in Appendix 5). The sum of dimensions at impact sites was 342.6 metres in IY4, which is less than the baseline mean of 354.7 metres (a decrease of 12.1 metres or 3.4%). The sum of dimensions at control sites was 434.6 metres in IY4, which is less than the baseline mean of 438.8 metres (a decrease of 4.2 metres or 1.0%). The relative change in the dimensions of the impact sites was therefore a decrease of 2.5%, although this change was not statistically significant (BACI contrast = 0.6640; SE = 0.6950; F-statistic = 0.9132; numerator DF = 1; denominator DF = 59; P = 0.3432).

**Chart 2 Sum of dimensions (metres) of Alpine Bogs over time relative to the baseline mean ± one standard deviation (BM±SD)**

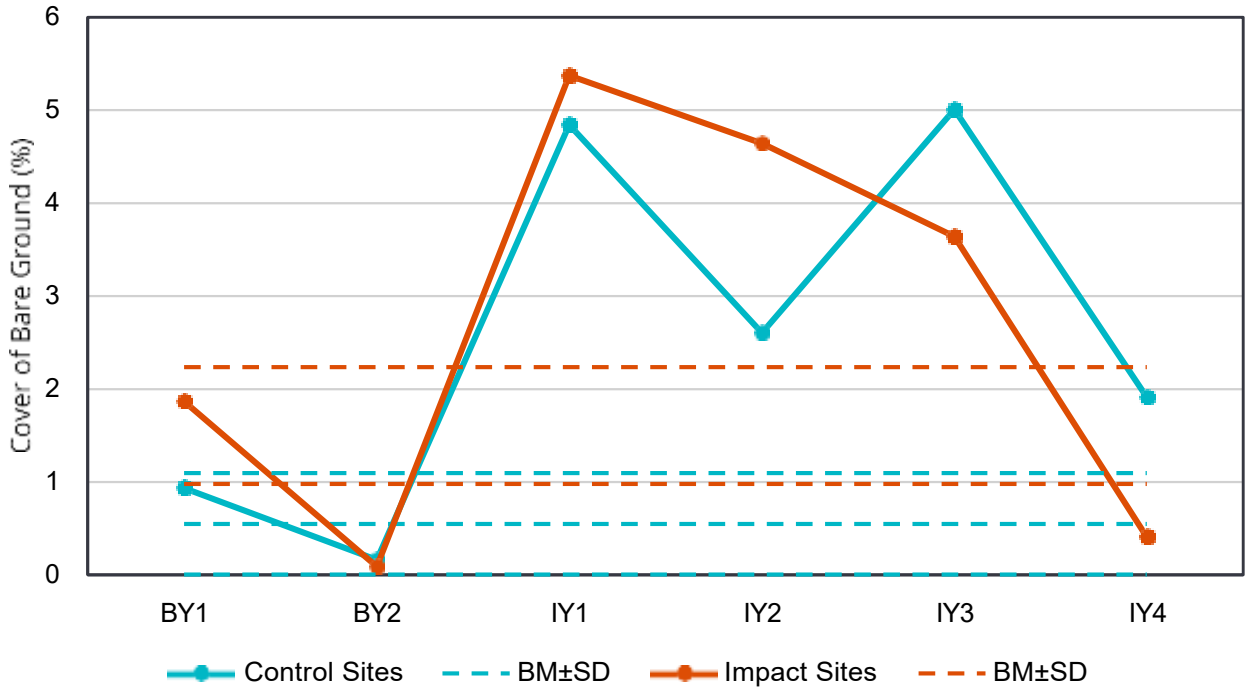
Line transects (point intersections) were also used to estimate the cover of bare ground. These estimates are displayed in Chart 3 (raw results for each Alpine Bog are available in Appendix 5). The cover of bare ground returned to baseline levels at impact sites and close to baseline levels at control sites in IY4, after three years of being relatively elevated at all sites. In IY4, the cover of bare ground was 0.4% at impact sites and 1.9% at control sites, compared with baseline mean covers of 1.0% and 0.5% respectively. The changes in bare ground at impact sites relative to control sites have not been statistically significant (BACI contrast = 0.0087; SE = 0.0135; F-statistic = 0.4119; numerator DF = 1; denominator DF = 59; P = 0.5235).

**Chart 3 Percentage cover of total bare ground at Alpine Bogs over time relative to the baseline mean ± one standard deviation (BM±SD)**

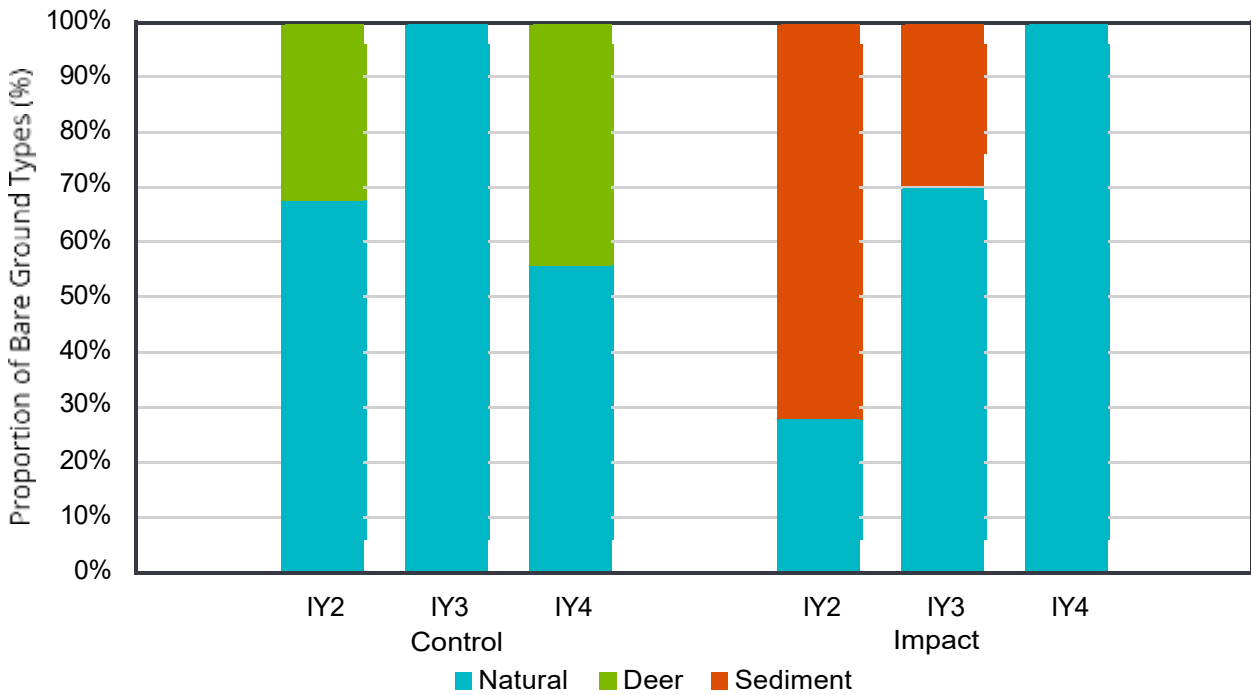
The causes of bare ground differed at impact sites compared with control sites, as shown in Chart 4 (note that the cause or type of bare ground was not recorded prior to IY2). At impact sites, all bare ground was attributed to natural causes in IY4. This was an improvement from IY2 and IY3, when 72.5% and 30% of bare ground was attributed to sedimentation at Mount Buller. At control sites, 44.7% of bare ground was attributed to deer activity at Mount Stirling in IY4, which was an increase from IY3, when all bare ground was considered natural. The absolute cover of bare ground attributed to deer activity at control sites in IY4 was 0.9%, which was the same cover recorded in IY2 (although the overall decrease in bare ground cover at control sites in IY4 meant that deer activity contributed to a greater proportion of bare ground in IY4 than in IY2).

**Chart 4** Types of bare ground recorded at control and impact sites as a proportion of all bare ground recorded at those sites

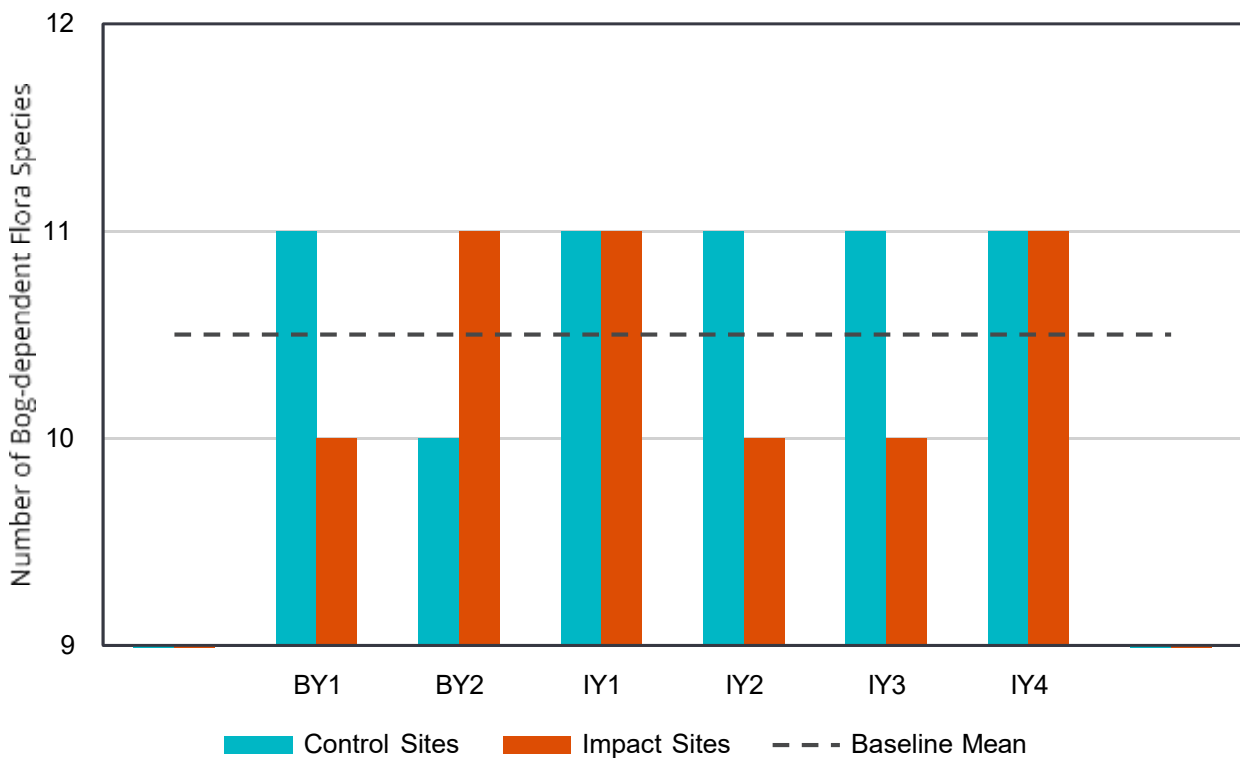
Using line transects (point intersections) and belt transects (quadrats), a total of twelve bog-dependent flora species have been recorded at impact and control sites since monitoring started (Appendix 2; Appendix 5). Baseline monitoring detected 10-11 bog-dependent species across all impact sites and 10-11 bog-dependent species across all control sites (Chart 5). This means that the baseline mean bog-dependent species richness at impact sites and control sites was 10.5. In IY4, 11 bog-dependent flora species were recorded at impact sites and control sites (a 4.8% increase in species richness at both impact sites and control sites when compared with the baseline mean). As a result, there was no relative change in species richness at impact sites relative to control sites in IY4 and the result was not statistically significant (BACI contrast = 0.1190; SE = 0.3850; F-statistic = 0.0957; numerator DF = 1; denominator DF = 59; P = 0.7581).

**Chart 5 Bog-dependent flora species richness at control and impact sites relative to the baseline mean**

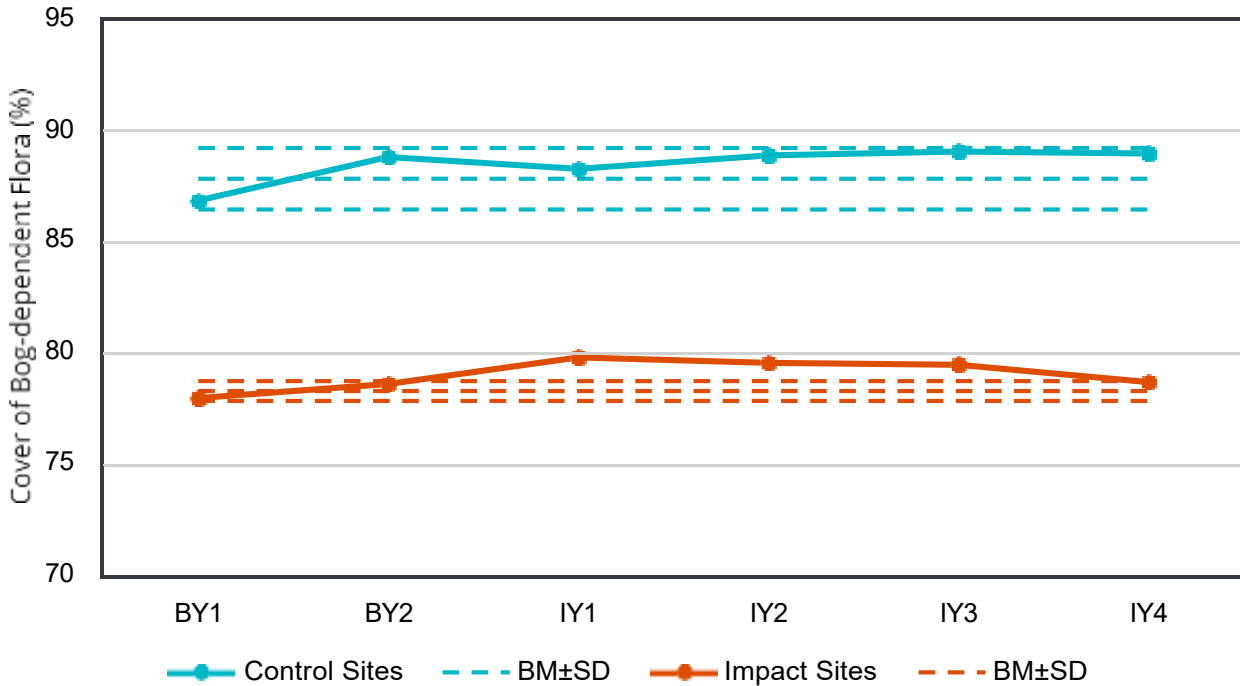
Line transects (point intersections) were also used to estimate the cover of bog-dependent flora species. Chart 6 shows these covers (raw results for each Alpine Bog are available in Appendix 5). The cover of bog-dependent flora species increased at impact sites from a baseline mean of 78.2% to 78.6% in IY4. The cover of bog-dependent flora species at control sites increased from a baseline mean of 87.2% to 88.6% in IY4. While the increase in cover of bog-dependent species is proportionally greater at control sites relative to impact sites, the increase is not statistically significant (BACI contrast = -0.0139; SE = 0.0102; F-statistic = 1.8515; numerator DF = 1; denominator DF = 59; P = 0.1788).

**Chart 6 Percentage cover of bog-dependent flora at Alpine Bogs over time relative to the baseline mean ± one standard deviation (BM±SD)**

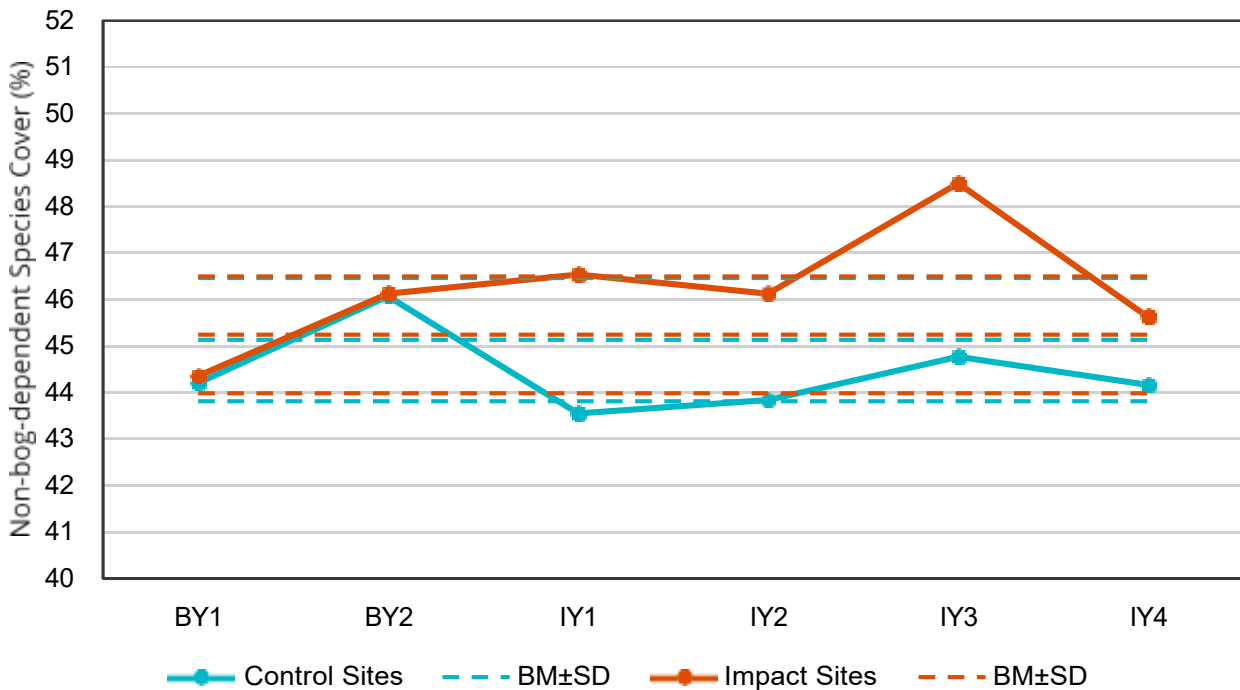
The cover of native non-bog-dependent flora species is shown in Chart 7. The cover of native non-bog-dependent flora increased at impact sites from a baseline mean of 45.2% to 45.6% in IY4 and decreased at control sites from a baseline mean of 45.1% to 44.2% in IY4. This represents a relative increase of 3.0% in the cover of native non-bog-dependent flora species at impact sites relative to control sites in IY4. The relative increase in cover of native non-bog-dependent flora at impact sites relative to control sites since construction of the water storage is statistically significant (BACI contrast = -0.0290; SE = 0.0124; F-statistic = 5.4803; numerator DF = 1; denominator DF = 59; P = 0.0226).

**Chart 7 Percentage cover of native non-bog-dependent flora at Alpine Bogs over time relative to the baseline mean ± one standard deviation (BM±SD)**

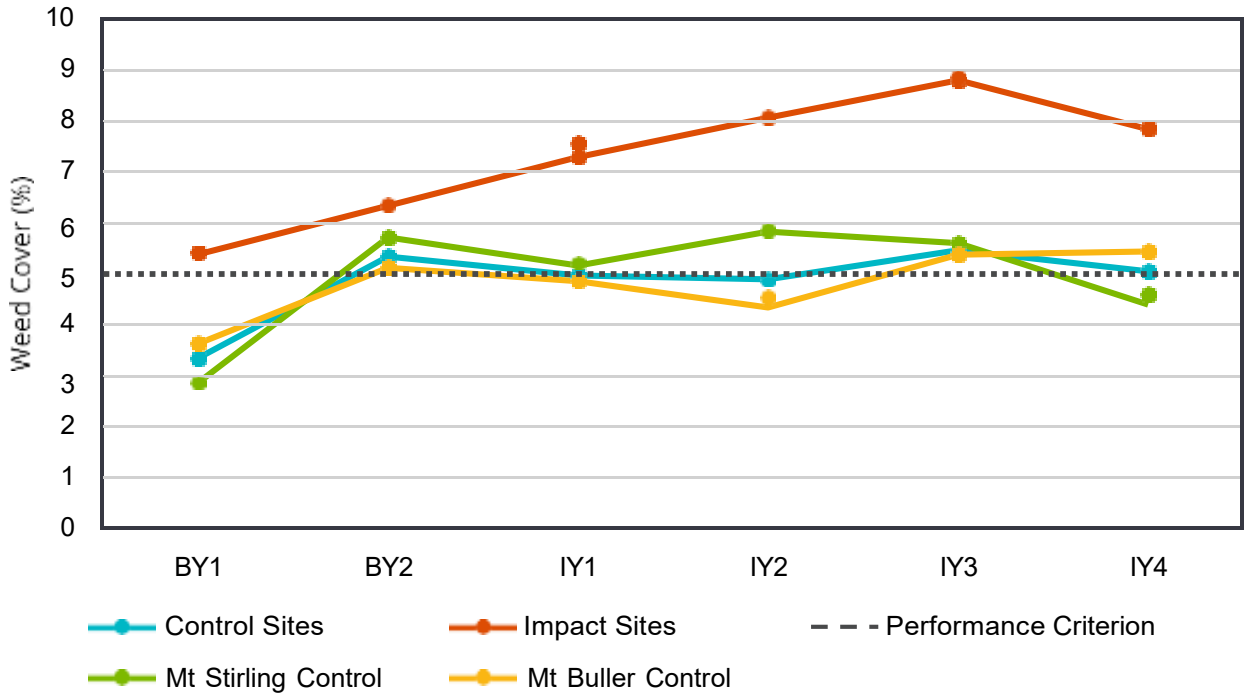
The cover of weeds is shown in Chart 8. The cover of weeds increased at impact sites from a baseline mean of 5.9% to 7.8% in IY4 and increased at control sites from a baseline mean of 4.3% to 5.0% in IY4. As a result of a decrease in weed cover at impact sites from IY3 to IY4, the elevated weed cover at impact sites relative to control sites since construction of the water storage is no longer statistically significant (BACI contrast = -0.0167; SE = 0.0087; F-statistic = 3.7415; numerator DF = 1; denominator DF = 59; P = 0.0579). Nevertheless, weed cover continues to be elevated at impact sites compared with control sites, regardless of which group of control sites used for comparison (Mount Buller controls sites or Mount Stirling control sites).

**Chart 8 Percentage weed cover at Alpine Bogs over time relative to the 5% performance criterion**

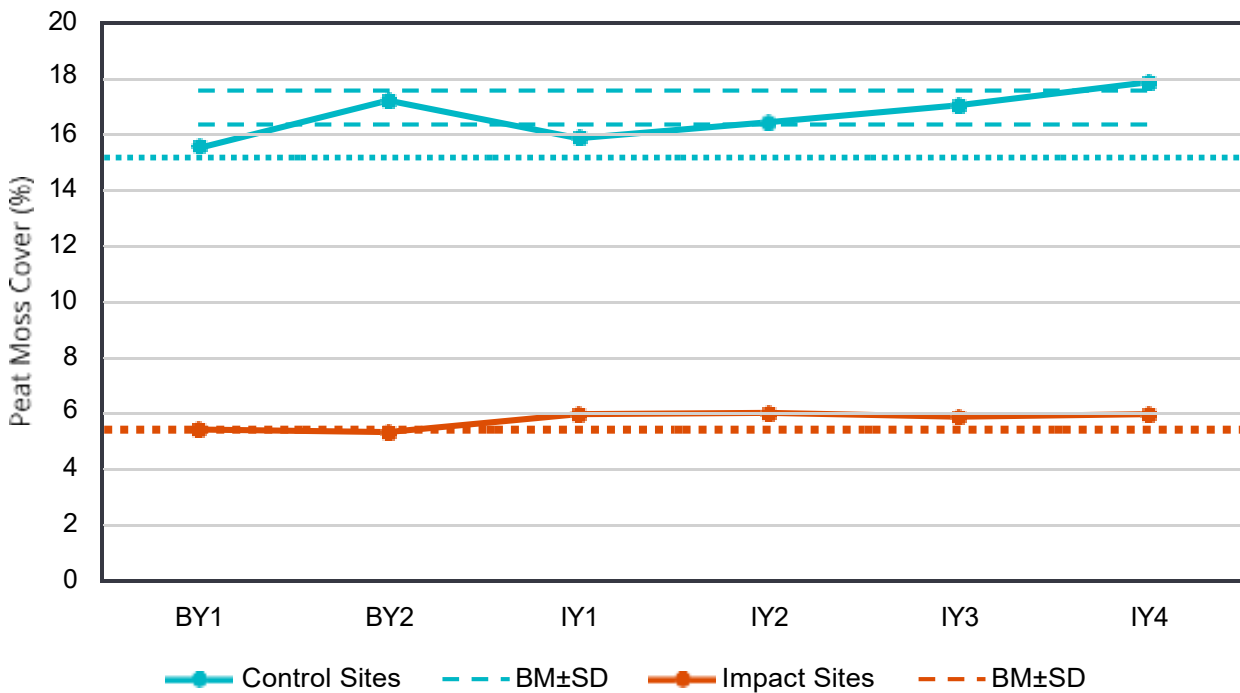
Line transects (point intersections) were used to estimate the cover of Peat Moss *Sphagnum* spp. at impact sites and control sites. These estimates are displayed in Chart 9 (raw results for each Alpine Bog are available in Appendix 5). At impact sites, the cover of Peat Moss increased from a baseline mean cover of 5.4% to a cover of 6.0% in IY4, which represents a 11.0% increase. At control sites, the cover of Peat Moss increased from a baseline mean cover of 16.4% to a cover of 17.9% in IY4, which represents a 9.2% increase. In real terms, this means that Peat Moss cover increased by 1.8% at impact sites relative to control sites. However, the relative increase in Peat Moss cover at impact sites compared with control sites is not statistically significant (BACI contrast = -0.0083; SE = 0.0087; F-statistic = 0.9230; numerator DF = 1; denominator DF = 59; P = 0.3406).

**Chart 9 Percentage cover of Peat Moss at Alpine Bogs over time relative to the baseline mean ± one standard deviation (BM±SD)**

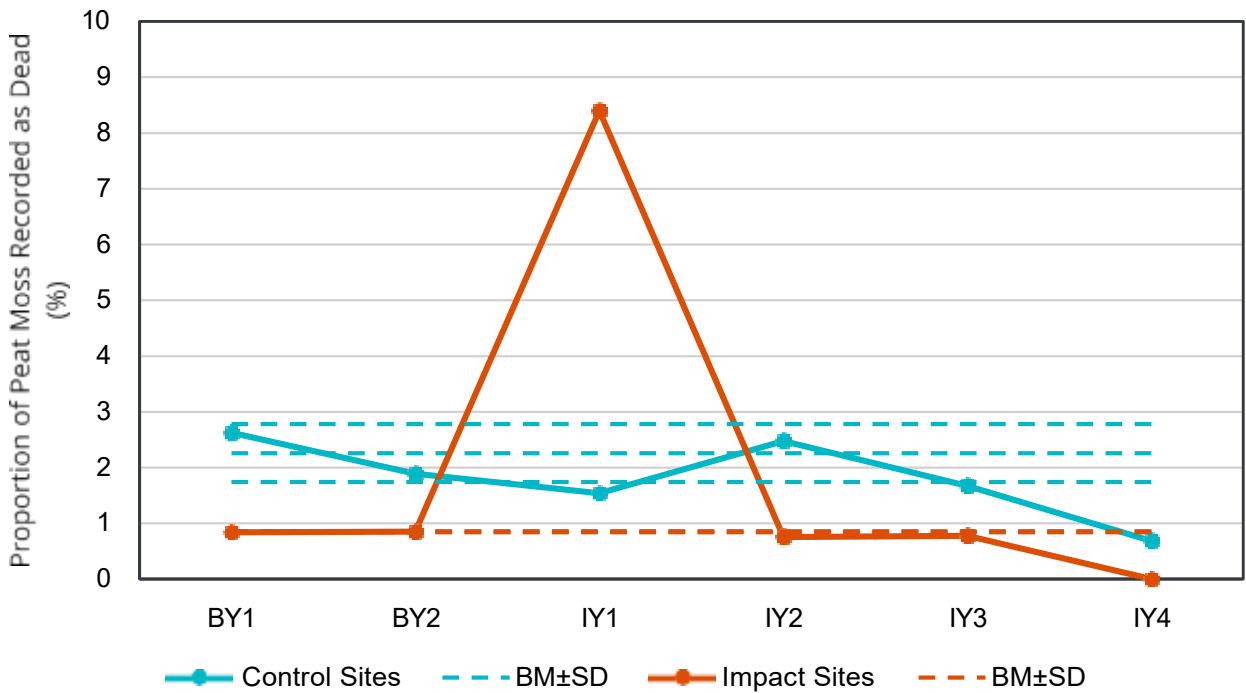
The proportion of dead Peat Moss at impact sites and control sites is shown in Chart 10. A substantial (albeit statistically insignificant) increase in dead Peat Moss was observed at impact sites in IY1, but the result has not been repeated since. At impact sites, the proportion of dead Peat Moss in IY4 was 0.0% and lower than the baseline mean of 0.8%. Changes in the proportion of dead Peat Moss at impact sites compared with control sites before and after construction have not been statistically significant (BACI contrast = -0.0013; SE = 0.0042; F-statistic = 0.0974; numerator DF = 1; denominator DF = 59; P = 0.7560).

**Chart 10 Proportion of Peat Moss recorded as dead relative to the baseline mean  $\pm$  one standard deviation (BM $\pm$ SD)**

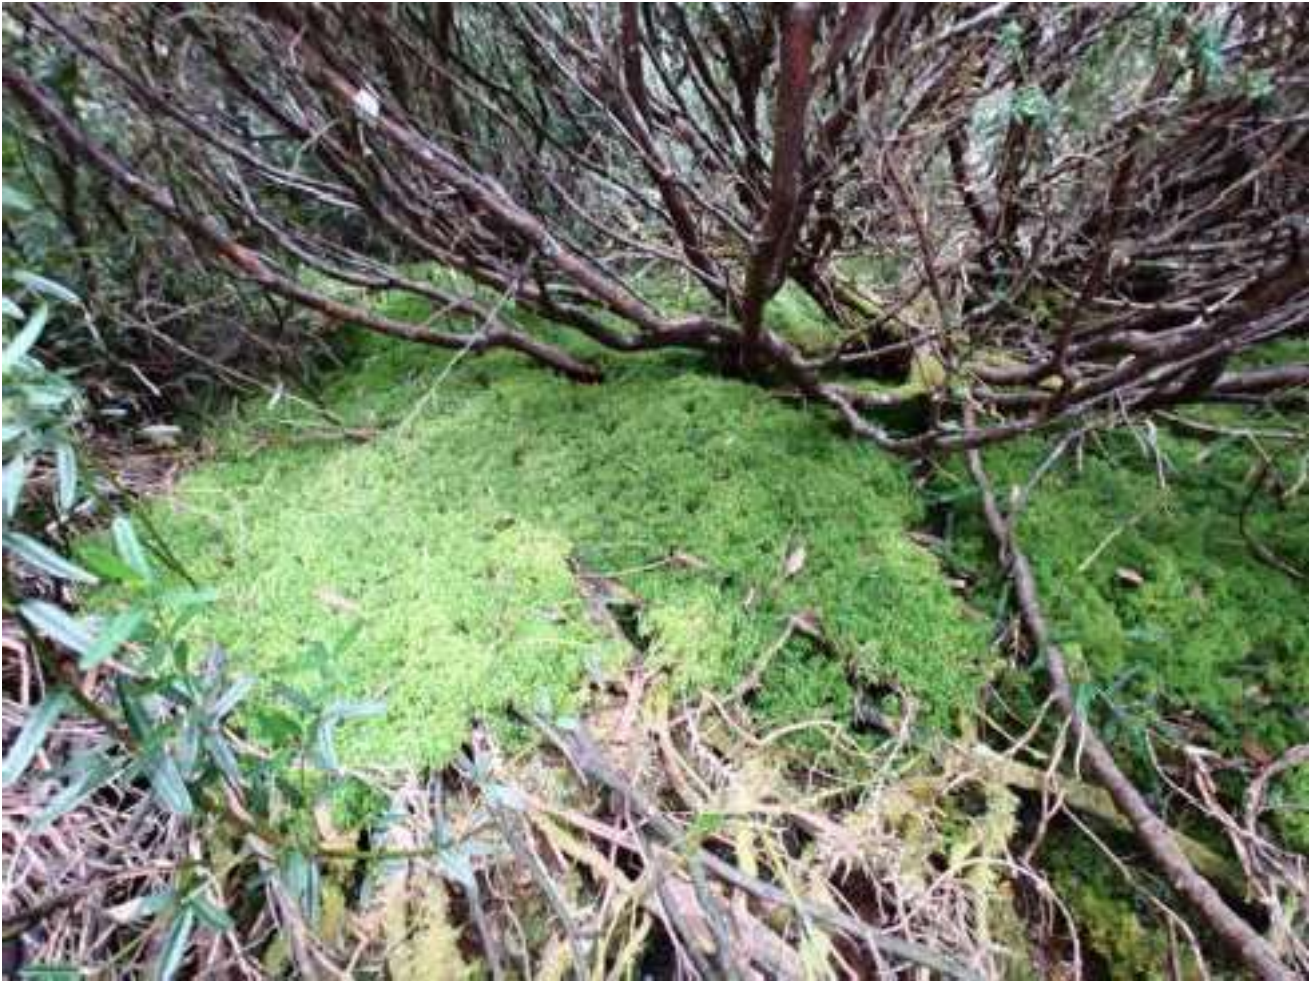
**Photo 1** Peat Moss observed expanding beneath a canopy of Alpine Podolobium and Mountain Plum-pine (IY4; 27 February 2023)

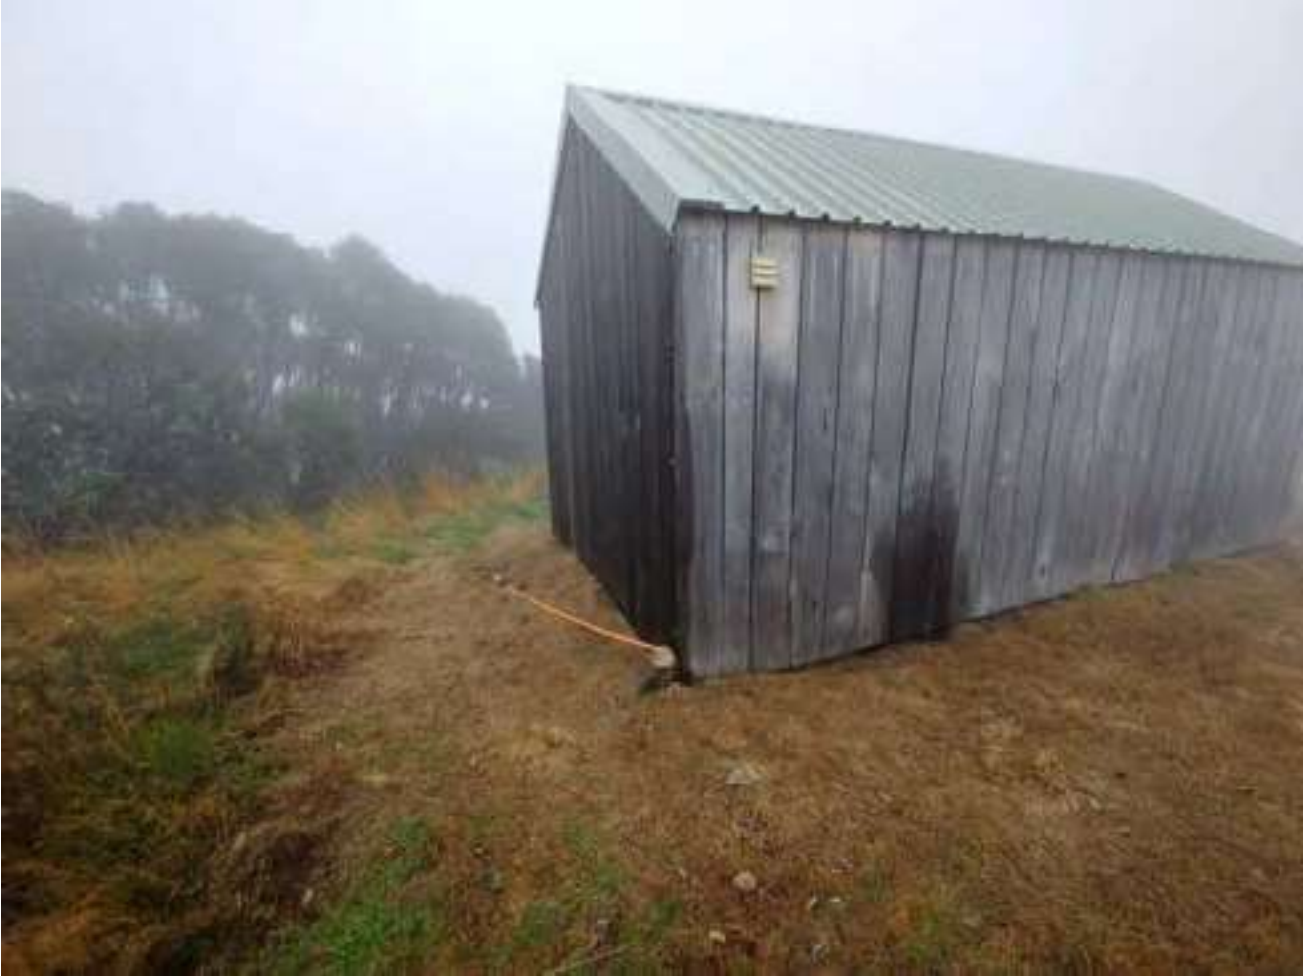
**Photo 2 Discharge of water from Baldy Turrent pump house, upslope of Bog 1 (IY4; 28 April 2023)**

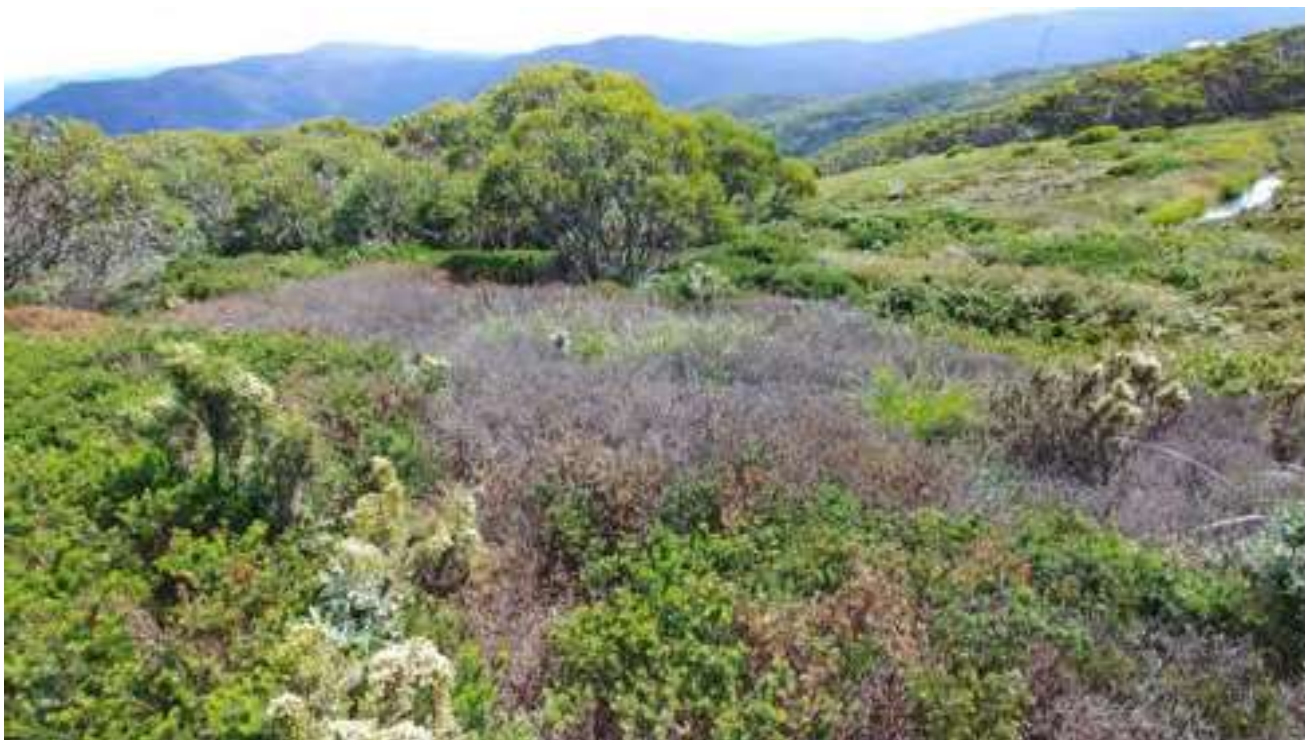
**Photo 3** Dieback of non-bog-dependent flora at western boundary of Bog 11.2 (Location D1; IY3; 1 February 2022; compare with Photo 4)

4. Dieback locations must continue to be re-visited in future years to investigate possible causes, to track vegetation recovery or succession and to plan any necessary management interventions e.g. revegetation.

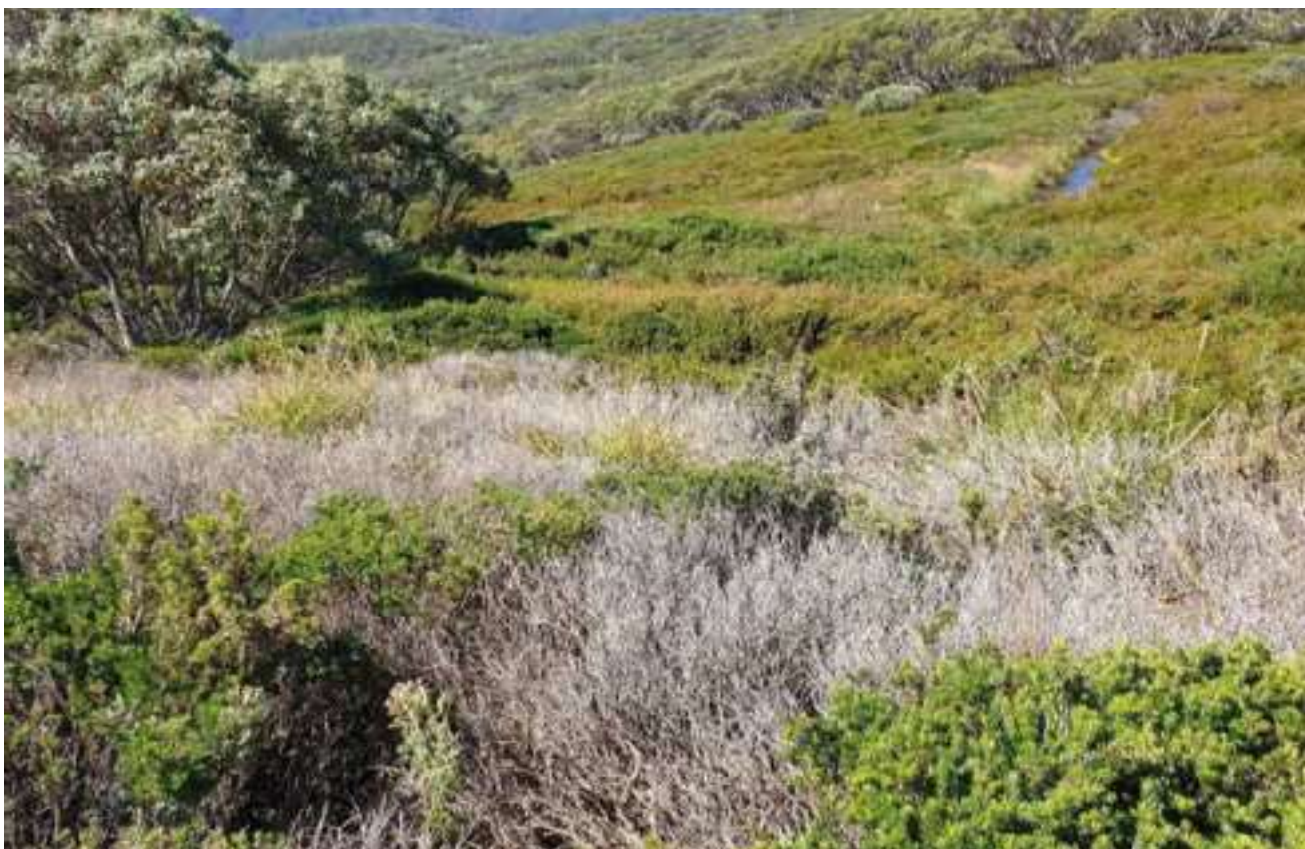
**Photo 4** Increased dieback of non-bog-dependent flora at western boundary of Bog 11.2 (Location D1; IY4; 21 February 2023; compare with Photo 3)

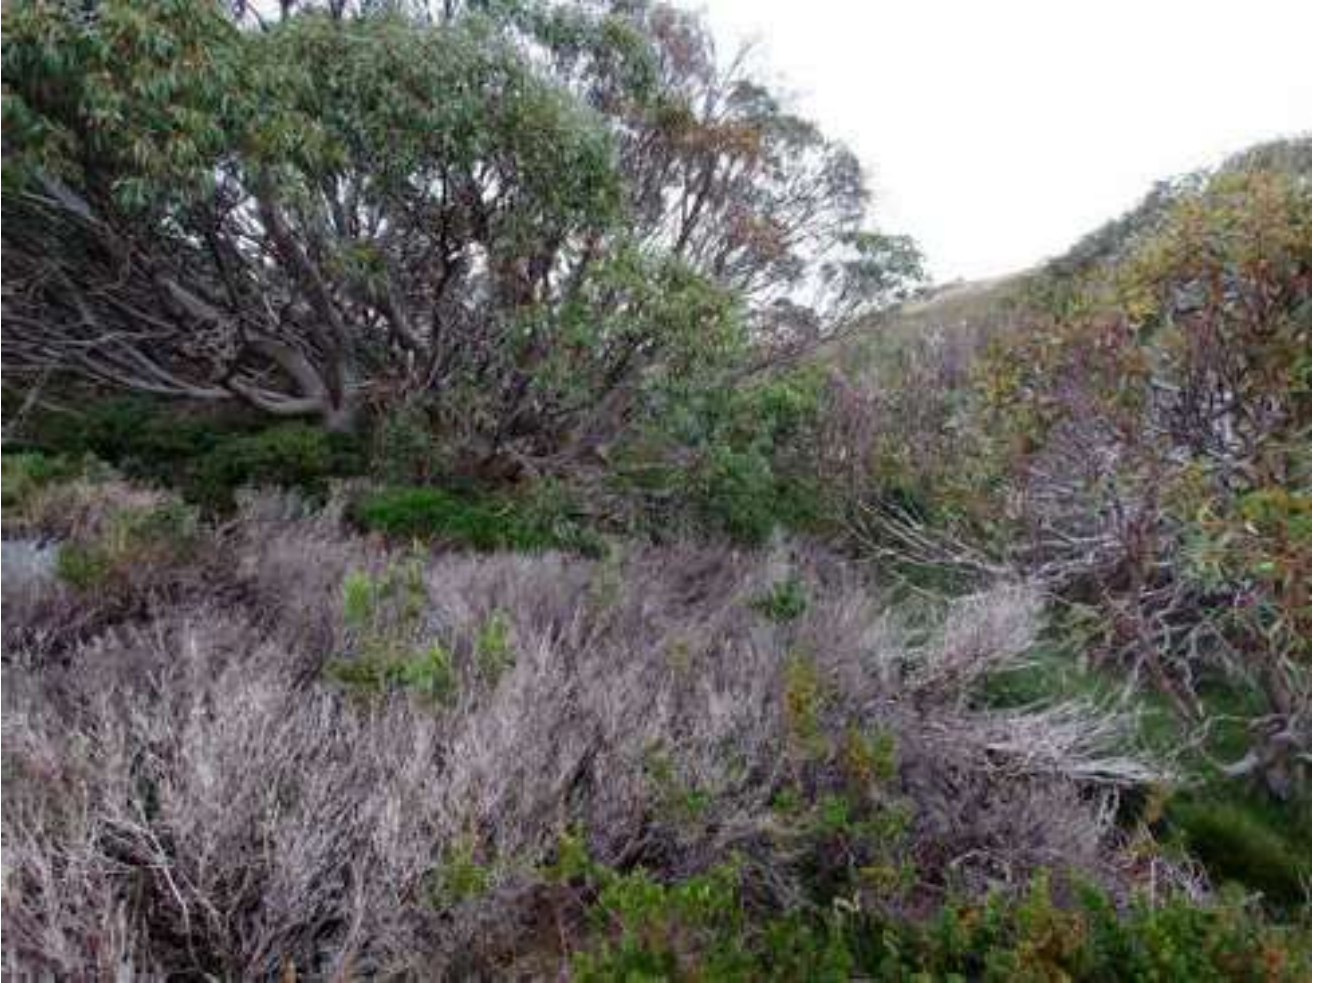
**Photo 5 Dieback of non-bog-dependent flora near southern boundary of Bog 4.2 (Location D11/D14; IY4; 28 February 2023)**

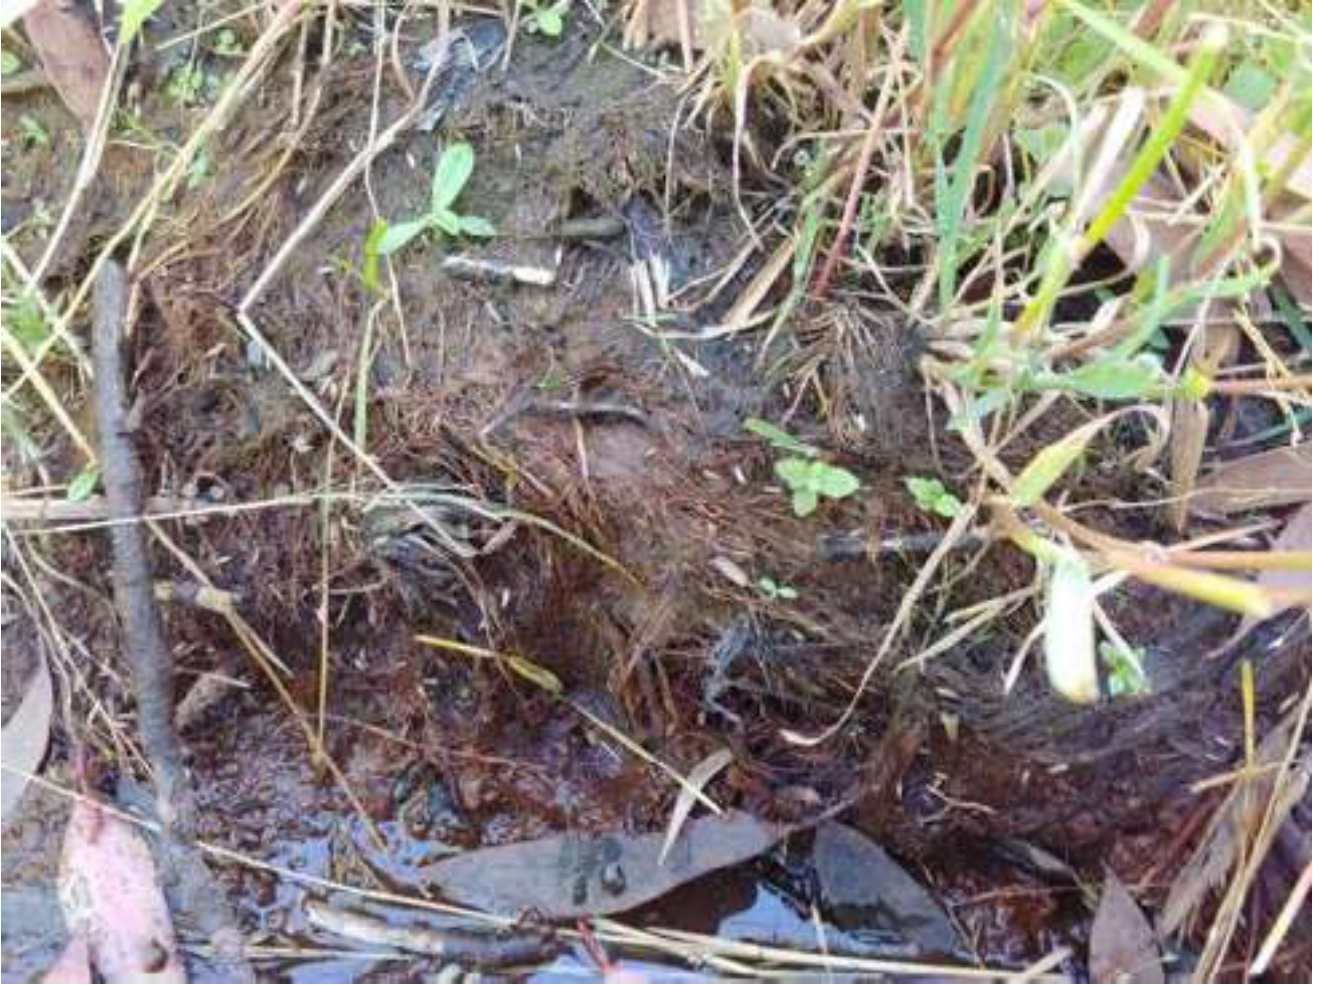
**Photo 6 Sediment becoming incorporated into humus layer midway down Bog 6 (IY4; 1 March 2023)**

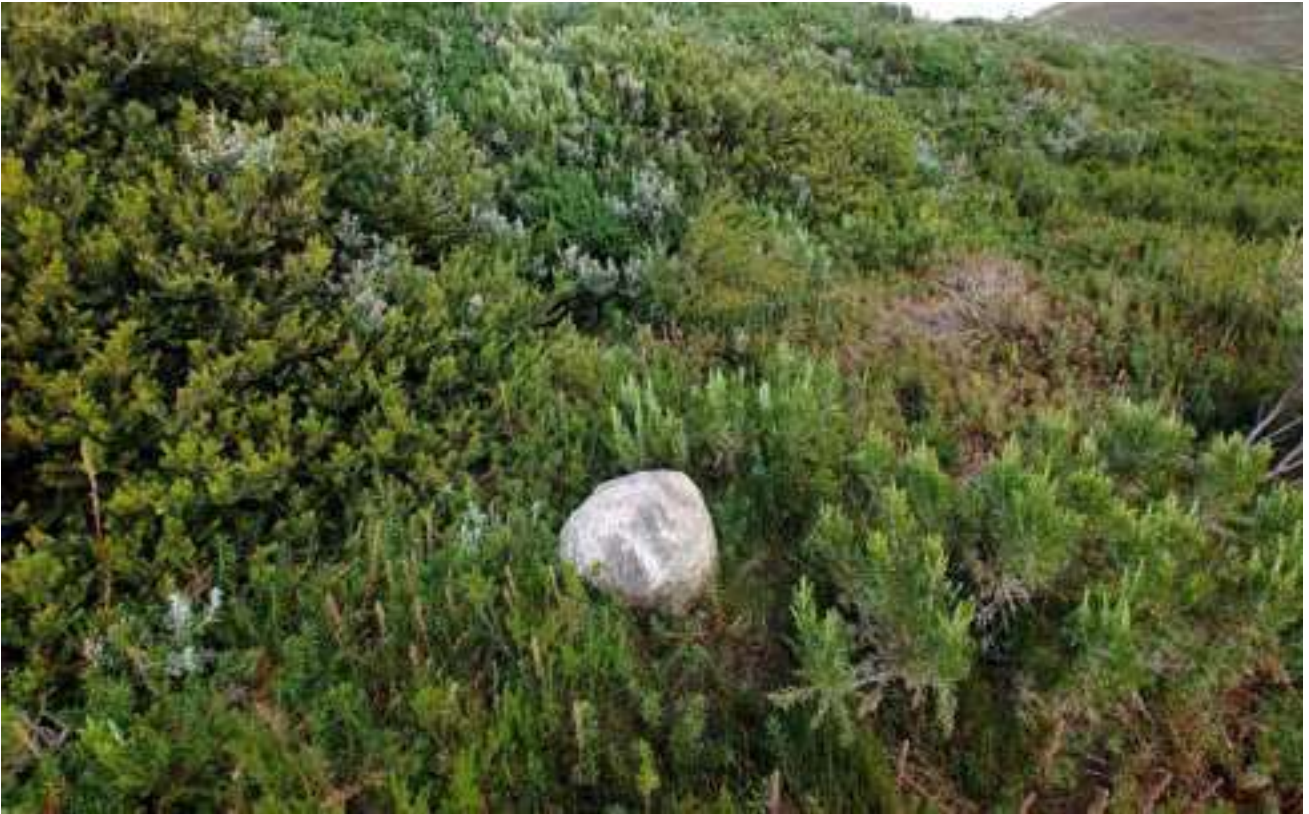
**Photo 7** A rock that entered Bog 11.2 from the PCF in IY1 (IY2; 18 February 2020)

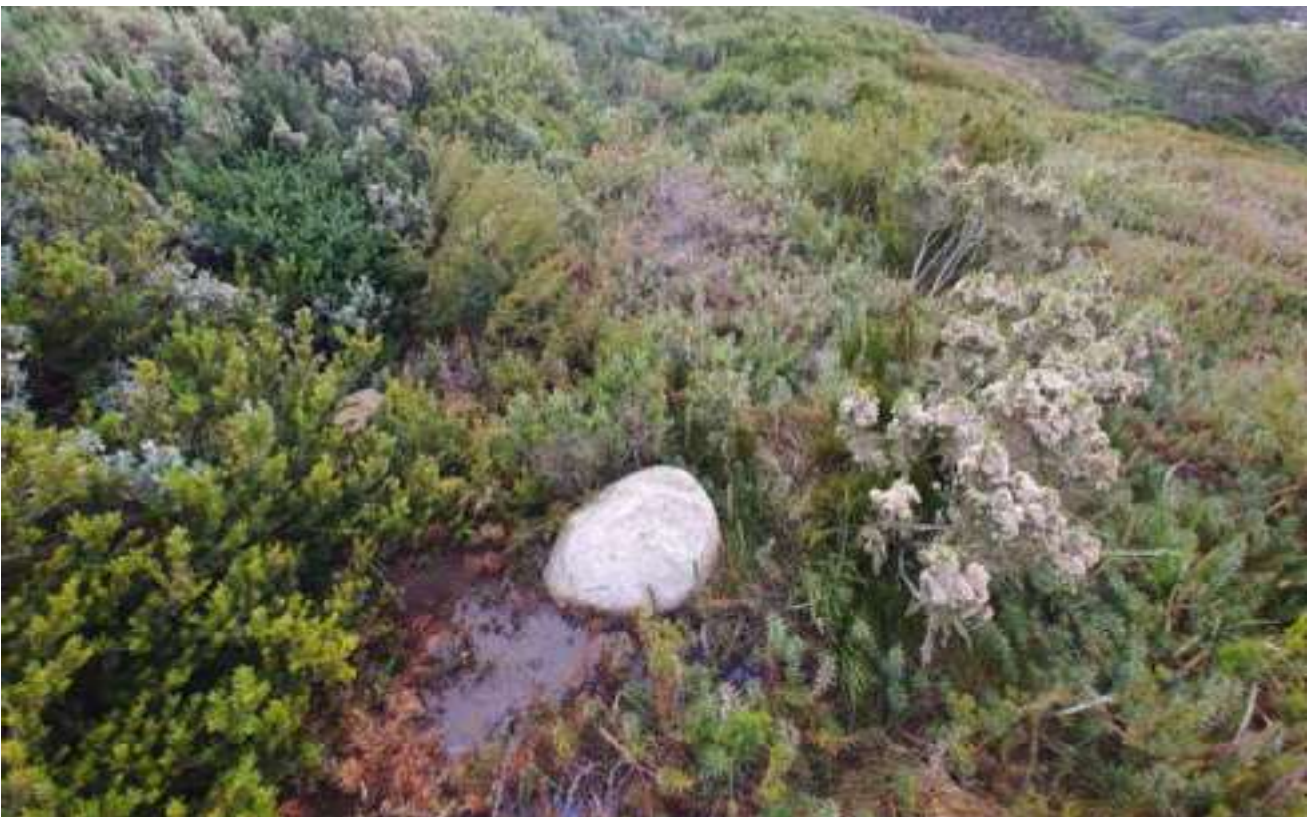
**Photo 8** The rock in Bog 11.2 in IY2, with death of surrounding vegetation (IY2; 24 February 2021)

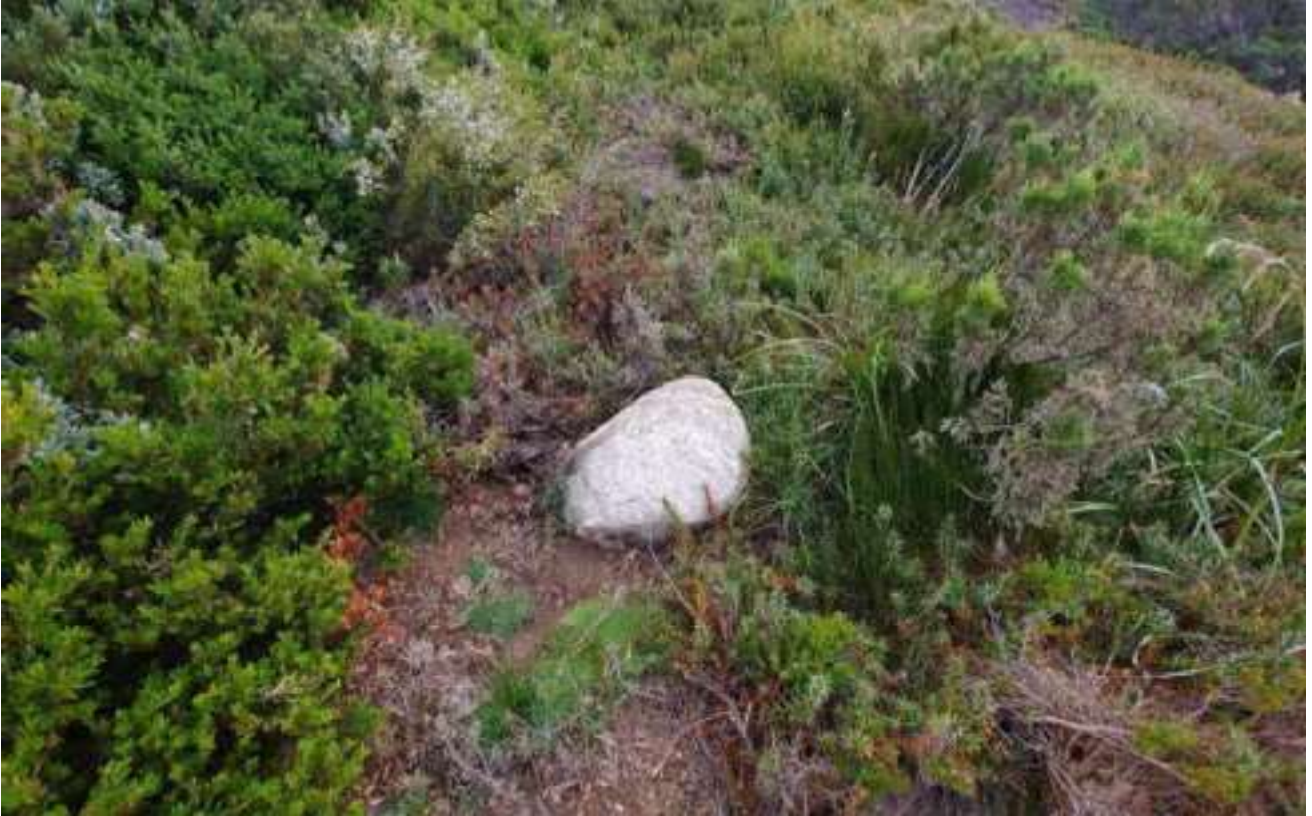
**Photo 9** The rock in Bog 11.2 in IY3, with some recovery of bog-dependent flora but also colonisation by weeds (IY3; 17 February 2022)
