# Mount Buller Water Storage Project: Hydrological and Ecological Monitoring and Adaptive Management Program - Impact Year 4

30 October 2023

Mount Buller Water Storage Project  
Hydrological and Ecological Monitoring and  
Adaptive Management Program  
Impact Year 4 Monitoring

FINAL REPORT

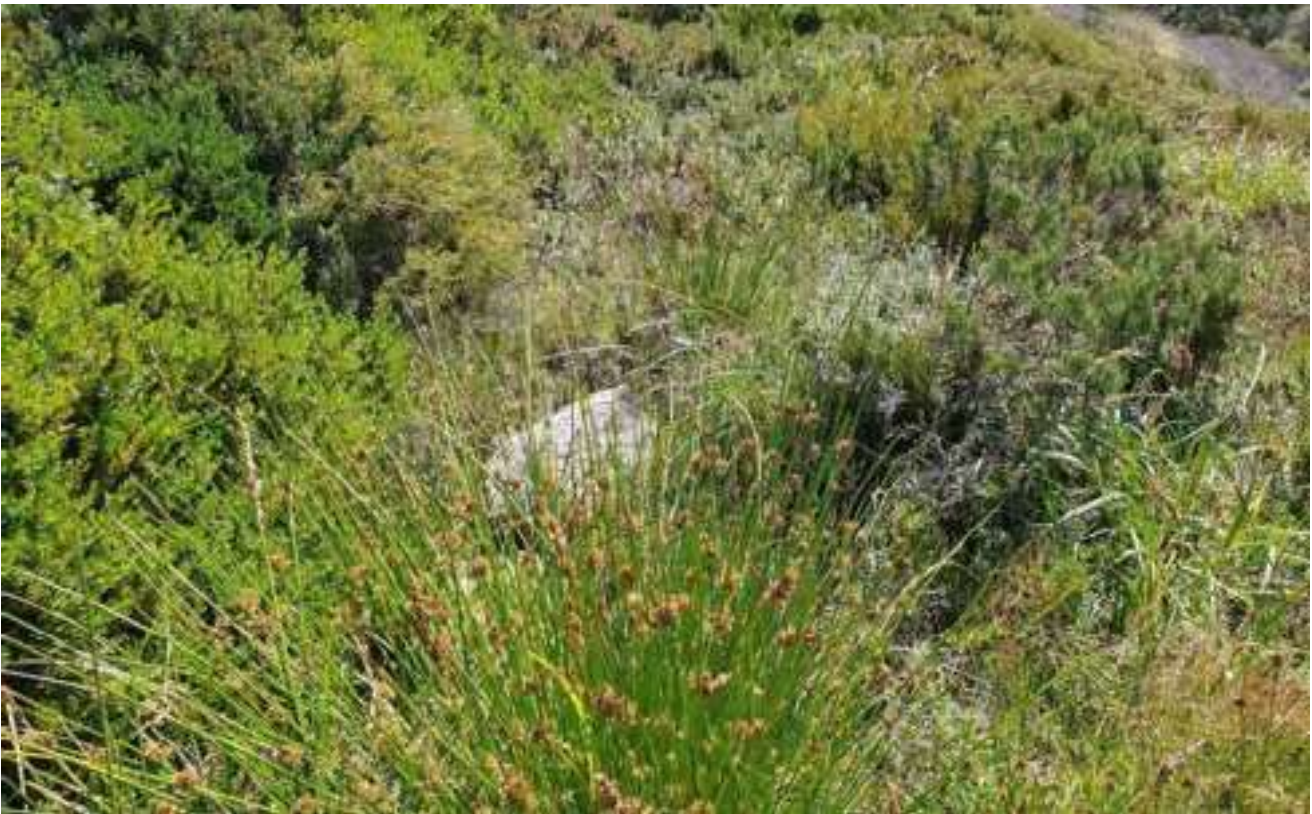
**Photo 10** The rock in Bog 11.2 in IY4, with colonisation by weeds (IY4; 21 February 2023)

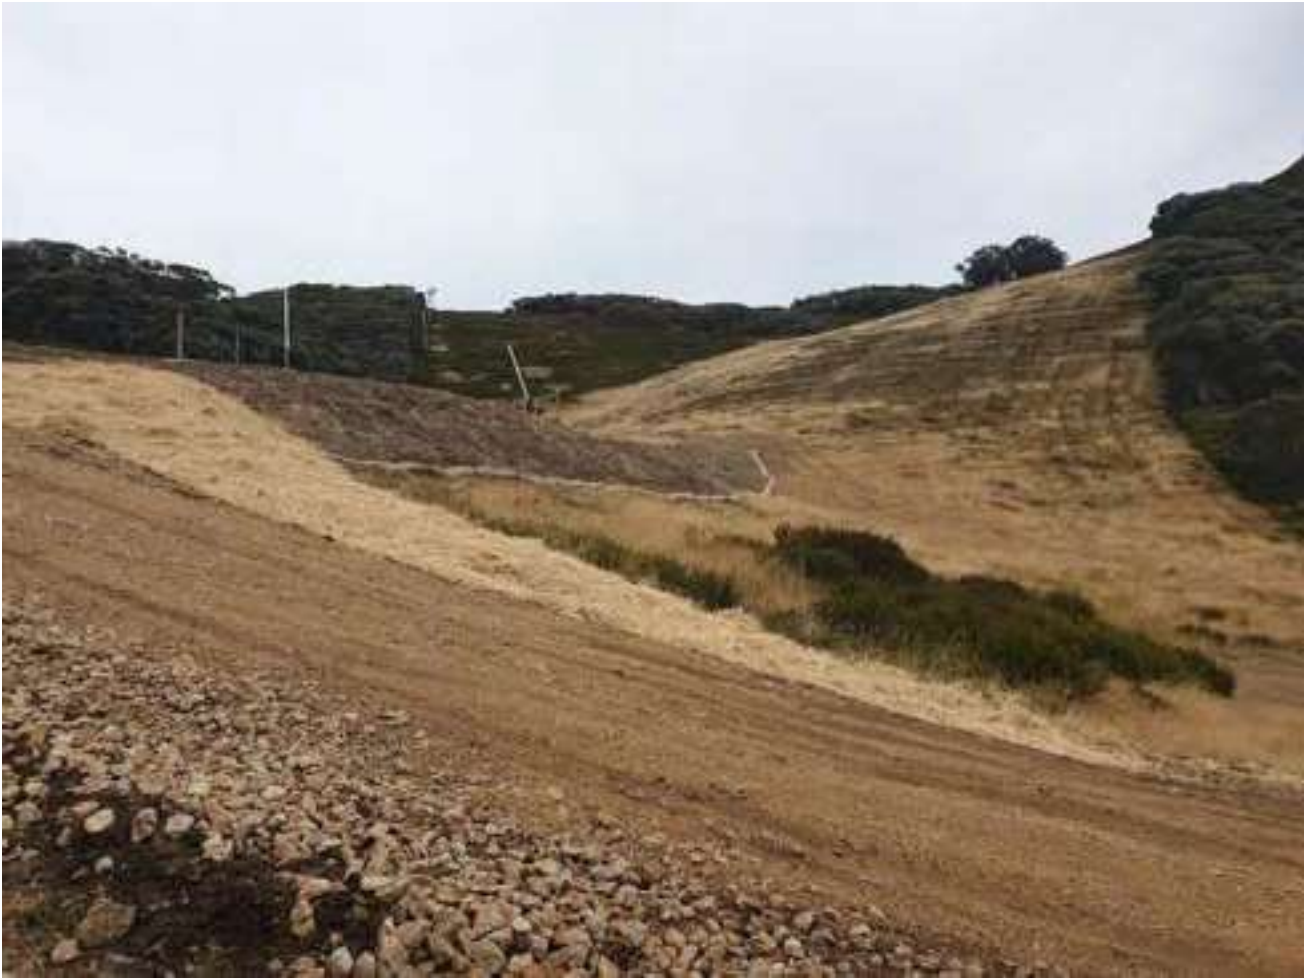
**Photo 11 Earthworks surrounding Bog 13 in IY4 (IY4; 25 May 2023)**

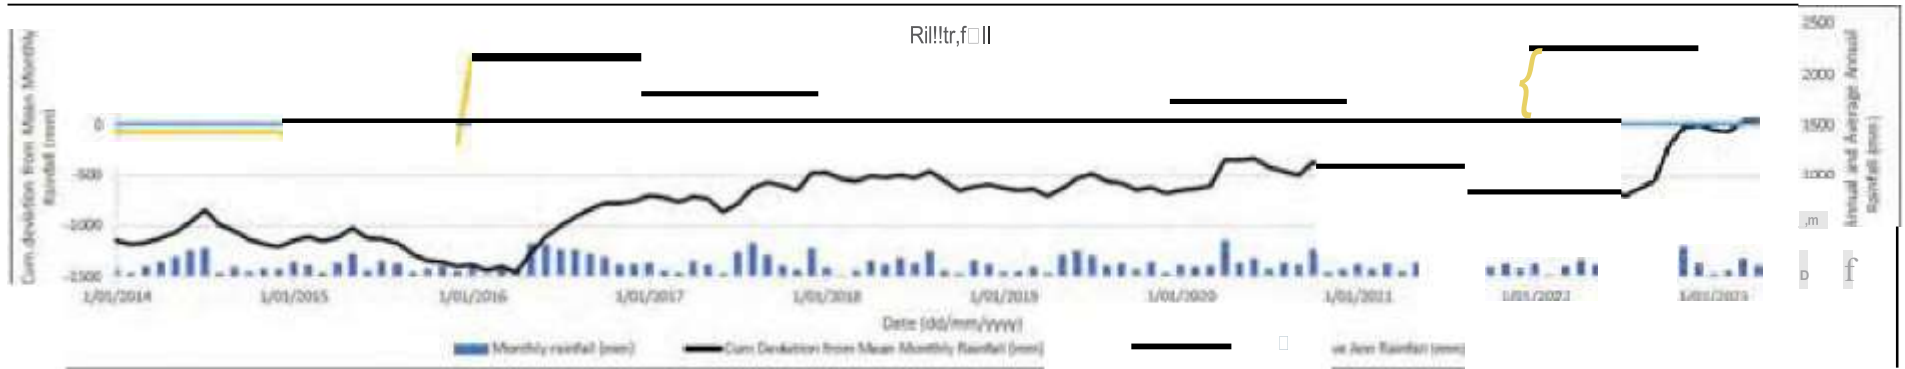
Figure 2 Rainfall trends January 2014 - June 2023
