# Water Quality Annual Report

2025-26

Alpine Resorts  
Victoria

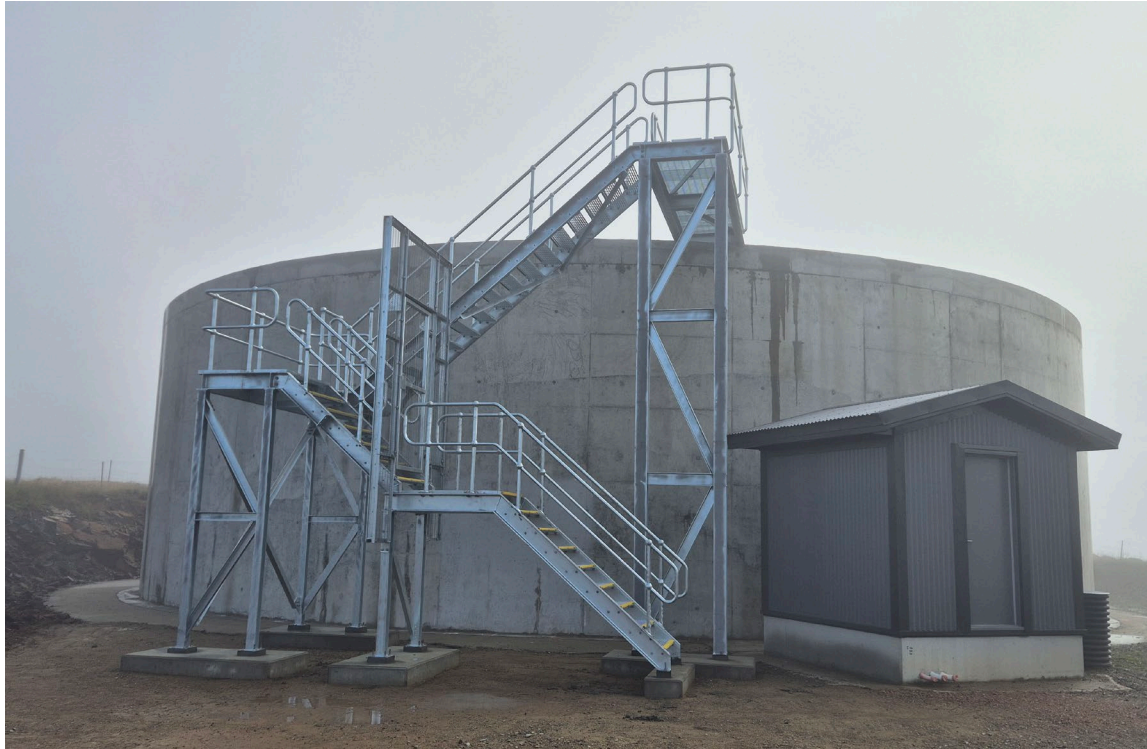
**Figure 9: The Higgi Tank Access Stairway.**

The stairway shown in Figure 9 was built to provide safe access to the inspection hatch in the roof of the 2.2 ML tank on Mt Higginbotham.

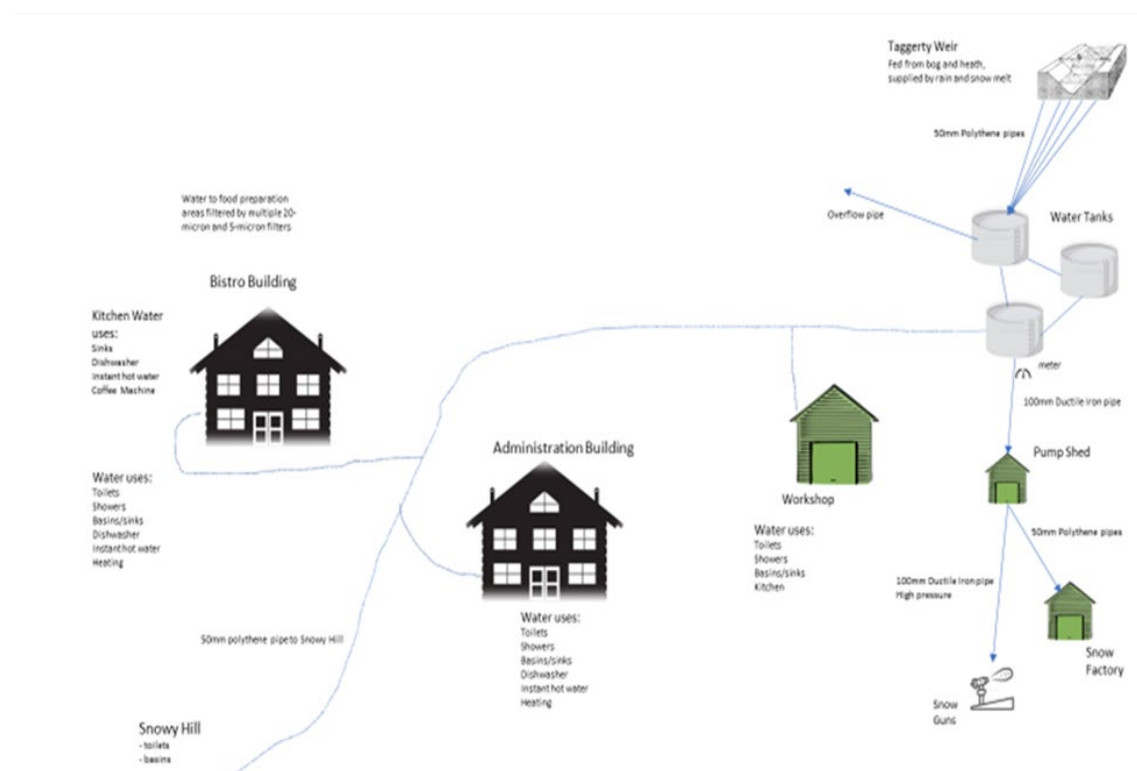
Figure 10: Lake Mountain regulated water supply system

Gerraty's serves as the resort's village centre. Water is sourced from the Upper Taggerty River, a small stream fed by the bog and heath catchment area of Echo Flat. This plateau is situated within the Yarra Ranges National Park and considered a pristine environment. Potential human contact within the catchment is minimal, restricted to portions of the cross-country ski trail network that borders the catchment area, and the possibility of people camping in remote areas away from access to toilets.

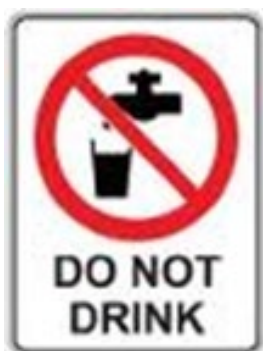
**Figure 11: Signage displayed at all water outlets**

- A blanket signage program for all water outlets on the resort has been completed and maintenance schedule that is monitored through the resort Water Supply Risk Management Plan. All water outlets have been signed warning visitors to Lake Mountain that water is untreated and of the health risks that may arise from its use.
