WATER SUPPLY
ANNUAL REPORT
2017-18

Southern Alpine Resort Management Board

Water supply 2017-18 Annual Report

Lake Mountain Alpine Resort and Mount Baw Baw Alpine Resort

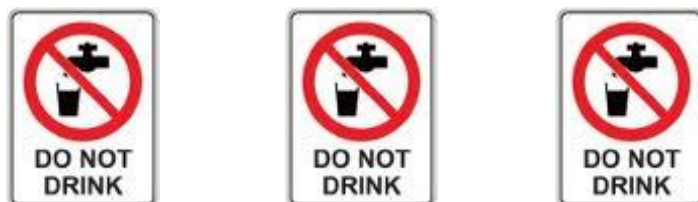
- A blanket signage program for all water outlets on the resort has been completed and maintenance schedule that is monitored through the resort Water Supply Risk Management Plan. All water outlets have been signed warning visitors to Lake Mountain that water is untreated and of the health risks that may arise from its use.

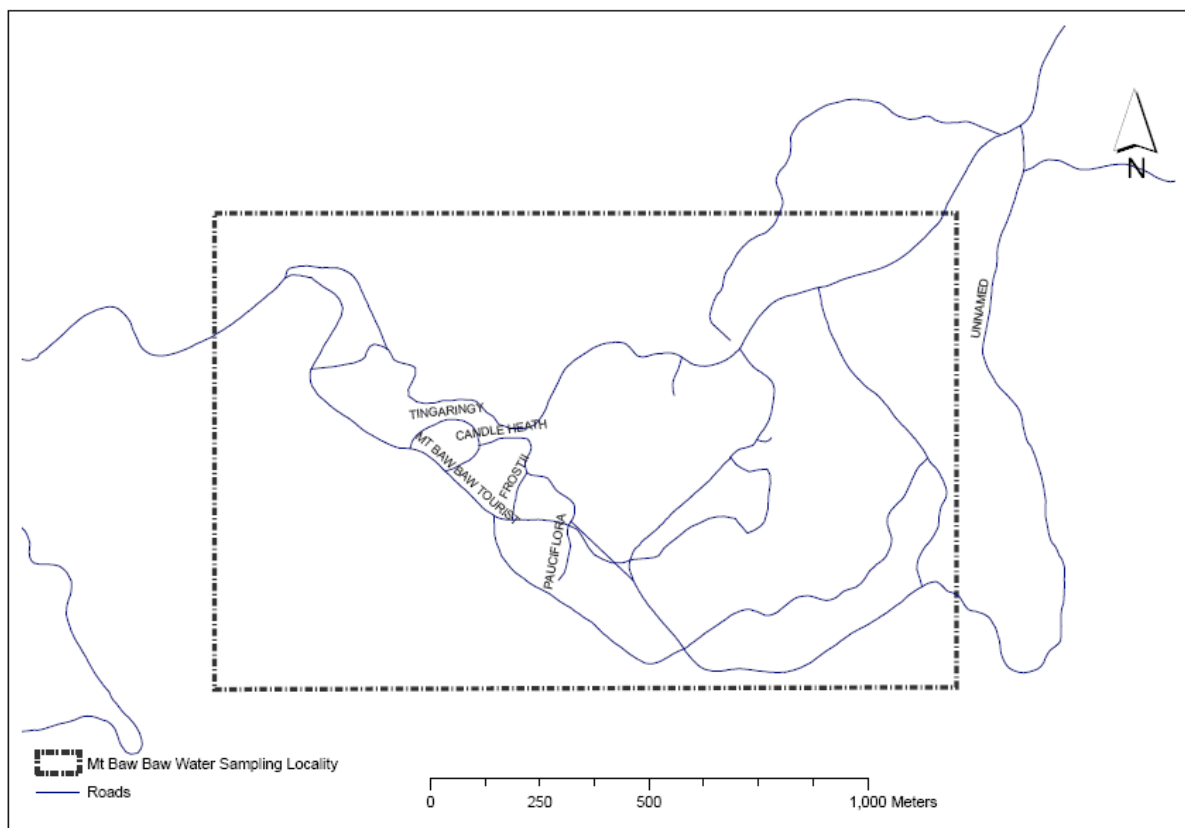
Figure 1: Map outlining the water sampling locality of the resort

Regular monthly sampling of raw water in the catchment area is undertaken to monitor the raw water quality and includes monitoring for parameters such as turbidity and organic chemicals.

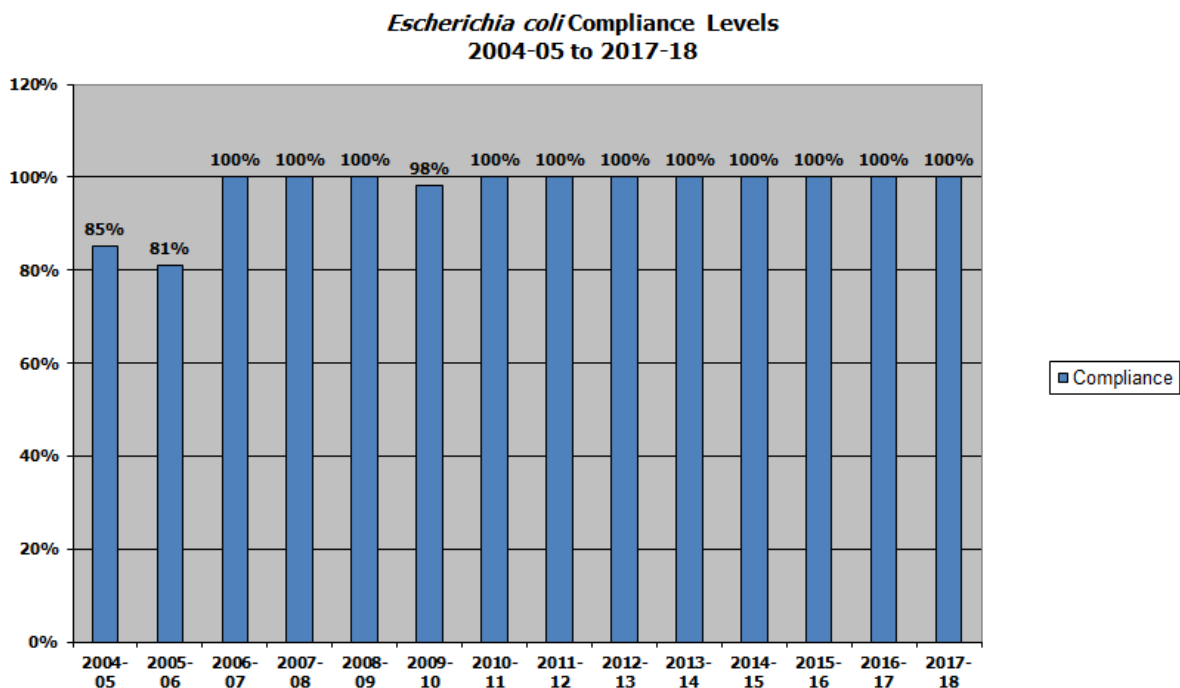
Figure 7: Results for *E.coli* compliance throughout recent reporting years

The trend for *E.coli* compliance is shown below in Figure 7.

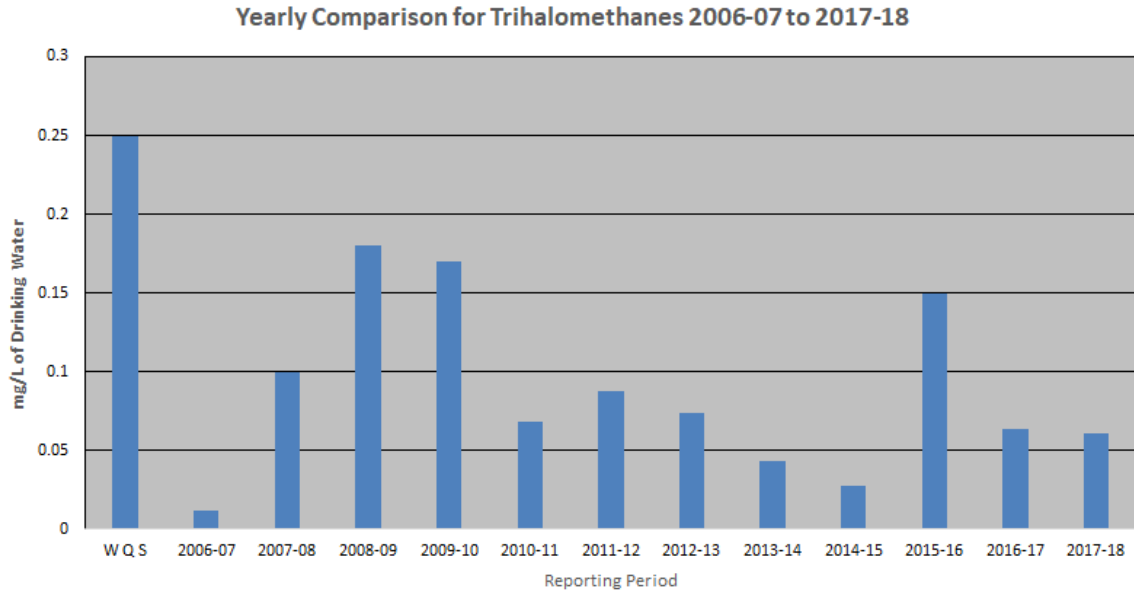
Figure 8: Results for maximum trihalomethanes showing the yearly trend. WQS = Water Quality Standard as specified in Schedule 2 of the Safe Drinking Water Regulations 2015.

As shown below in Figure 8 there has been a slight decrease in the level of trihalomethanes during the period 1 July 2017 to 30 June 2018 when compared to 2016/2017.

The most notable issue in the previous two reporting periods being the level of trihalomethanes recorded during the 2015/2016 reporting period. The highest recorded result of 0.15mg/L was recorded during the month of May 2016 when it was difficult to undertake sluicing operations due to low catchment inflows. These low inflows restricted the amount of water available for

use in the village reticulation system. The 2017/2018 results are still below the water quality standard of 0.25 mg/L (Shown as WQS in Figure 8 below) for trihalomethanes and results have reduced to lower levels as a result of regular snowfalls and increased system loading.

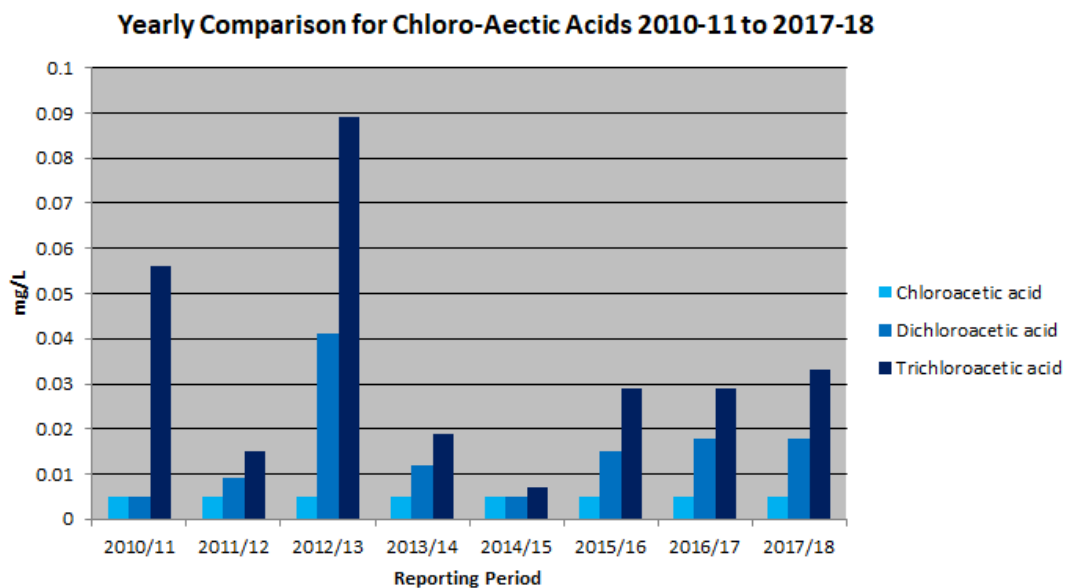
Figure 9: Results for maximum chloroacetic acids over past eight reporting periods. Chloroacetic acid WQS: ≤0.15mg/L, dichloroacetic acid WQS: ≤0.1mg/L, trichloroacetic acid WQS: ≤0.1mg/L

The results for maximum other chlorine by-products (chloroacetic acids), have been relatively consistent as can be seen below in Figure 9, especially over previous three reporting periods. There has been a very slight increase when comparing the 2016/17 period to the 2017/18 period, however, this negligible and well below the WQS thresholds.

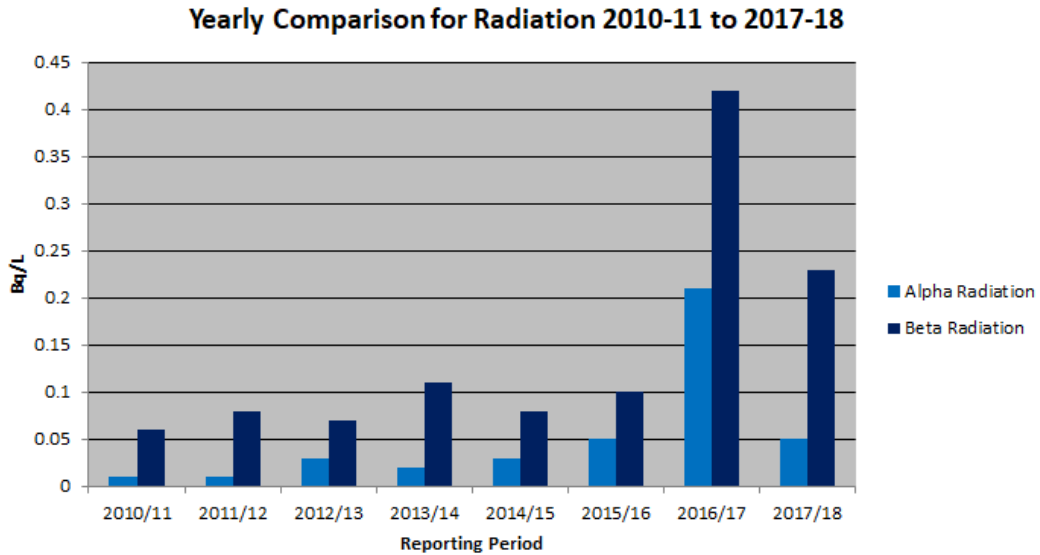
Figure 10: Results for maximum radiation over past eight reporting periods. Radiation WQS: ≤ 0.5 Bq/L.

The results for radiation show a decrease in both alpha and beta radiation when comparing the 2016/17 period to the 2017/18 period (see Figure 10). Both of these years are below the WQS threshold.

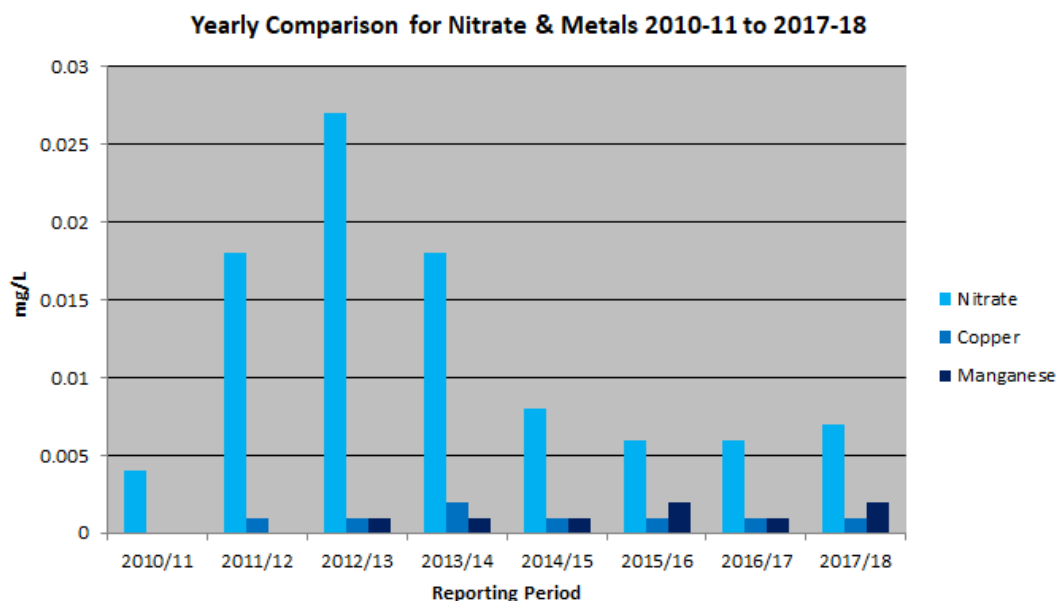
Figure 11: Results for maximum nitrate, copper and manganese for past eight reporting periods. Results unavailable for copper for 2010/11, and for manganese until 2012/13
 Nitrate WQS: ≤ 50 mg/L, copper WQS: ≤ 2 mg/L, manganese WQS: ≤ 0.5 mg/L.

The levels of nitrate, copper and manganese in over the past four reporting periods have stayed relatively low, with each parameter being well below the required WQS (see Figure 11). The results are slightly higher for the current 2017/18 period than the previous period.

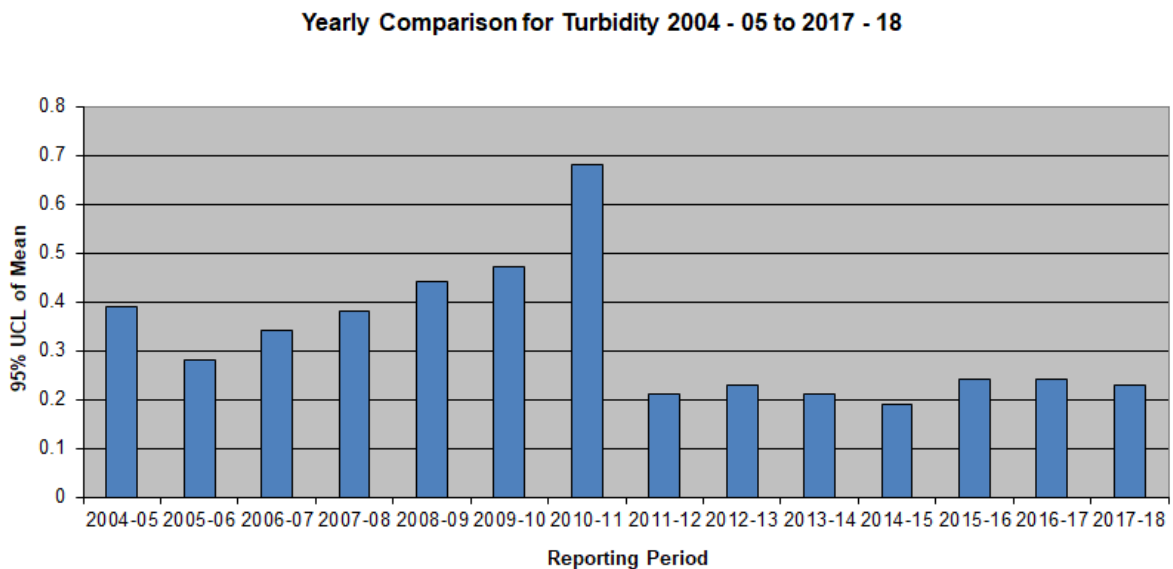
Figure 12: Results for Turbidity showing the yearly trends

Turbidity levels for the period 1 July 2017 to 30 June 2018 remained stable with a slight decrease compared to the previous two years. Full compliance was met for the turbidity water quality standard for the reporting period with 95th percentile of twelve month period being 0.23 for 2017/2018 (see Figure 9). These results are lower when compared with previous periods where the result was as high as 0.68, recorded in the 2010/2011 reporting period.

Mount Baw Baw Alpine Resort continues to undertake a regular reduction of intake flows, particularly with regard to major rain events. Major rain events have the potential to increase turbidity levels within the raw water catchment. The reduction in intake flows can reduce the incidence of turbid water entering the village potable water supply, resulting in the supply of a higher quality of drinking water.
