## Southern Alpine Resort Management Board

## Water supply 2018-19 Annual Report

### Lake Mountain Alpine Resort and Mount Baw Baw Alpine Resort

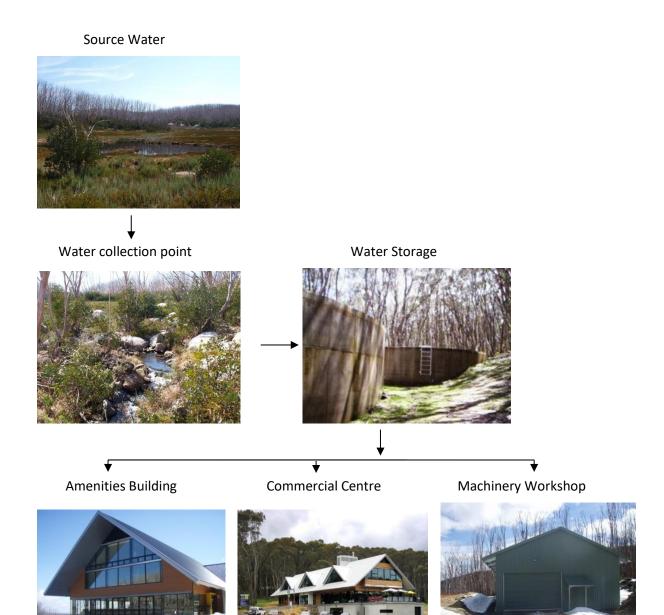
### Resort Water Supply, Storage and Reticulation System Gerratys

The main water supply system for Gerratys, the resorts village centre, consists of a small concrete weir directing water, via a series of 50mm poly pipes under a gravity/syphons process from the Taggerty River to 3 enclosed concrete tanks. The combined storage capacity of theses tanks is 800kl. The storage tanks supply water to resorts facilities via a 100mm Ductile Iron pipe.

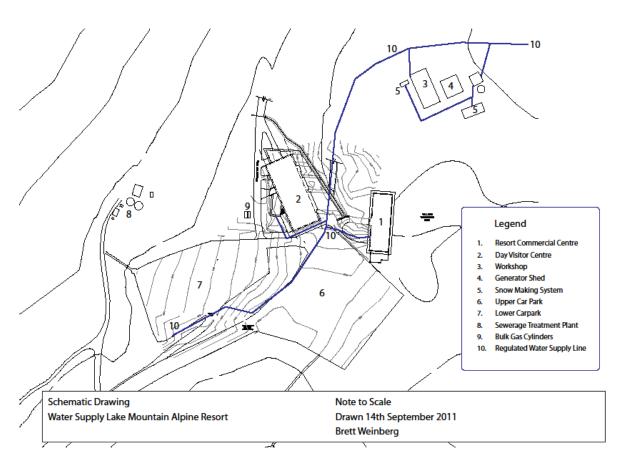
## 3. Schematic Drawing

Water Supply Lake Mountain Alpine Resort

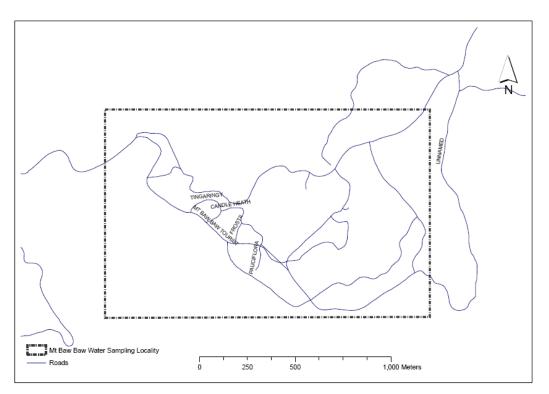
Figure 1: Map outlining the water sampling locality of the resort

Regular monthly sampling of raw water in the catchment area is undertaken to monitor the raw water quality and includes monitoring for parameters such as turbidity and organic chemicals.

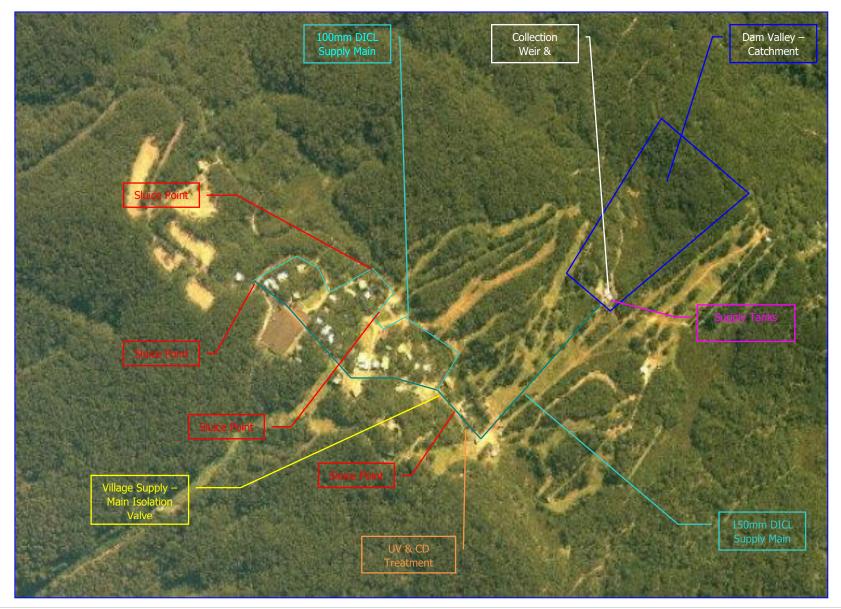
Figure 2: Plan and aerial view of the Mount Baw Baw Village – Water Supply System

There are four scour points within the system and these are run usually at monthly intervals to ensure that there is no accumulation of sediments within the system. The reticulation system is of a ring main configuration hence creating minimal dead ends, which in turn will not allow stagnation to occur (see Figures 2 & 3).

Prior to final distribution to consumers all water is treated by Ultra Violet (UV) Treatment Plant located at the Mountain Sports Centre at the base of the ski area (see Figure 2). A sketch image and photograph of the UV treatment plant is shown below.

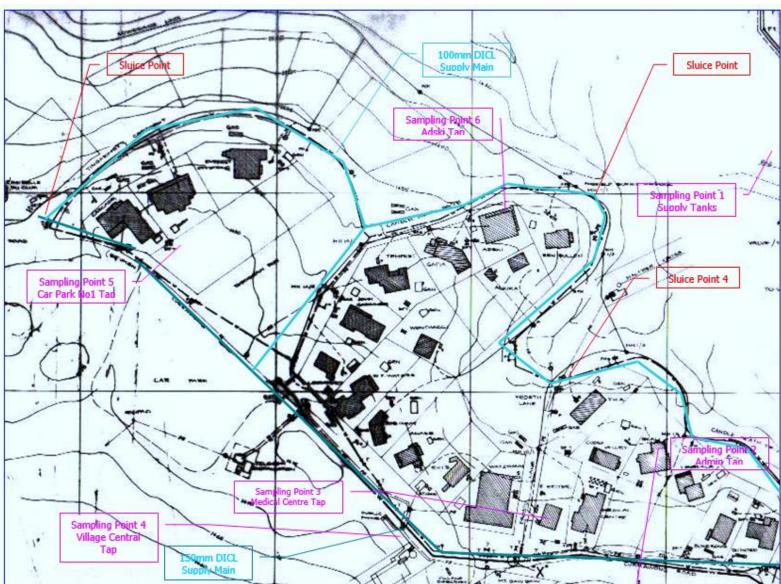
Figure 3: Schematic of the Mount Baw Baw Alpine Resort water supply system

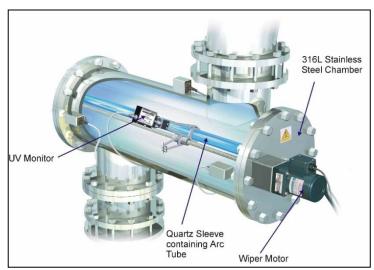
Figure 4: Cutaway diagram of ultraviolet treatment plant

In addition to the abovementioned UV Treatment Plant (see Figures 4 & 5), a residual trim unit provides automated chlorine dosing, after being treated with UV. The residual trim unit acts as a secondary disinfection barrier in Mount Baw Baw's multiple barrier approach to water treatment. This unit provides the ability to control the level of chlorine and provide a disinfection residual within the water supply distribution system (see Figure 6).

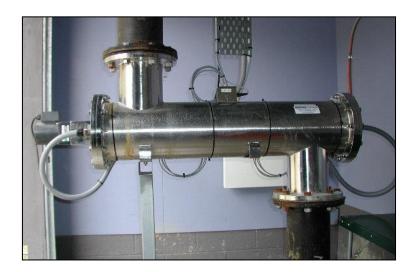
Figure 5: Photograph of actual UV treatment plant at Mt Baw Baw Alpine Resort

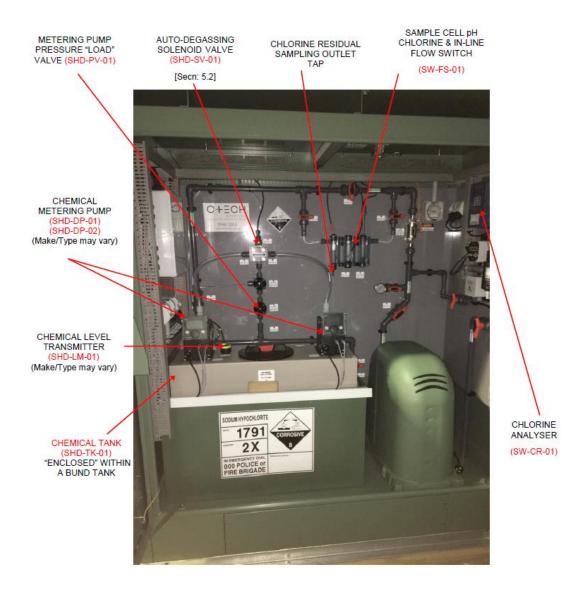
Figure 6: Labelled photograph of the residual trim unit

Since the installation of the automated dosing system the chlorine residual within the distribution system have stabilised with measurements logged in the range of 0.10 mg/L - 1.13 mg/L for Free Chlorine and 0.21 mg/L - 1.27 mg/L for total Chlorine.

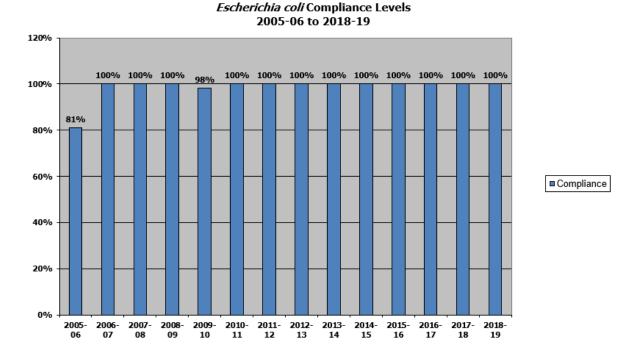
Figure 7: Results for *E.coli* compliance throughout recent reporting years

The introduction of improved systems management, the effect of the UV treatment plant, manual disinfection using chlorine, the installation of an automated chlorine dosing plant and thorough staff training in relation to sampling procedures and techniques have assisted with the improvement in compliance across the last ten reporting periods.

The trend for *E.coli* compliance is shown below in Figure 7.

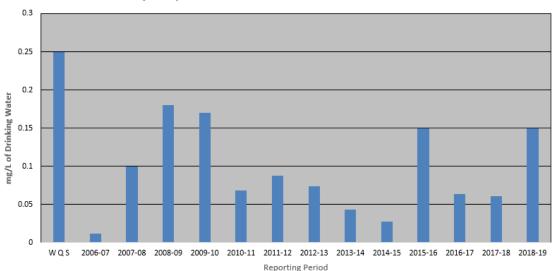
Yearly Comparison for Trihalomethanes 2006-07 to 2018-19

Figure 8: Results for maximum trihalomethanes showing the yearly trend. WQS = Water Quality Standard as specified in Schedule 2 of the Safe Drinking Water Regulations 2015.

As shown below in Figure 8 there has been an increase in the level of trihalomethanes during the period 1 July 2018 to 30 June 2019 when compared to the previous 2017/2018 period.

The maximum result of 0.15mg/L was recorded during the month of May 2016 when it was difficult to undertake sluicing operations due to low catchment inflows. These low inflows restricted the amount of water available for use in the village reticulation system. This same issue occurred in February 2019. The 2018/2019 results are still below the water quality standard of 0.25 mg/L (Shown as WQS in Figure 8 below) for trihalomethanes.

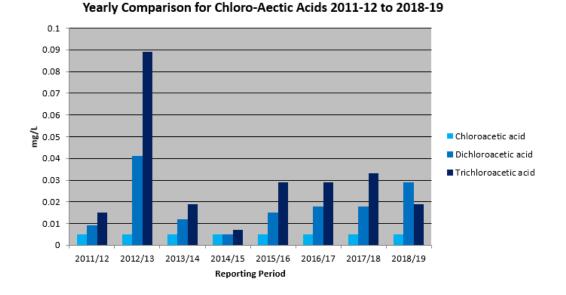
Figure 9: Results for maximum chloroacetic acids over past eight reporting periods. Chloroectic acid WQS: ≤0.15mg/L, dichloroacetic acid WQS: ≤0.1mg/L, trichloroacetic acid WQS: ≤0.1mg/L

The results for maximum other chlorine by-products (chloroacetic acids), have been relatively consistent as can be seen below in Figure 9, especially over the previous three reporting periods. There has been a slight change in levels when comparing the recent reporting periods to the 2018/19 period. However, it is negligible and well below the WQS thresholds.

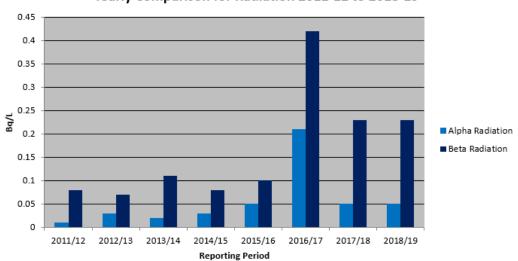
Yearly Comparison for Radiation 2011-12 to 2018-19

Figure 10: Results for maximum radiation over past eight reporting periods. Radiation WQS: ≤0.5 Bq/L.

The results for radiation show a constant level for both alpha and beta radiation when comparing the 2017/18 period to the 2018/19 period (see Figure 10). Both of these years are below the WQS threshold.

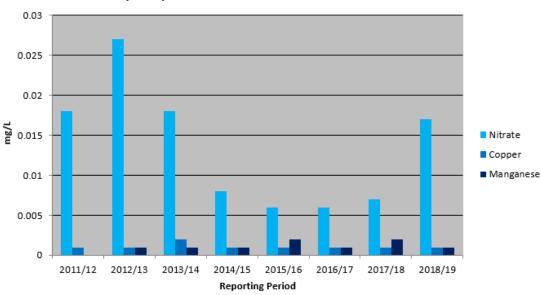
Yearly Comparison for Nitrate & Metals 2011-12 to 2018-19

Figure 11: Results for maximum nitrate, copper and manganese for past eight reporting periods. Results unavailable for manganese until 2012/13.

Nitrate WQS: ≤50 mg/L, copper WQS: ≤2 mg/L, manganese WQS: ≤0.5 mg/L.

The levels of nitrate, copper and manganese in the past four reporting periods have stayed relatively low, with each parameter being well below the required WQS (see Figure 11). The nitrate results have increased for the current 2018/19 period compared to recent years.

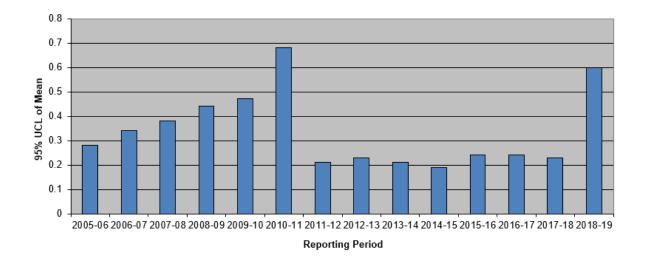
Yearly Comparison for Turbidity 2005 - 06 to 2018 - 19

Figure 12: Results for Turbidity showing the yearly trends. The turbidity metric was changed to 95% ile of sample results, whereas the UCL was prior to 2015.

Turbidity levels for the period 1 July 2018 to 30 June 2019 increased significantly compared to the previous seven years. Full compliance was met for the turbidity water quality standard for the reporting period with 95<sup>th</sup> percentile of twelve month period being 0.6 for 2018/2019 (see Figure 9). This is still lower when compared with previous periods where the result was as high as 0.68, recorded in the 2010/2011 reporting period.

The resort continues to undertake a regular reduction of intake flows, particularly with regard to major rain events. Major rain events have the potential to increase turbidity levels within the raw water catchment. The reduction in intake flows can reduce the incidence of turbid water entering the village potable water supply, resulting in the supply of a higher quality of drinking water.
