# Alpine Resorts Victoria Drinking Water Quality Annual Report 2023-24

Alpine Resorts  
Victoria

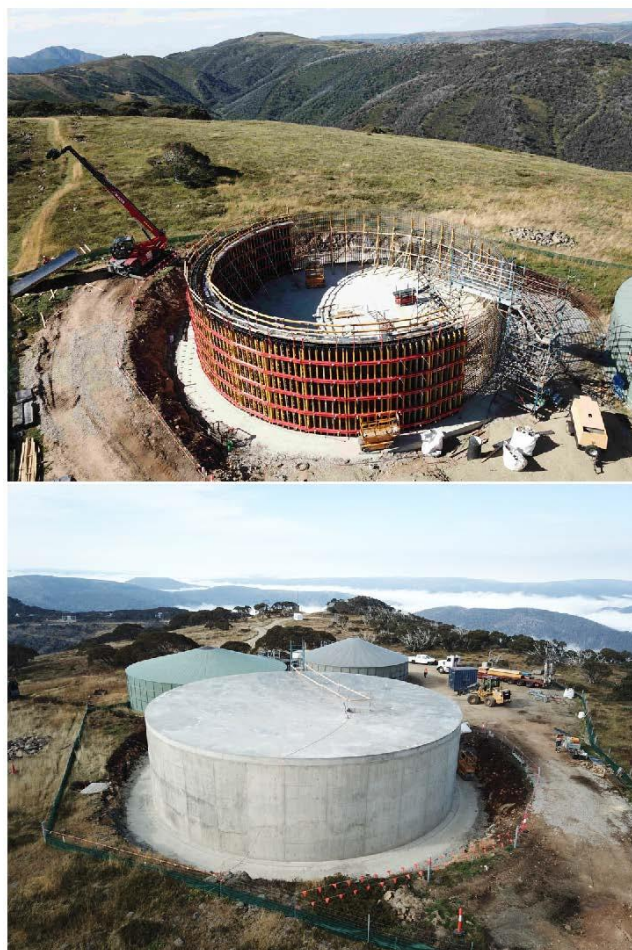
**Figure 9: New 2.2ML Mt Higgi Raw Water Storage Tank**

- A new \$2.2M, 2.2ML concrete raw water storage tank for Mt Hotham, was commissioned May 2024 (Figure 9). It was built alongside the other 2 tanks at Mt Higgi replacing the previously decommissioned/ demolished 3 smaller tanks.
- \$14,781 Replacement Chlorine analyser with pH probe at Mt Buller High Level WTP
- \$21,726 Chlorine analyser replacement Mirimbah
- Critical parts spares – pump \$7,707
- Pump soft starter \$4,440
- \$44,683 worth of various Replacement instrumentation at MBMSAR
- \$6,761 Mt Striling clear water storage tank replacement
- \$13,530 no return valve replacement at Mt Buller's Boggy 2.
- Continuation of the multi-year staged rising main replacement project at Mt Hotham.

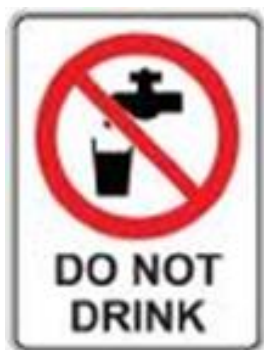
**Figure 11: Signage displayed at all water outlets**

- A blanket signage program for all water outlets on the resort has been completed and maintenance schedule that is monitored through the resort Water Supply Risk Management Plan. All water outlets have been signed warning visitors to Lake Mountain that water is untreated and of the health risks that may arise from its use.
