ANNUAL REPORT 2019-20

DRINKING WATER SUPPLY

MT BULLER & MT STIRLING ALPINE RESORTS

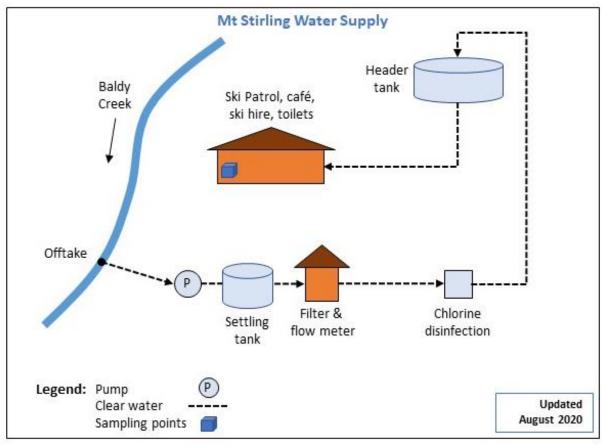
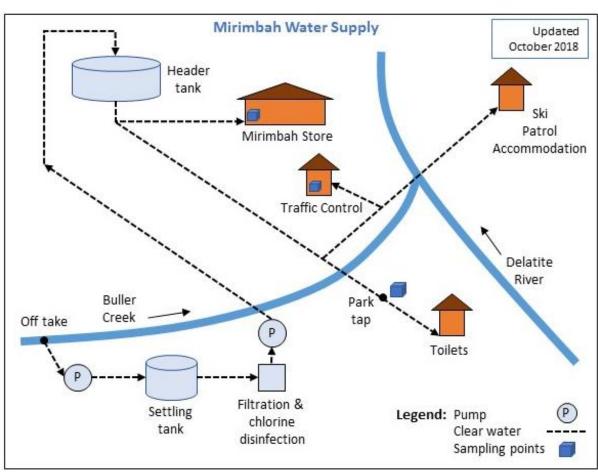
The Mirimbah water supply comes from the perennial and reliable Buller Creek, approximately 300m upstream from the junction with the Delatite River at an elevation of 620m. Water is collected through a small diversion channel, pumped to a settling tank, passed through cartridge filters, dosed with hypochlorite, and then pumped to an elevated tank approximately 60m higher than the creek. Water is then gravity fed to the Mirimbah Store, resort entry building, public toilets, and to the ski patrol accommodation on the far side of the Delatite River (refer over).

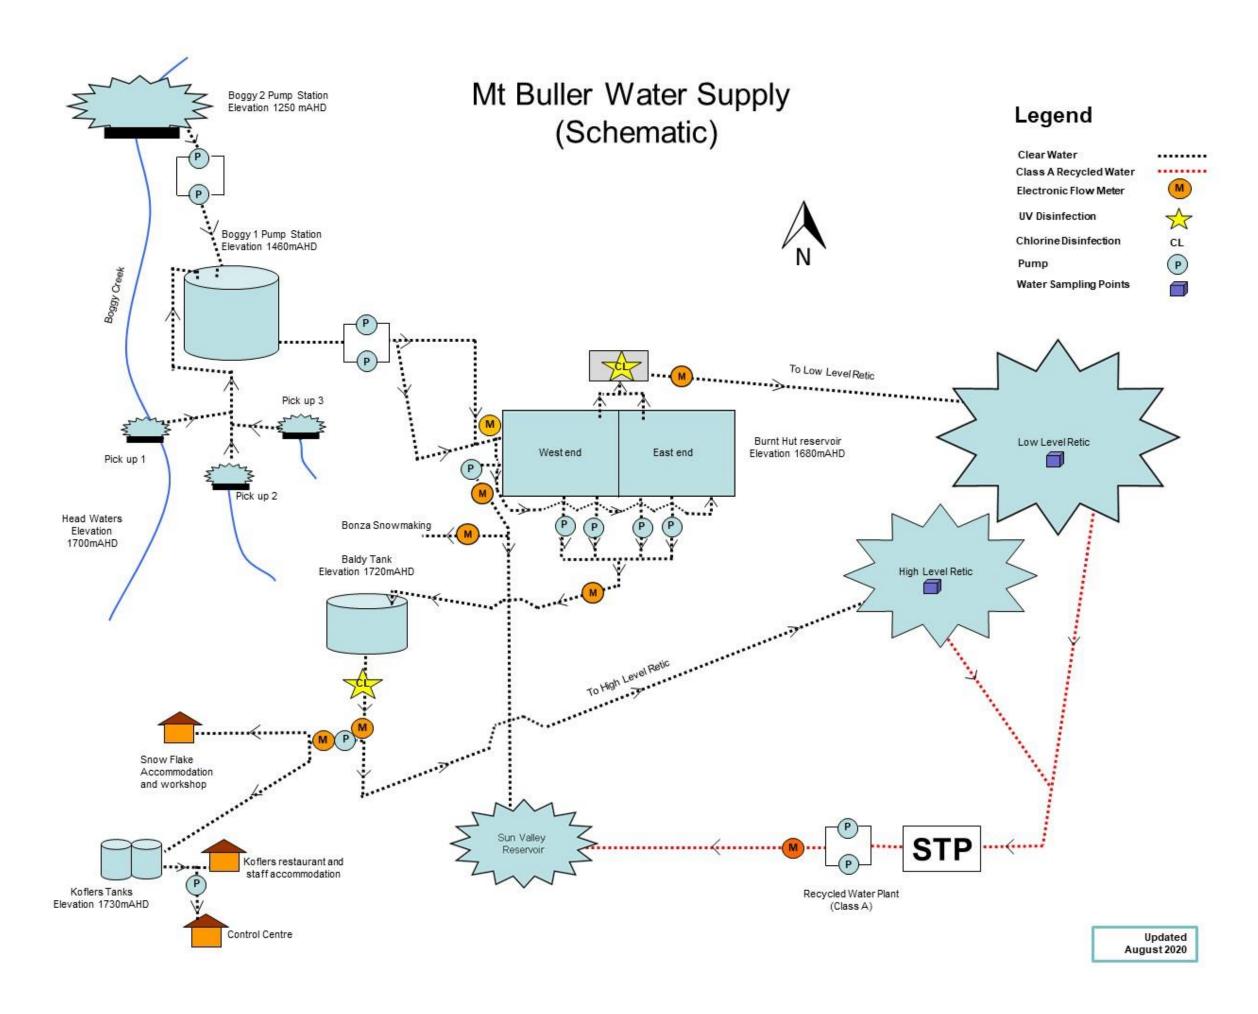
There is a 100m elevation difference across the Village. This results in the reticulation being divided in two and fed from reservoirs at different levels to keep the maximum water pressure within the system below 1,000KPa. Source water is drawn from Boggy Creek and pumped to an open (600 KL) holding tank. Source water from the Catchment Weirs is gravity fed into the same tank. This water is then pumped into the open Burnt Hut Reservoir, along with water from the Headwaters. This reservoir serves the low-level reticulation system with water subjected to UV radiation and dosed with hypochlorite before being reticulated throughout the lower two thirds of the village.

Water is also pumped from Burnt Hut reservoir to an underground concrete tank (1 ML) reservoir known as Baldy Reservoir. This serves the upper-level reticulation system with water subjected to UV radiation and dosed with hypochlorite before being gravity fed throughout the upper third of the Village, to the lift company workshop and public toilet, and to a restaurant in the ski area called Kofler's Hutte. The workshops are served by a rising main, while Kofler's is served through a rising main to two storage tanks ($2 \times 10 \text{ KL}$) and then gravity fed to the Hutte.
