# **DRINKING WATER QUALITY ANNUAL REPORT 2022-2023**

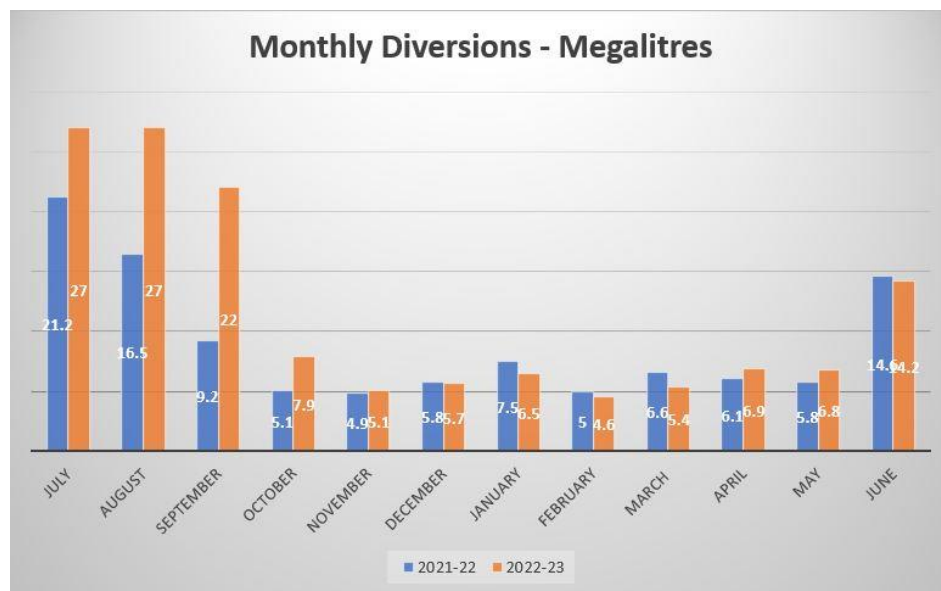
Water consumption for the 2022-23 reporting period increased closer to volumes seen pre-2020. The average demand for the six years prior to 2020 was 160ML per year. The 2022 ski season was one of the biggest on record with huge visitation. Unfortunately, the summer season was impacted due to the landslide on the Bogong High Plains Road, which closed the road and access to Falls Creek for six months.

The monthly diversions for the past two reporting periods are shown in the graph below:

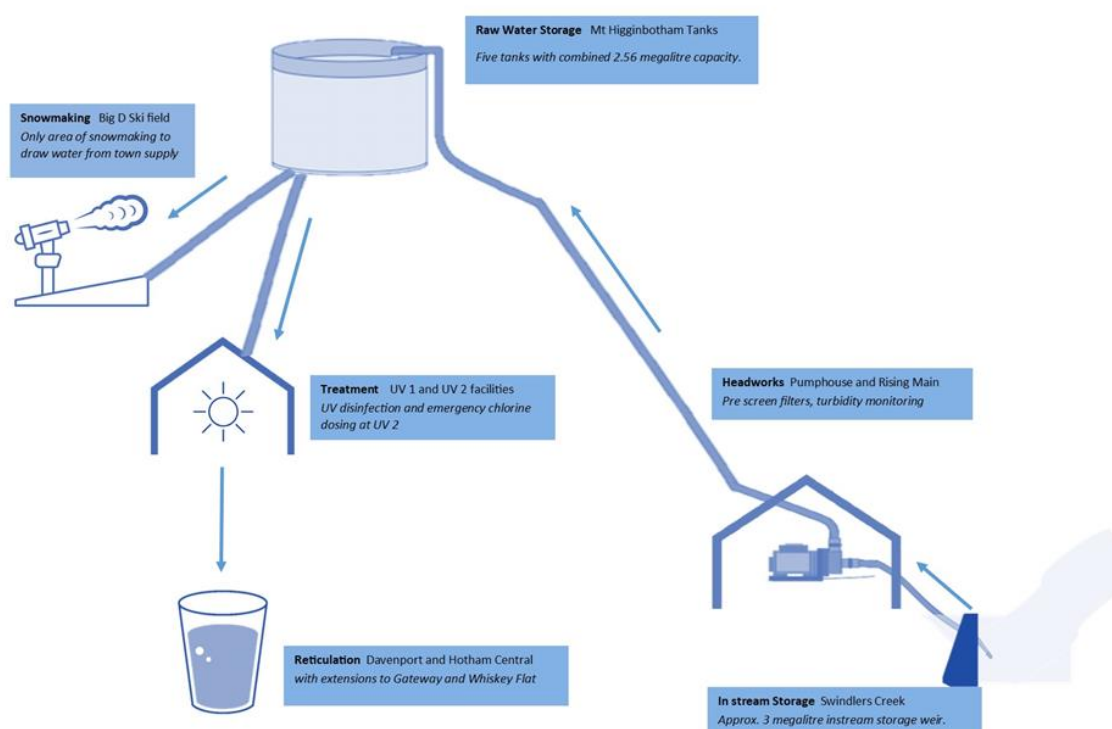
**Figure 3.1. Schematic overview of water supply system**

Water is sourced from Upper Swindlers Creek, a catchment of approximately 177 hectares. Water is collected at the Swindlers pipeline inlet headwall and raw water is gravity fed to the pump station before being pumped through a pressure rising main to storage tanks located at the summit of Mt Higginbotham. From the storage tanks, raw water flows to the ultraviolet (UV) units 1 and 2 where it is disinfected immediately prior to its distribution to customers through the village water reticulation system. The water supply system is outlined in Table 1 and a working overview is shown in Figure 1. The key components of the water supply system are detailed in Figure 1.

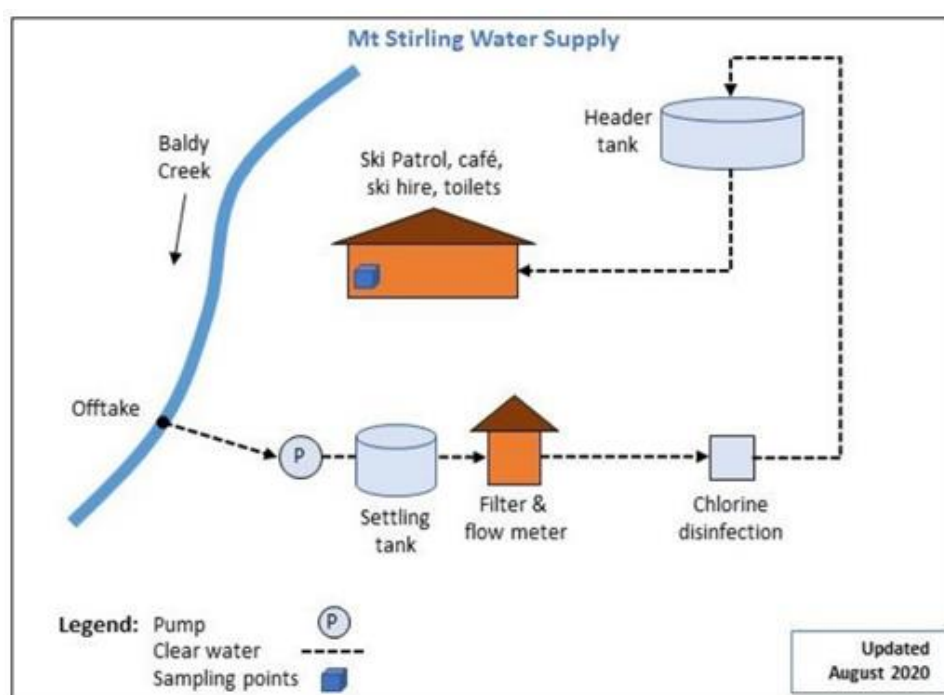
**Figure 4.1: Mt Stirling Water Supply**

The Mt Stirling water supply comes from the perennial and reliable Baldy Creek which runs adjacent to the building at Telephone Box Junction. Water is pumped from the creek to a settling tank, passed through carbon and cartridge filters, dosed with hypochlorite, pumped to a header tank, and then gravity fed through the reticulation system.

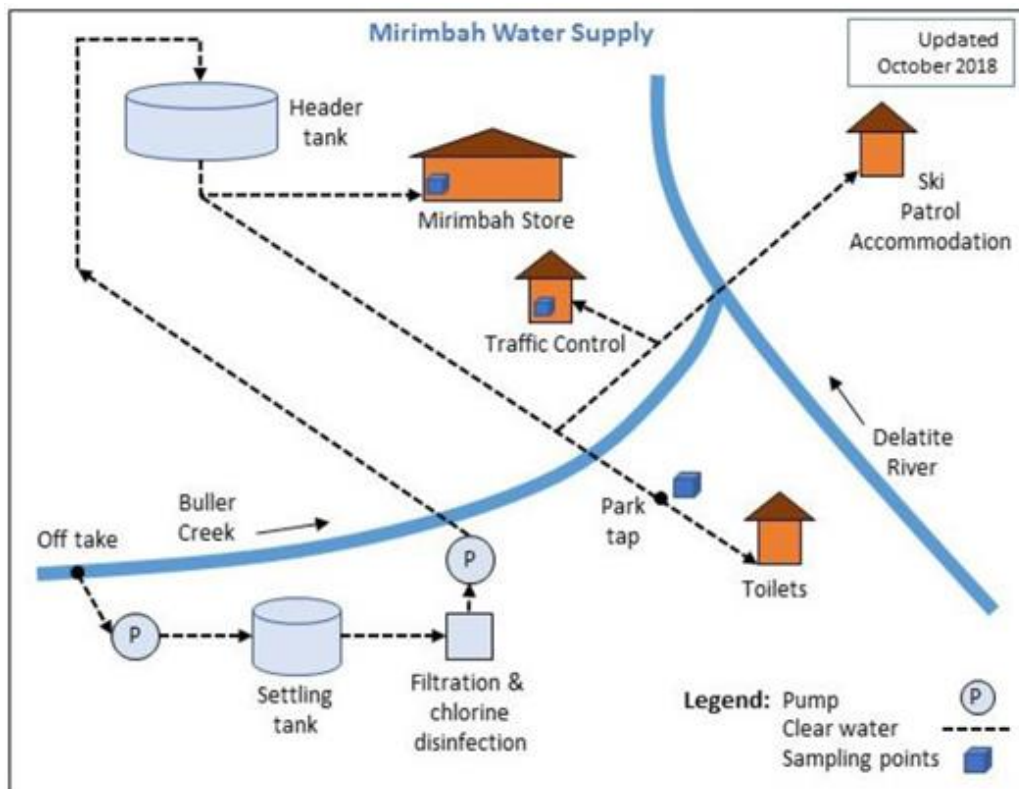
**Figure 4.2: Mirimbah Water Supply**

The Mirimbah water supply comes from the perennial and reliable Buller Creek, approximately 300m upstream from the junction with the Delatite River at an elevation of 620m. Water is collected through a small diversion channel, pumped to a settling tank, passed through cartridge filters, dosed with hypochlorite, and then pumped to an elevated tank approximately 60m higher than the creek. Water is then gravity fed to the Mirimbah Store, resort entry building, public toilets, and to the ski patrol accommodation on the north side of the Delatite River. Recently a low voltage chlorine analyser has been installed at the header tank which is viewed via SCADA and alarmed if chlorine levels drop below target range. This alarm is via a SMS message to GVW operators and their control centre.

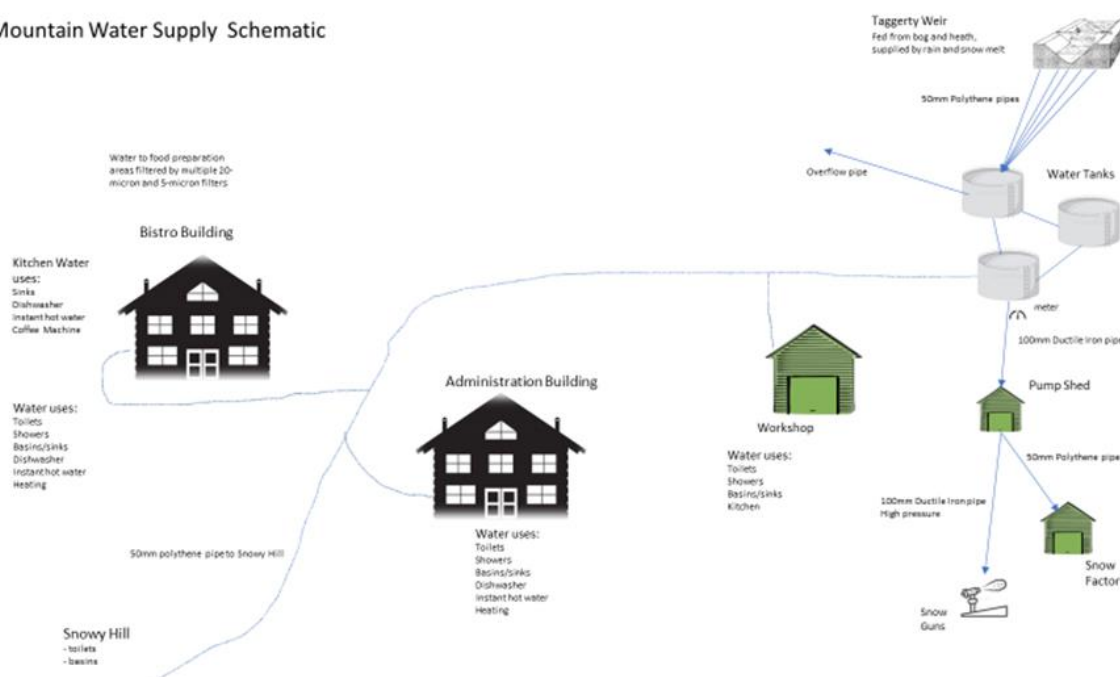
Figure A1: Lake Mountain Alpine Resort water supply schematic drawing

Lake Mountain Water Supply Schematic
