# Alpine Resorts Victoria

## Drinking Water Quality Annual Report 2024-25

29 October 2025

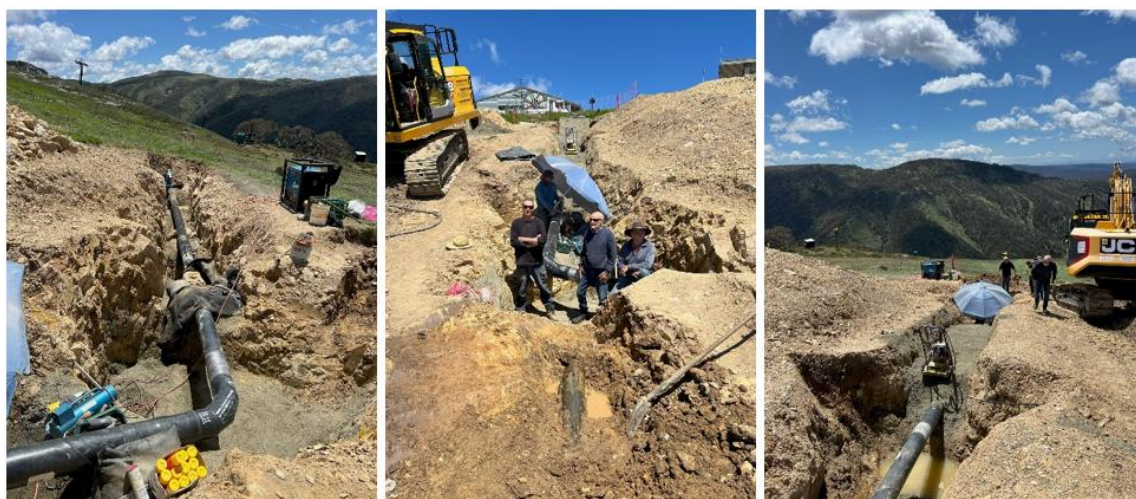
**Figure 9: Final Section of Raw Water Rising Main Replacement Project**

At Mt Hotham, Stage 2 of the raw water rising main replacement has been a unique and challenging multi-year project that began in 2018 (Stage 1, a lower section, was carried out in 2009/10). Due to the steep terrain, replacement of the aging pipeline with Sintokote steel pipe, had to be done in sections, in seasons when the weather conditions allowed. The final \$90K section of the (approx.) \$2M project was completed in December 2024 (figure 9).

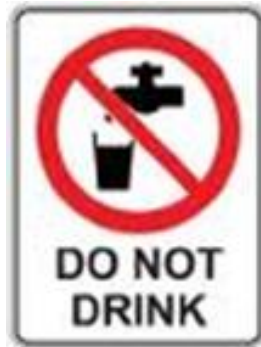
Plan. All water outlets have been signed warning visitors to Lake Mountain that water is untreated and of the health risks that may arise from its use.

**Figure 11: Signage displayed at all water outlets**
